**The City of Clearwater
North Ward School**

Building Assessment
August 13, 2024

Final Issuance

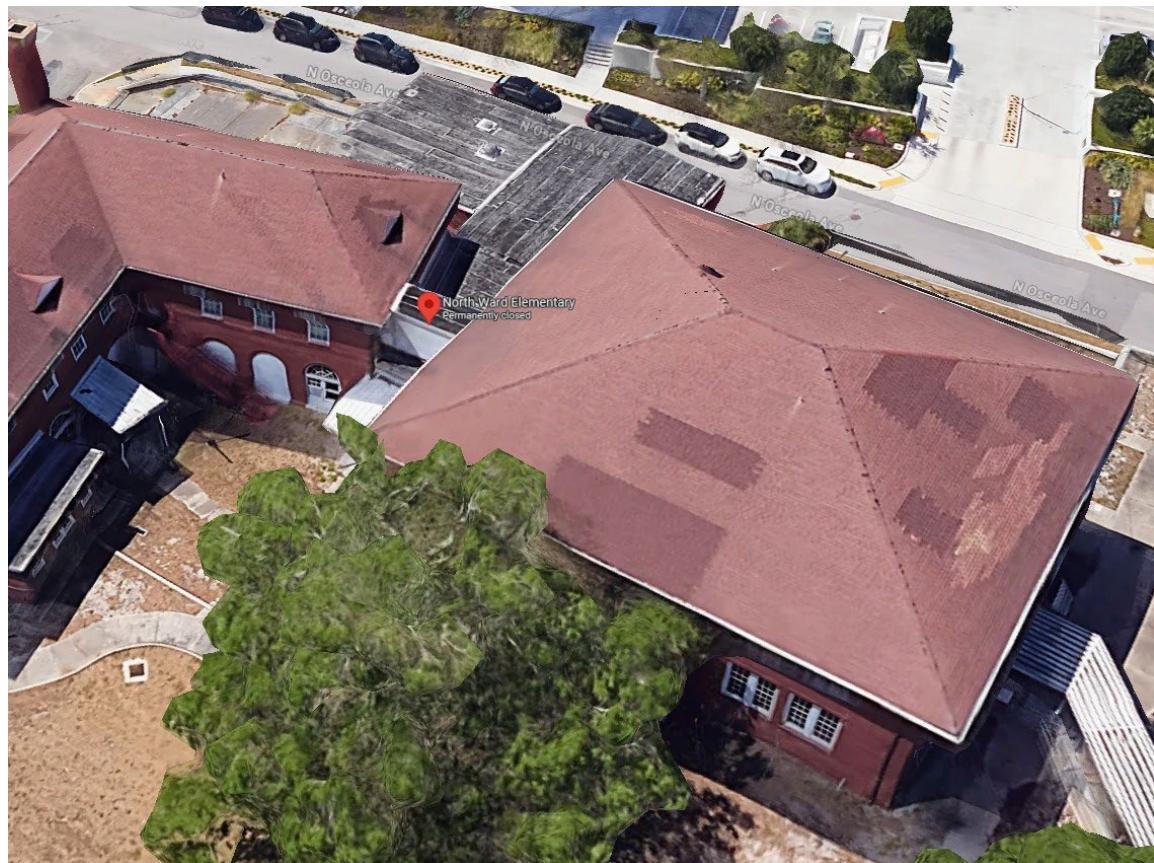
Aerial images of the roof indicate where roof repairs have occurred, based on the mismatched color shingles (*Figure 5*). Several rooms inside the building show evidence of active roof leaks (*Figure 6*). Given the amount of apparent water intrusion, it is likely that significant portions of the sheathing will need to be replaced, and perhaps some structural framing members as well. The extent of required repair cannot be assessed until the roofing has been removed.

Figure 5 – Aerial of Building 1

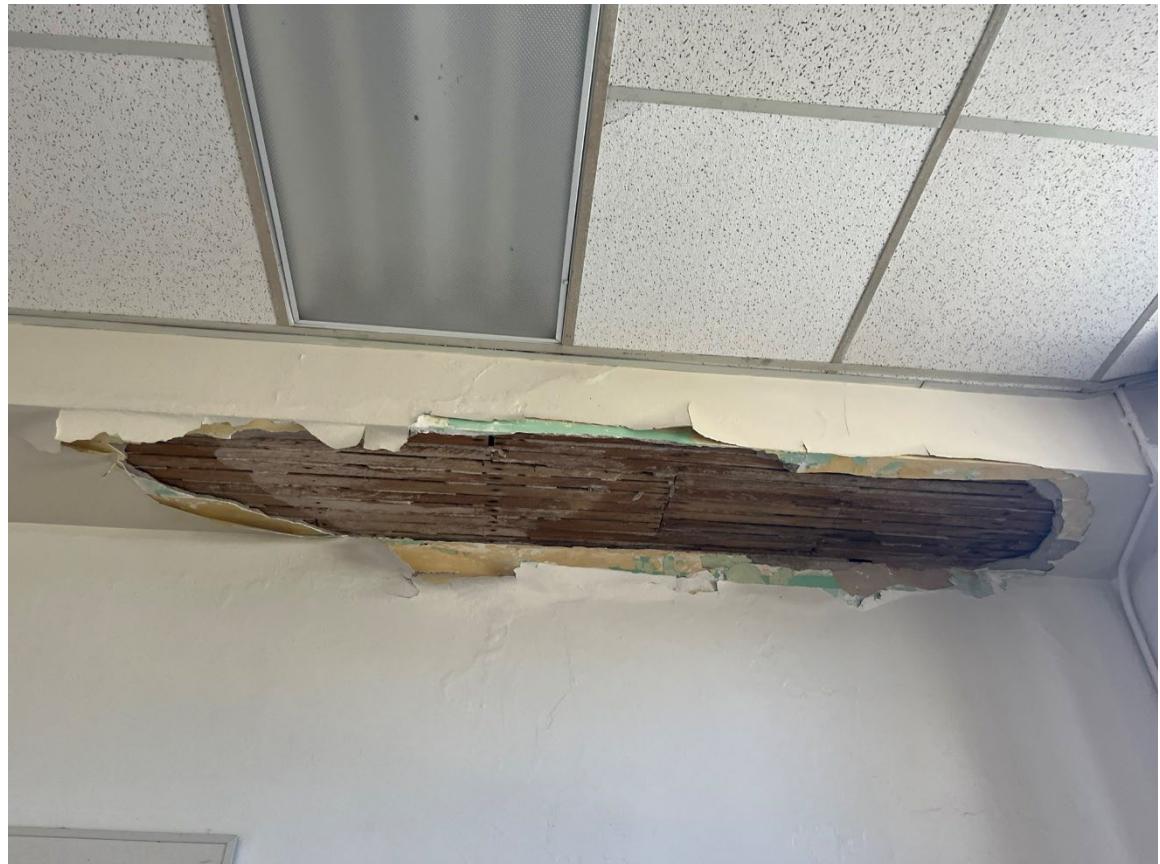
Figure 6 – Building 1 water damage

As noted previously, water intrusion from the roof has damaged ceiling tiles in several locations.

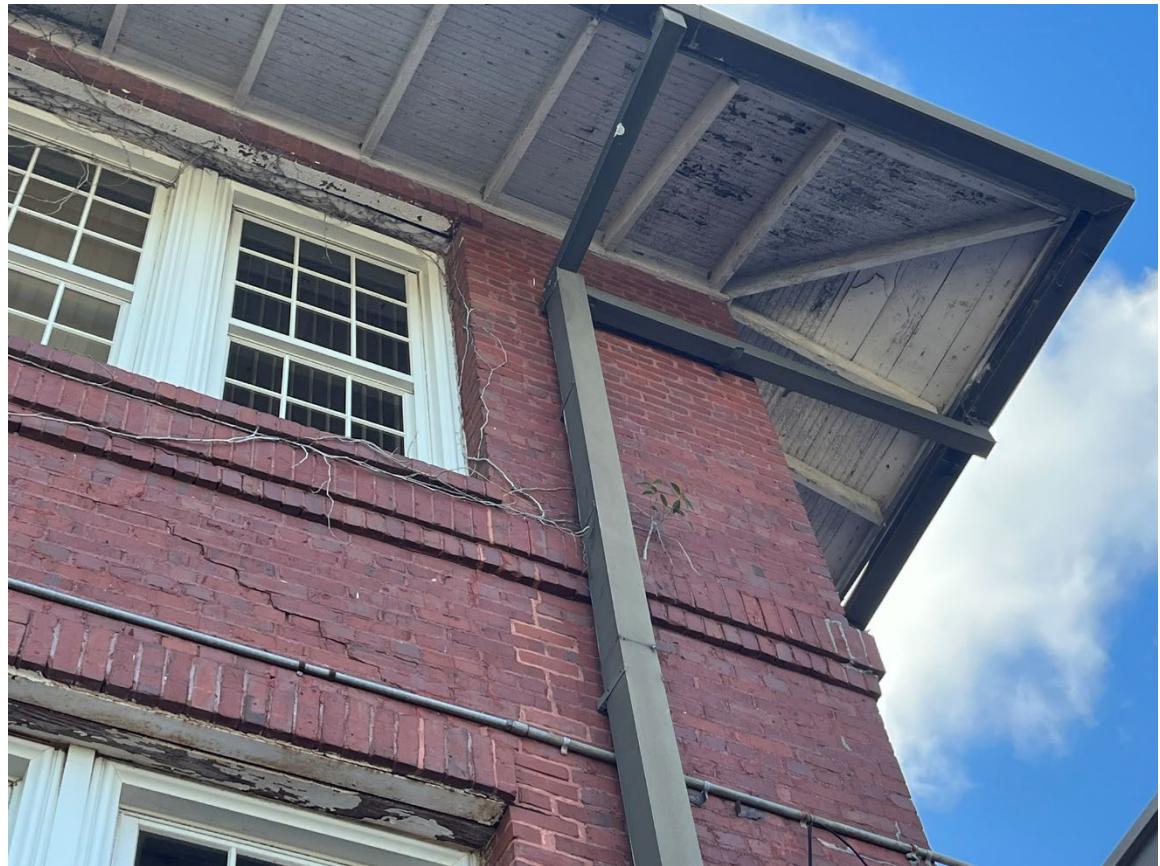
The gutters and downspouts are a mix of non-historic aluminum components (*Figure 7*). Some of the gutters have partially detached from the roof fascia. There are still some historic (though non-original) cast iron downspouts at or near grade.

Figure 7 – Building 1 gutters and downspouts

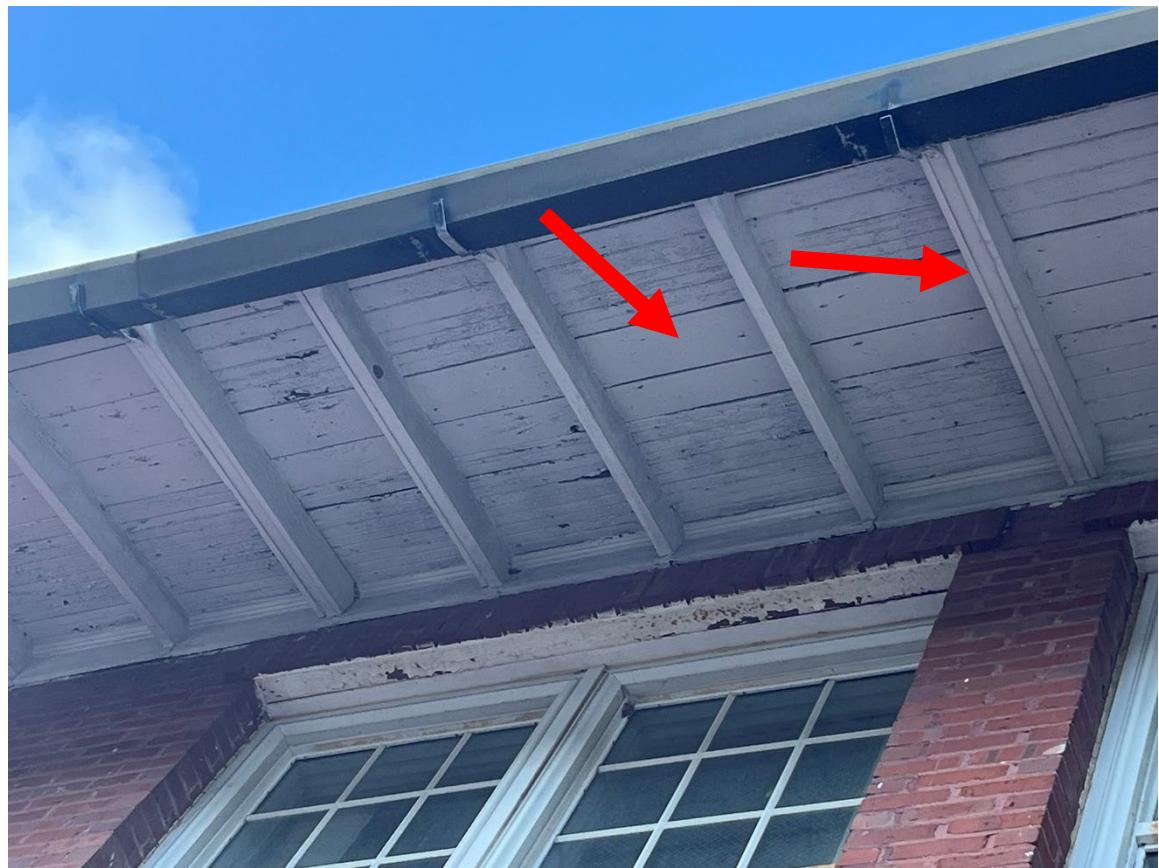
The roof overhang includes exposed 2x6 rafter tails spaced at 24 inches on center. The eave soffit material is tongue & groove wood beadboard. It is evident that repairs have been made over the years with dissimilar components (*Figure 8*) indicating that the original beadboard has suffered from water and/or termite damage. Similarly, repairs have been made to a few of the rafter tails, new members sistered to an existing member for structural support (*Figure 8*). The fascia and frieze boards sag and have partially detached in areas.

Figure 8 – Building 1 roof eave repairs

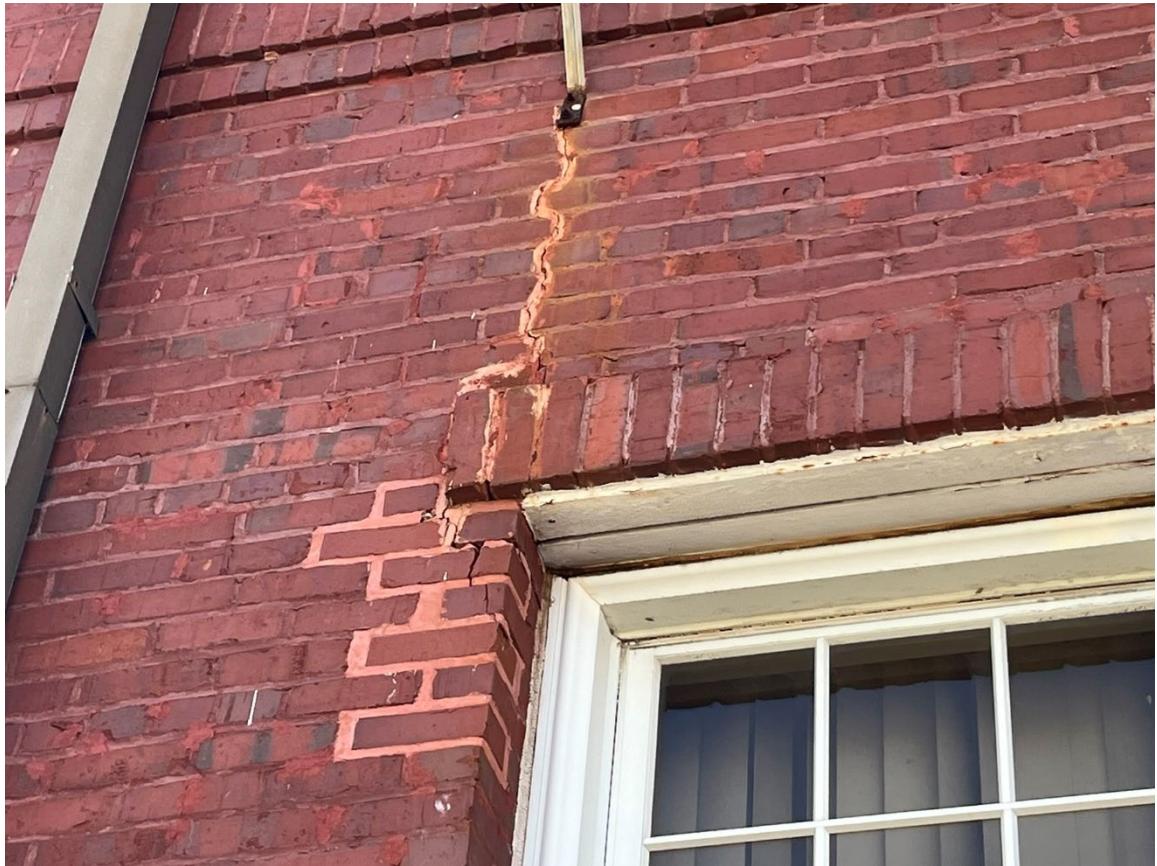
The condition of the brick is fair to good; other than structural work needed to repair step cracking (Figure 11), which is addressed elsewhere in this report, the brick itself shows little sign of deterioration. The mortar is also in fair to good condition, and requires only minor, targeted repointing.

Figure 11 – Building 1 step cracking

This movement also results in step cracking at the corner of the masonry opening (*Figure 11*). This type of settlement is common in buildings of this age but needs to be addressed. Refer to the structural assessment in this report.

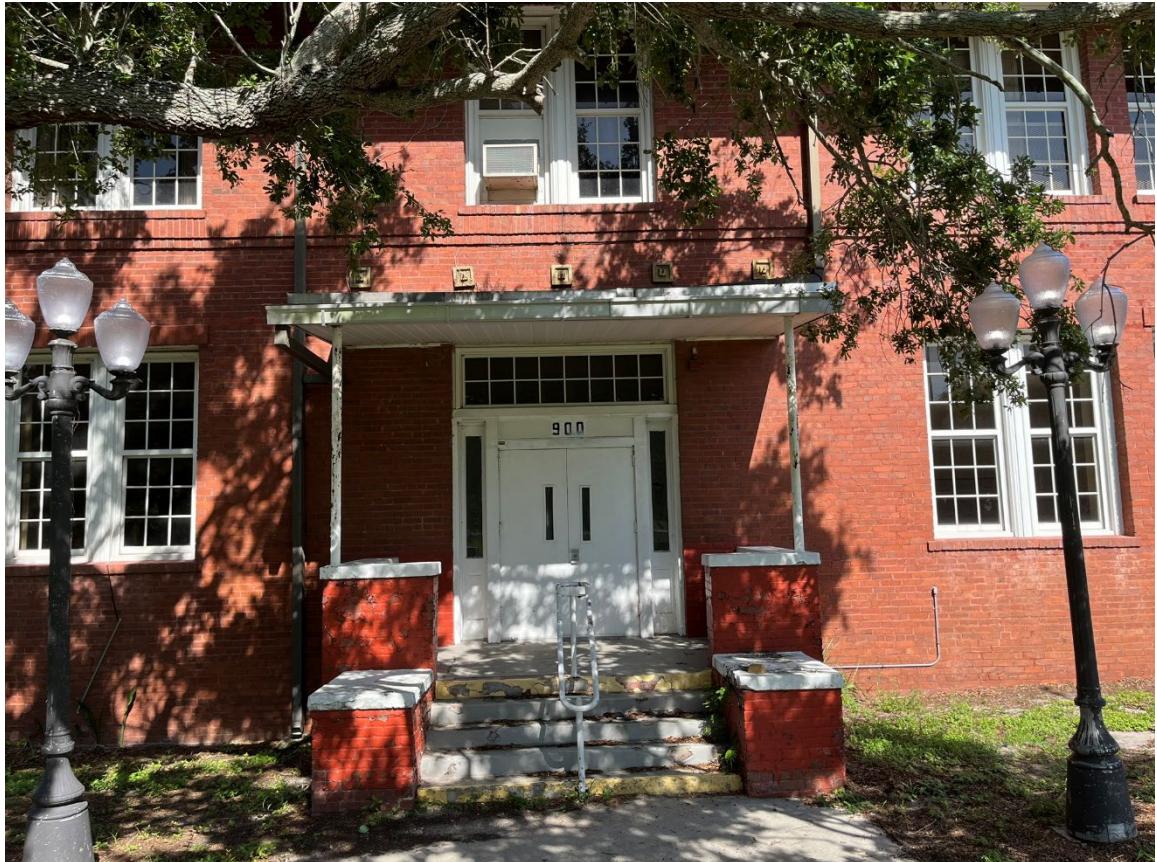
The front and side entry landings have been painted – both the brick wall construction as well as the cast stone coping caps (Figure 12). There is spray paint graffiti in some areas around the building, which has been partially cleaned and/or painted over.

Figure 12 – Building 1 entry stairs

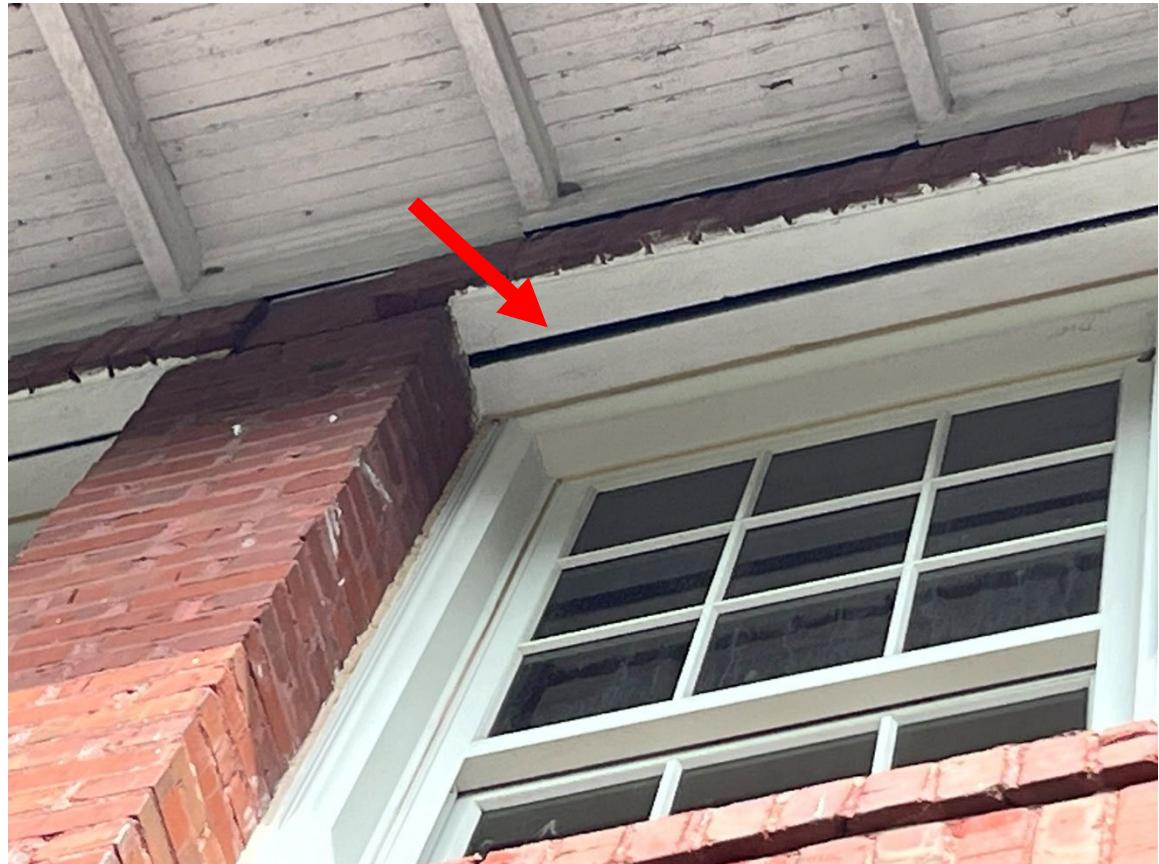
The masonry above each window opening is supported by back-to-back steel angle lintels. The paint on the lintels is peeling and the steel exhibits rust. More concerning is the uneven and wide gap between the lintels above some of the windows (*Figure 17*). This gap suggests that the masonry wall has settled, and this shift has pulled apart the lintels.

Figure 17 – Building 1 window lintels

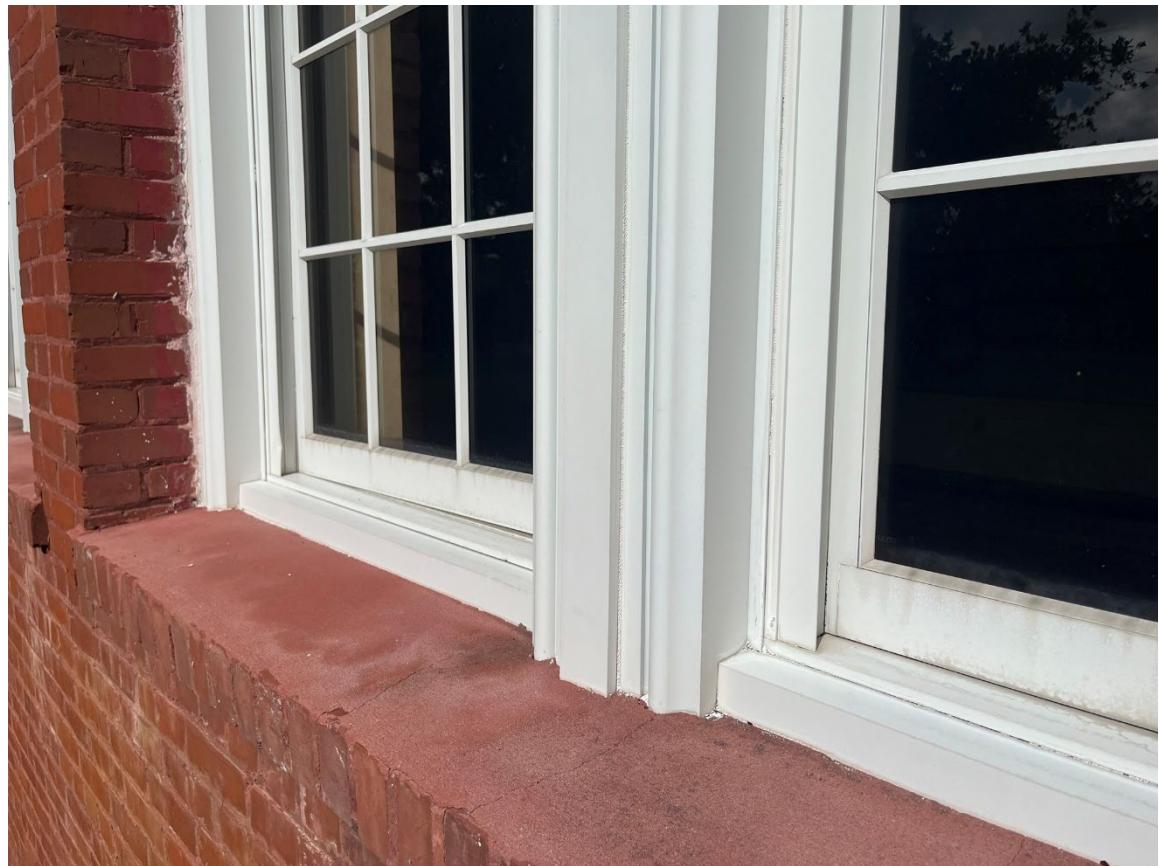
The windows sills are sloped with a mortar wash. Most of the sloped washes are intact but display cracking (*Figure 18*).

Figure 18 – Building 1 window sills

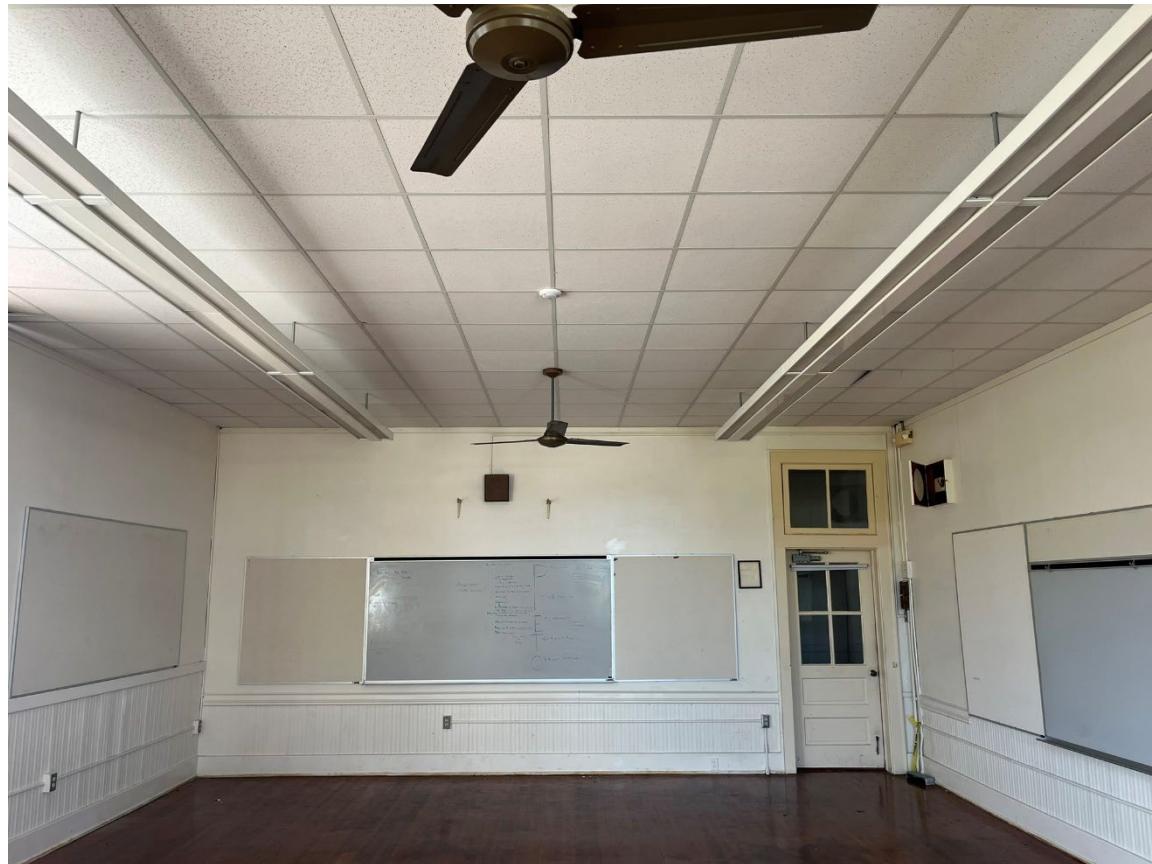
The existing ceiling components (light fixtures, ceiling fans, speakers, smoke detectors, etc.) are all non-historic and many are non-functioning (*Figure 19*) – refer to the electrical analysis elsewhere in this report for more information. The existing plenum space created by the contemporary dropped ceiling contains non-historic utilities, including fire sprinkler piping and loose low-voltage wiring.

Figure 19 – Building 1 lay-in ceiling

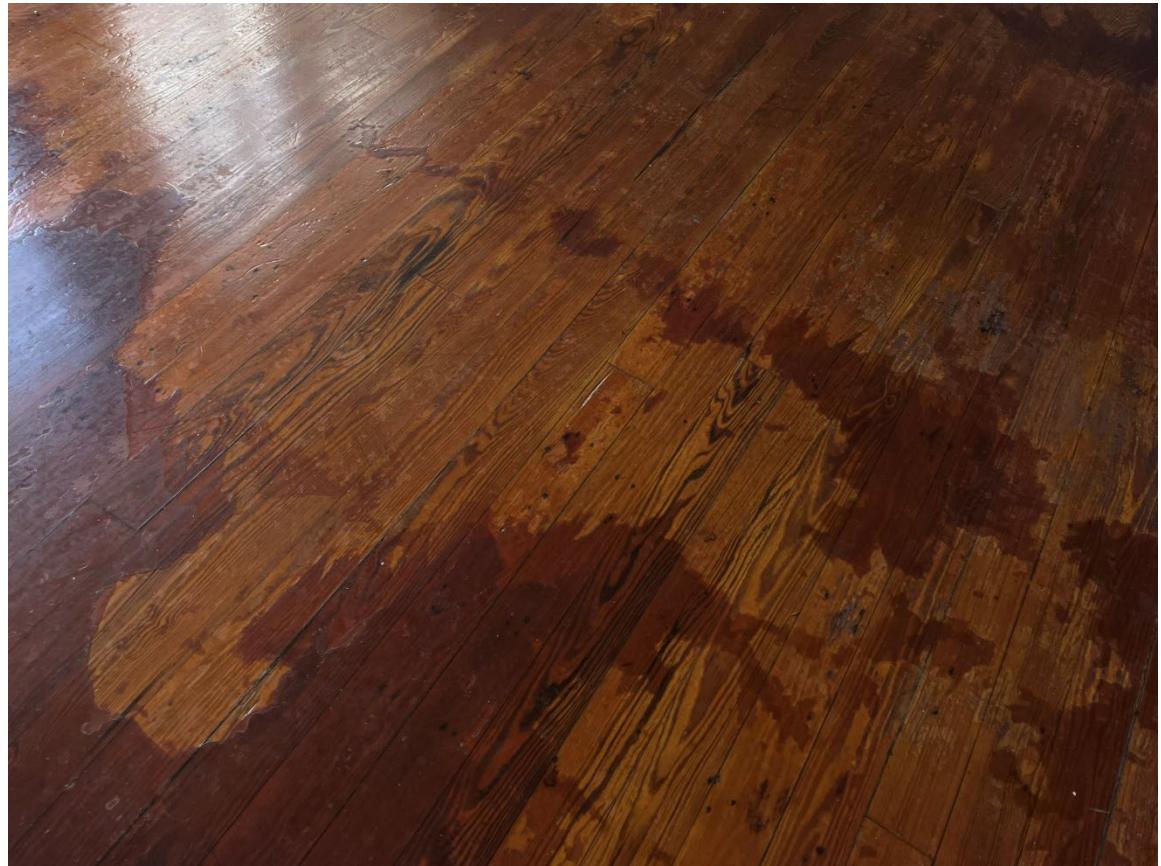
The original 3 1/4" plank pine flooring is still intact in many rooms. In one classroom on the first floor, there is significant discoloration, apparently due to misapplication of a finish or clear topcoat (*Figure 26*). In another classroom, the flooring has been sanded down, in an apparent attempt to refinish it (*Figure 27*). In general, the wood flooring appears to be in fair condition. There is some sponginess and creaking when walked upon but no areas of significant disrepair.

Figure 26 – Building 1 wood flooring

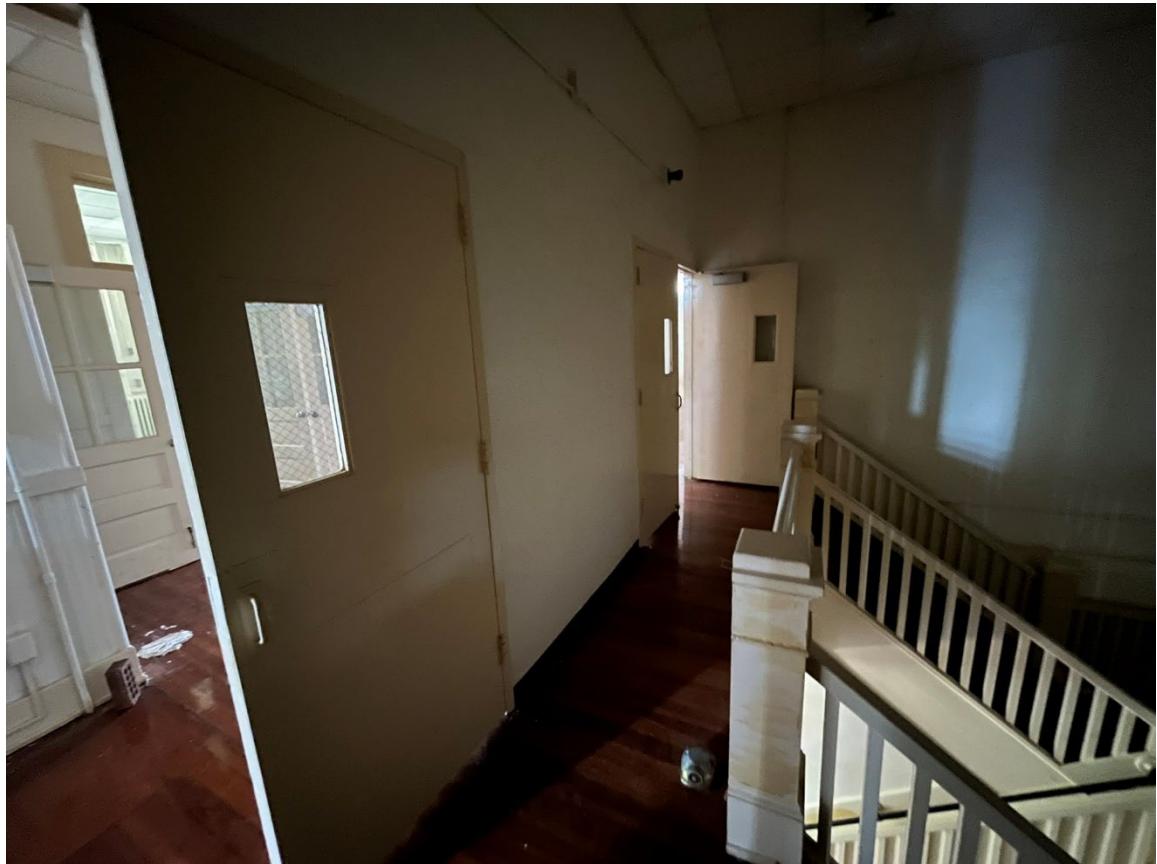
Most significantly, a partition and two sets of double doors have been added on the second floor (*Figure 35*, *Figure 36*), presumed as a means to provide fire separation between the two floors. The doors have hold-open devices on the floor.

The treads and risers generally appear to be code compliant. The balustrade is too low to act as a guard required by code. The added partition and doors at the top of the stairs are a gross modification to one of the building's character-defining features. Whether or not the current building code requires such a separation depends on the use of the building. A full analysis of the existing building, its proposed use, and the relevant codes will need to be conducted.

Figure 35 – Building 1 stair top landing

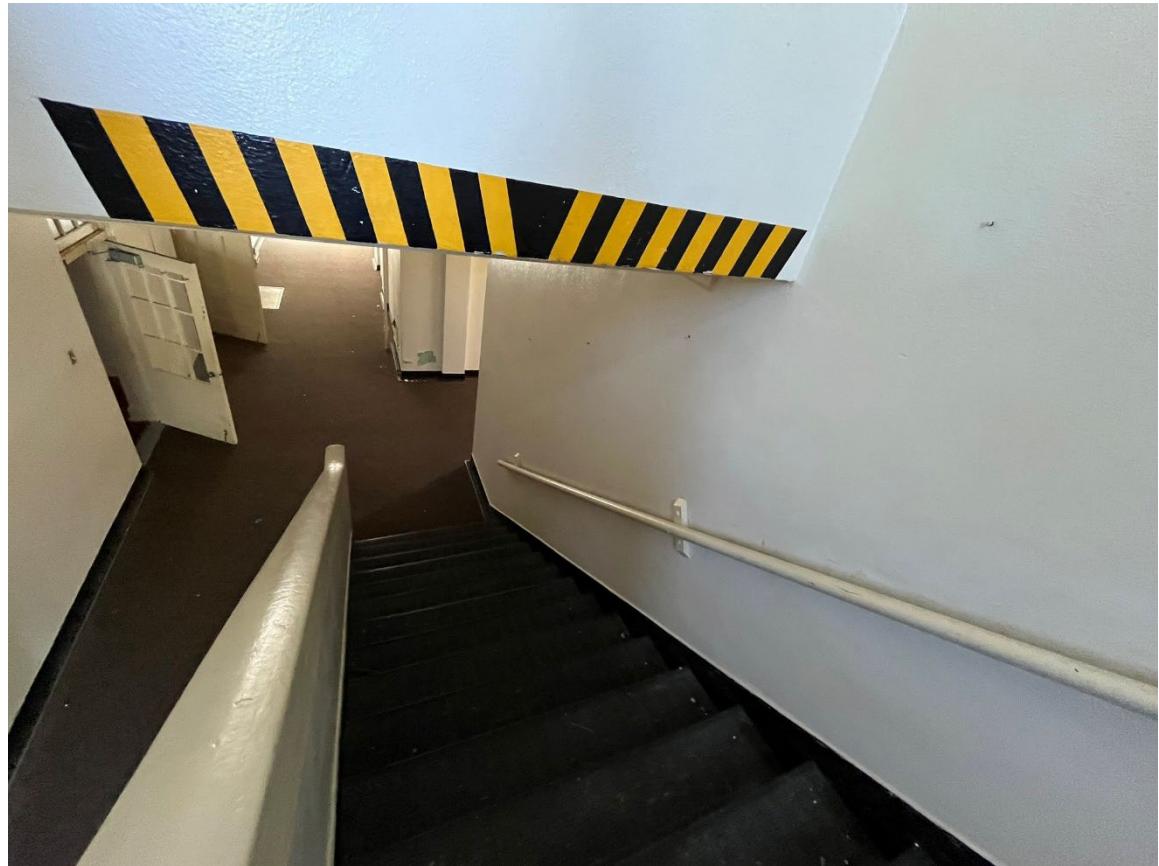
For reasons similar to Building 1, a partition and door have been added on the second floor, closing off the stairs from the corridor. No corresponding partition was added on the first floor. Relatedly, the second-floor classroom at the top of the stairs has a high window that opens into the stair enclosure. Whether or not the current building code requires a fire-rated separation depends on the use of the building. A full analysis of the existing building, its proposed use, and the relevant codes will need to be conducted. If a fire-rated enclosure is required, the classroom window will need to be eliminated. Even though the treads and risers generally appear to be code compliant, there are several code violations, including handrail configuration and an overhead obstruction on the lowest run of stairs (*Figure 55*).

Figure 55 – Building 2 stair

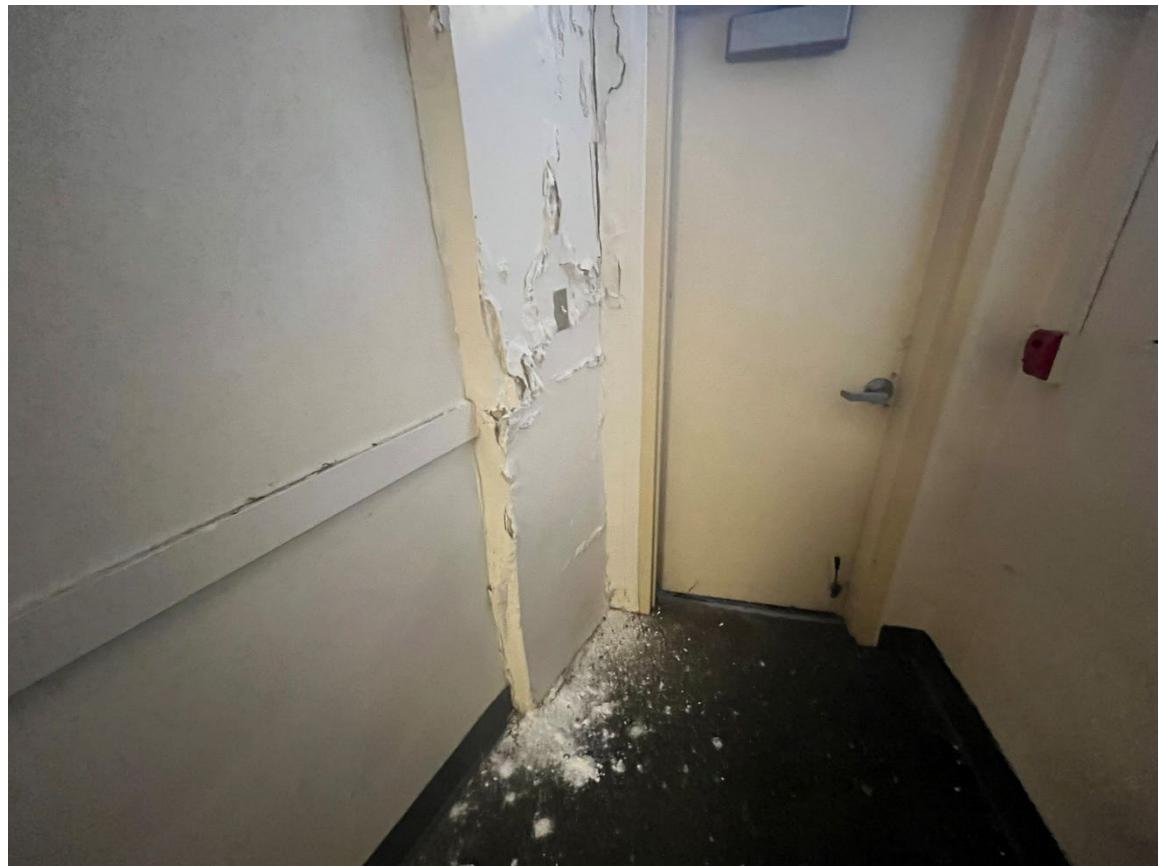
There is significant cracking in the exterior walls, visible from the inside, indicating settlement issues. Additionally, the interior paint coating is delaminating throughout the building, likely because of moisture intrusion. One area of particular concern is at the northeast corner of building where serious degradation is evident (*Figure 58*).

Figure 58 – Building 3 moisture damage

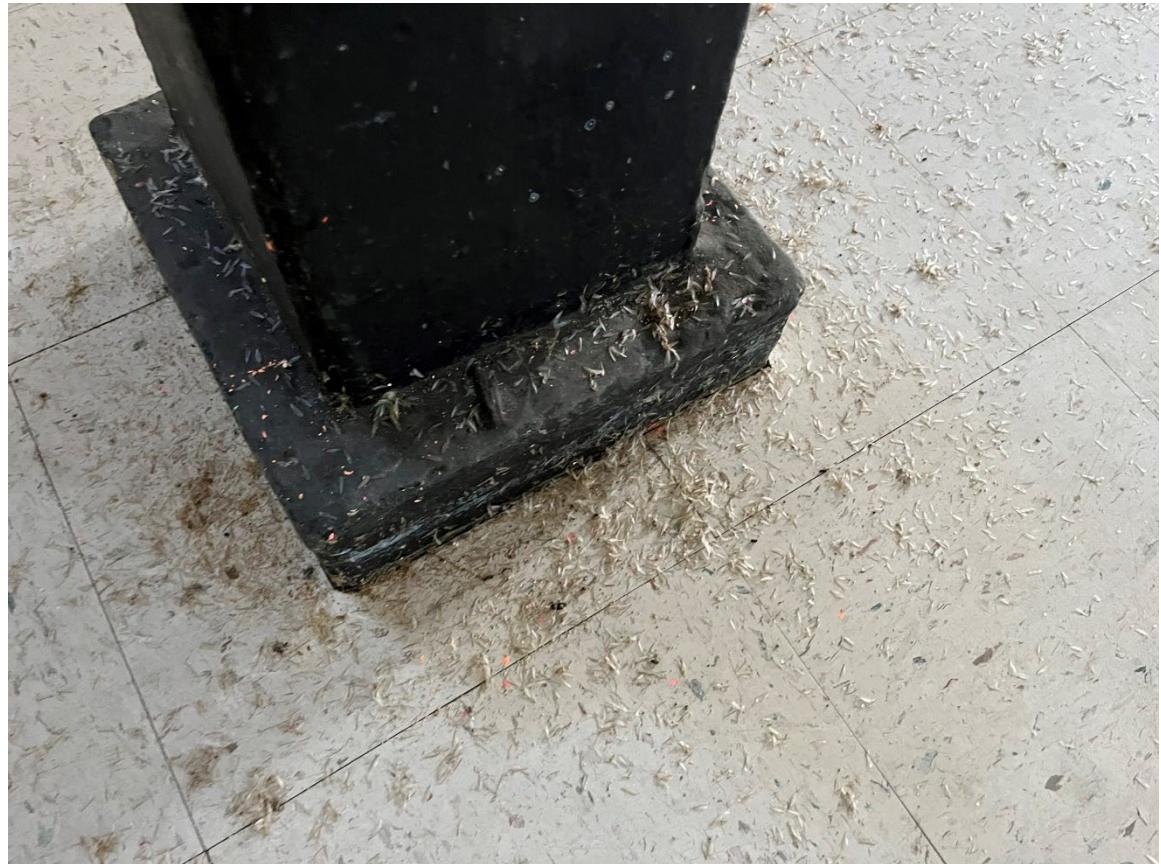
There are several significant cracks in the exterior wall, suggestive of major settlement issues. Unlike Buildings 1 and 2, there is evidence of extensive termite activity in the cafeteria (*Figure 63*). Additionally, the interior paint has delaminated from the walls in some areas, likely because of moisture intrusion.

Figure 63 – Building 4 termite activity

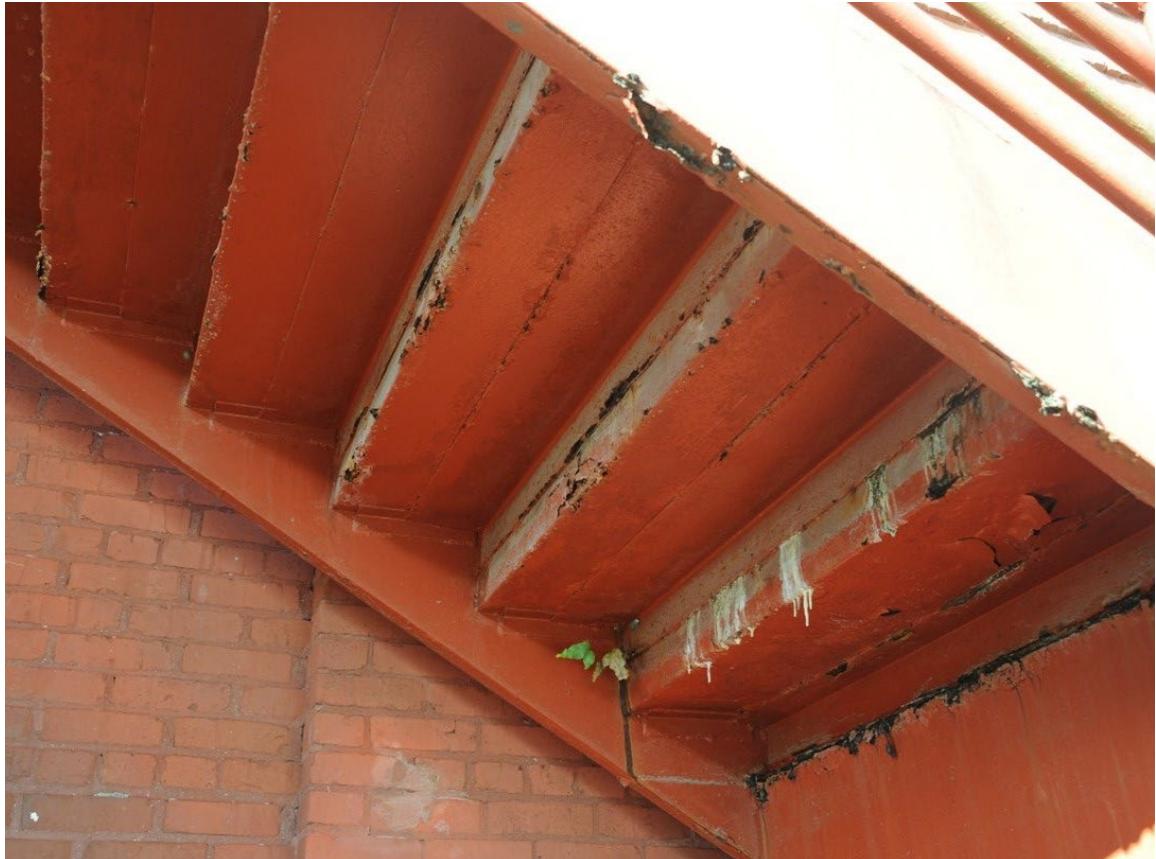
The existing 1915 and 1926 Buildings structure consists of load bearing wood studs on both sides of the corridor. Exterior walls consist of load bearing brick masonry (*Figure 68, Figure 69*). Settlement cracks were found in the brick bearing walls. It may be necessary to selectively underpin the foundations in these areas. Additional geotechnical studies will be necessary to determine the cause of the settlement. The corridor walls consist of wood studs that are 2x6 nominal @ 16" on center (*Figure 74*). The second-floor framing is 2x14 @ 16" on center. They span from the exterior load bearing walls to the corridor walls. First floor framing consists of 2x8 @ 16" on center. The framing is supported by wood girders in the crawl space spanning 12 feet supported by brick piers that were in good condition. The wood floor framing has the capacity to support a 40psf loading for classrooms. There is a concrete floor on the first floor of the 1926 building that can be seen in the boiler room (*Figure 73*). There is a metal pan stair providing egress from an assembly room on the second floor of the 1915 building (*Figure 70*). The stairs are corroded and should be replaced.

Figure 70 – View of corroded metal pan stair

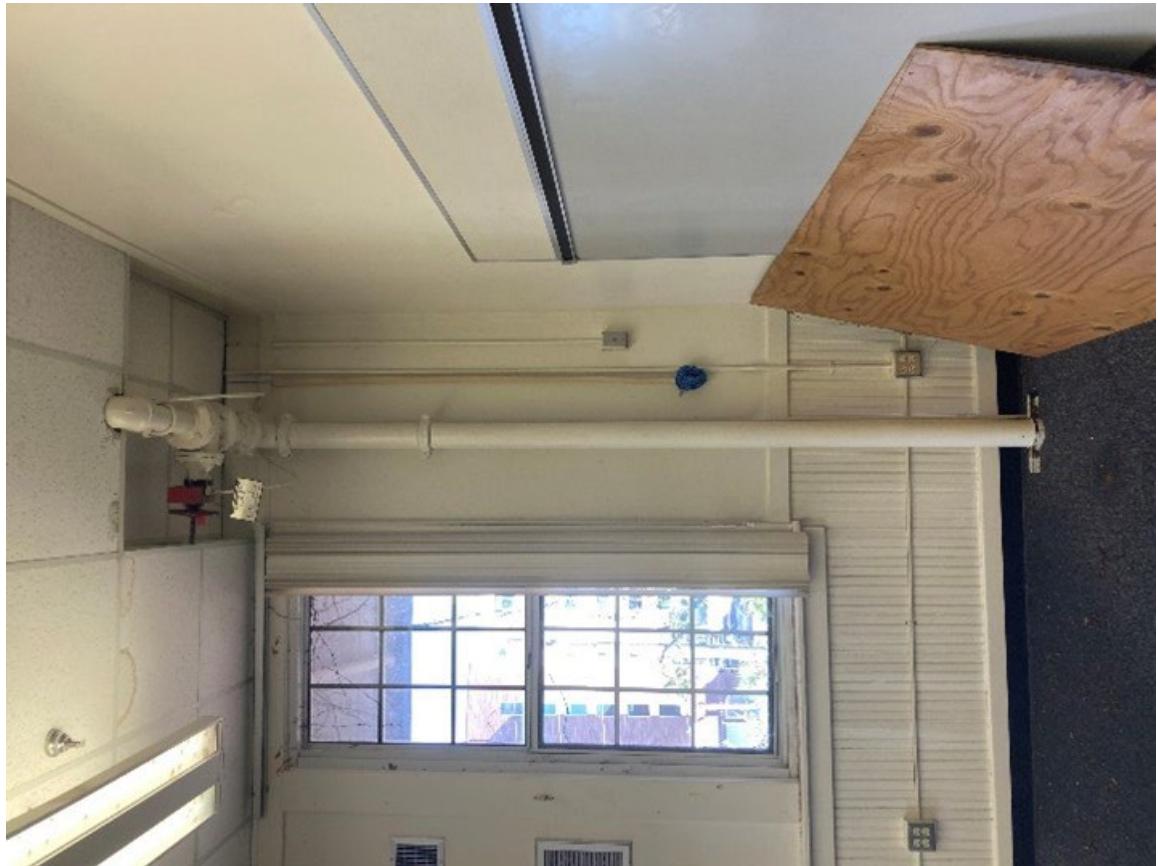
This system does not appear to be maintained. Wet pipe sprinkler systems should be tested bi-annually if not more. If not regularly tested the water will turn into a slime / slug that will not flow as intended to extinguish fires.

Figure 77 – Sprinkler riser in Building 1

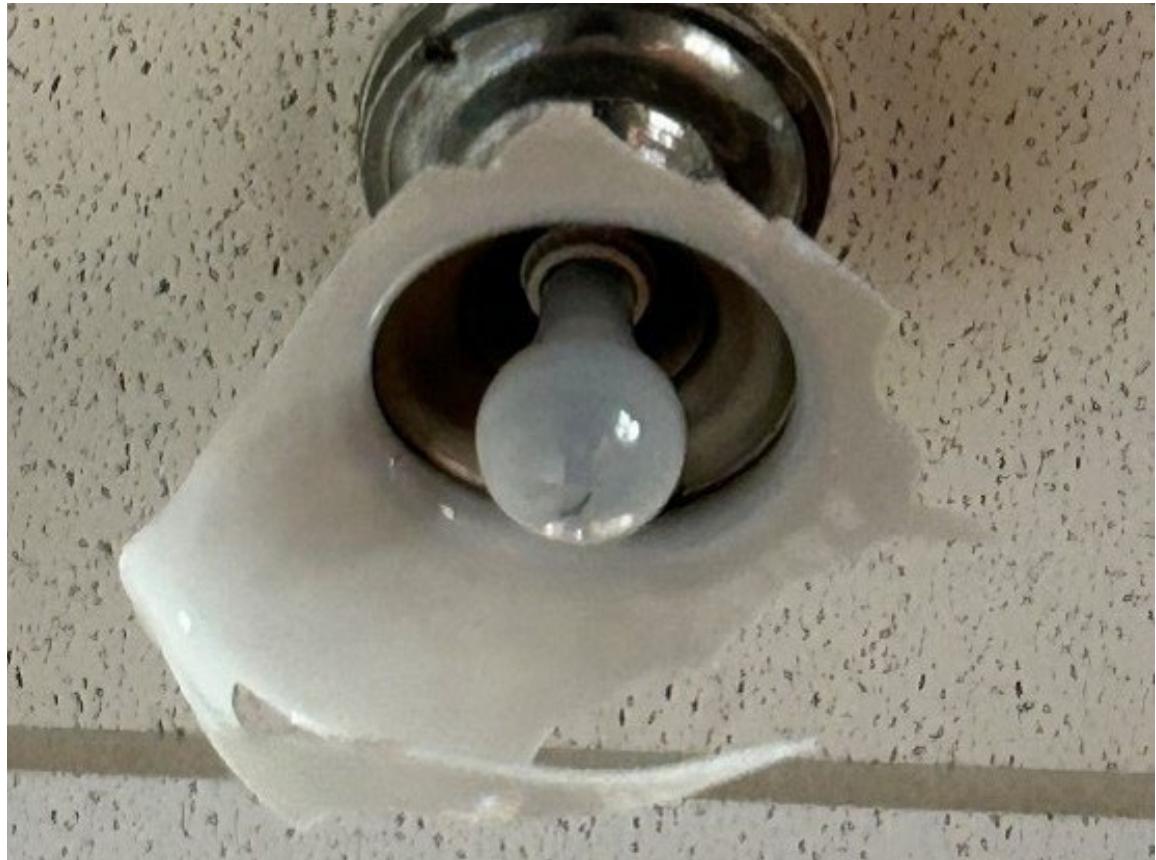
Figure 89 – Incandescent Schoolhouse Luminaire (broken)

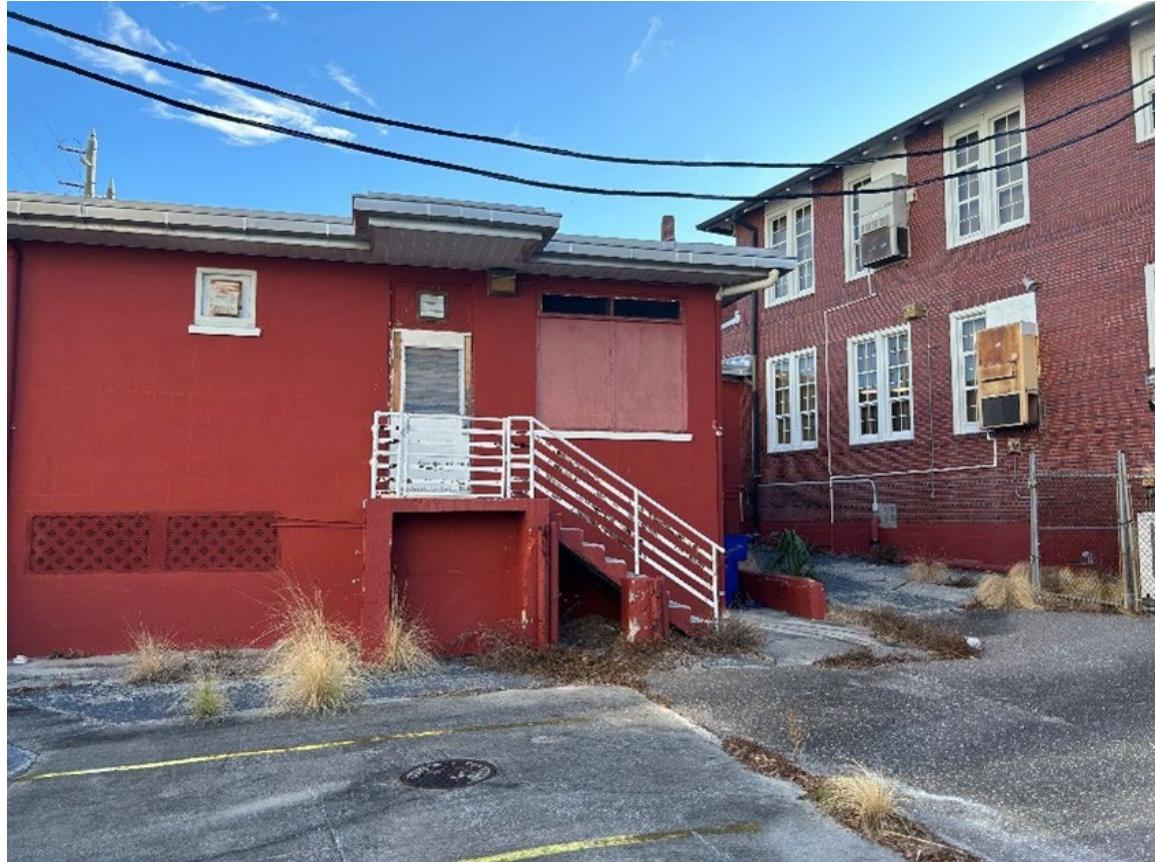
Figure 92 – Metal Halide Wall Packs - Yellowed

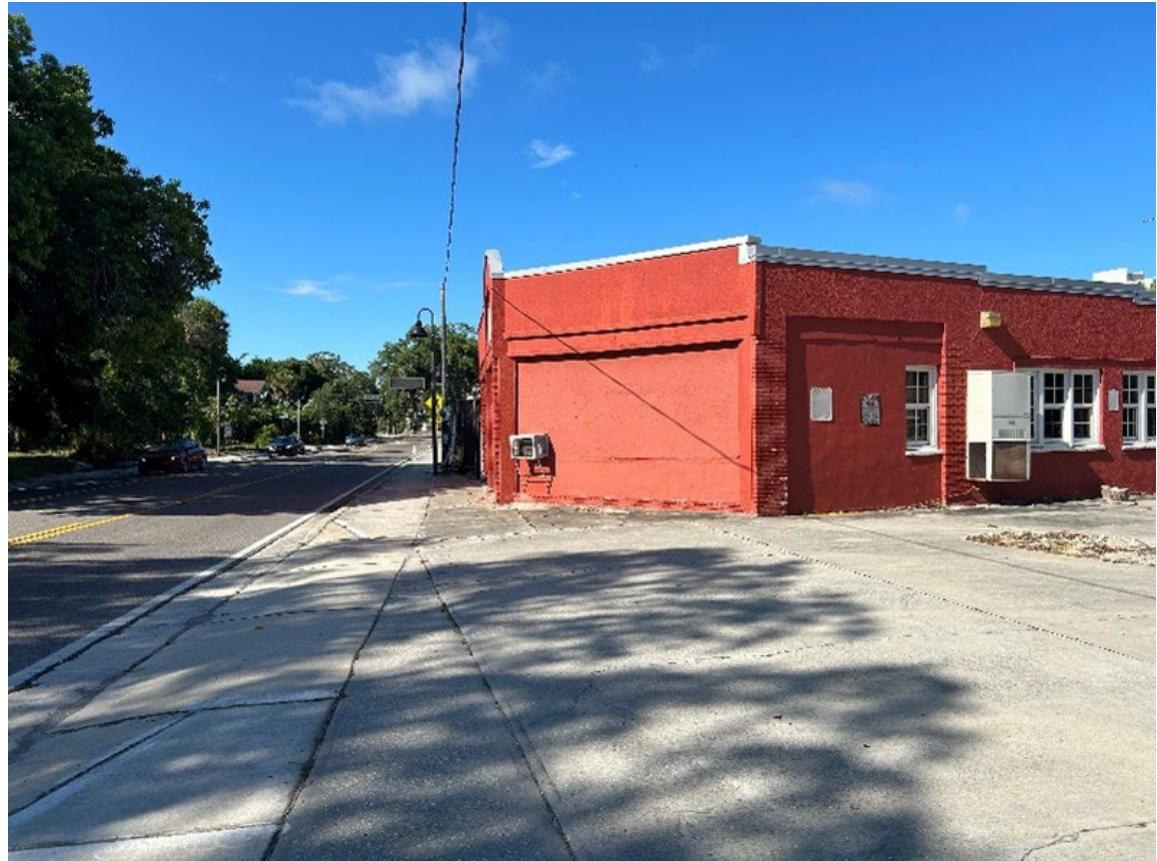
Figure 99 – Yellowed Wall Pack Lighting
