North Ward Elementary School

City Council Work Session
Sept. 15, 2025

The City of Clearwater
North Ward School

Building Assessment
August 13, 2024

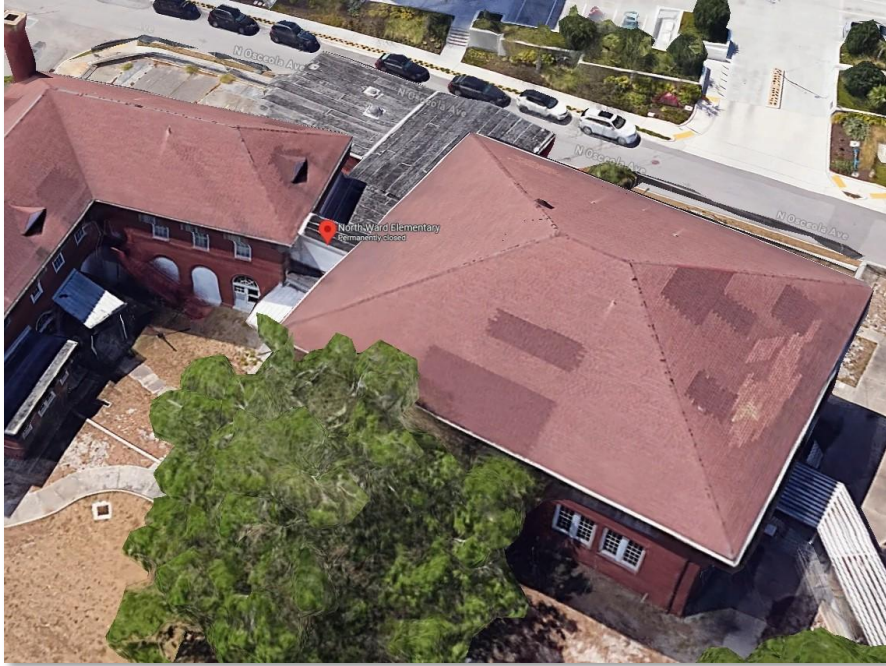
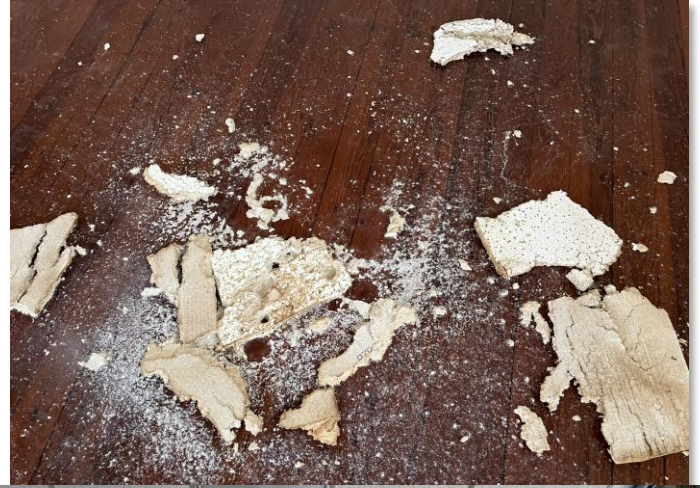
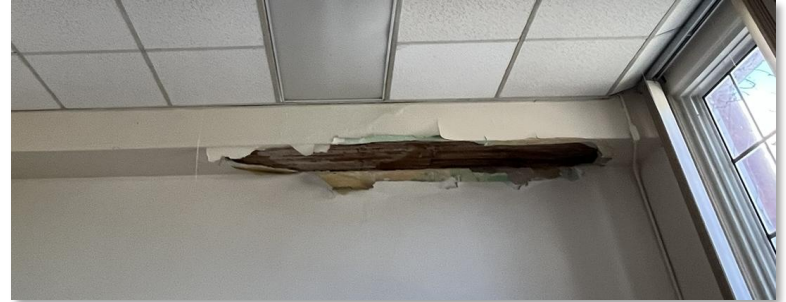
AREAS OF CONCERN - ROOF LEAKS

TIER 1 ROOF REPLACEMENT

ASPHALT SHINGLE

- +/-15 YEAR LIFESPAN
- IN-KIND REPLACEMENT
- APPROXIMATELY \$200,000

CLAY TILE

- +/-50 YEAR LIFESPAN
- IMPROVES STANDING FOR HP GRANTS
- APPROXIMATELY \$700,000

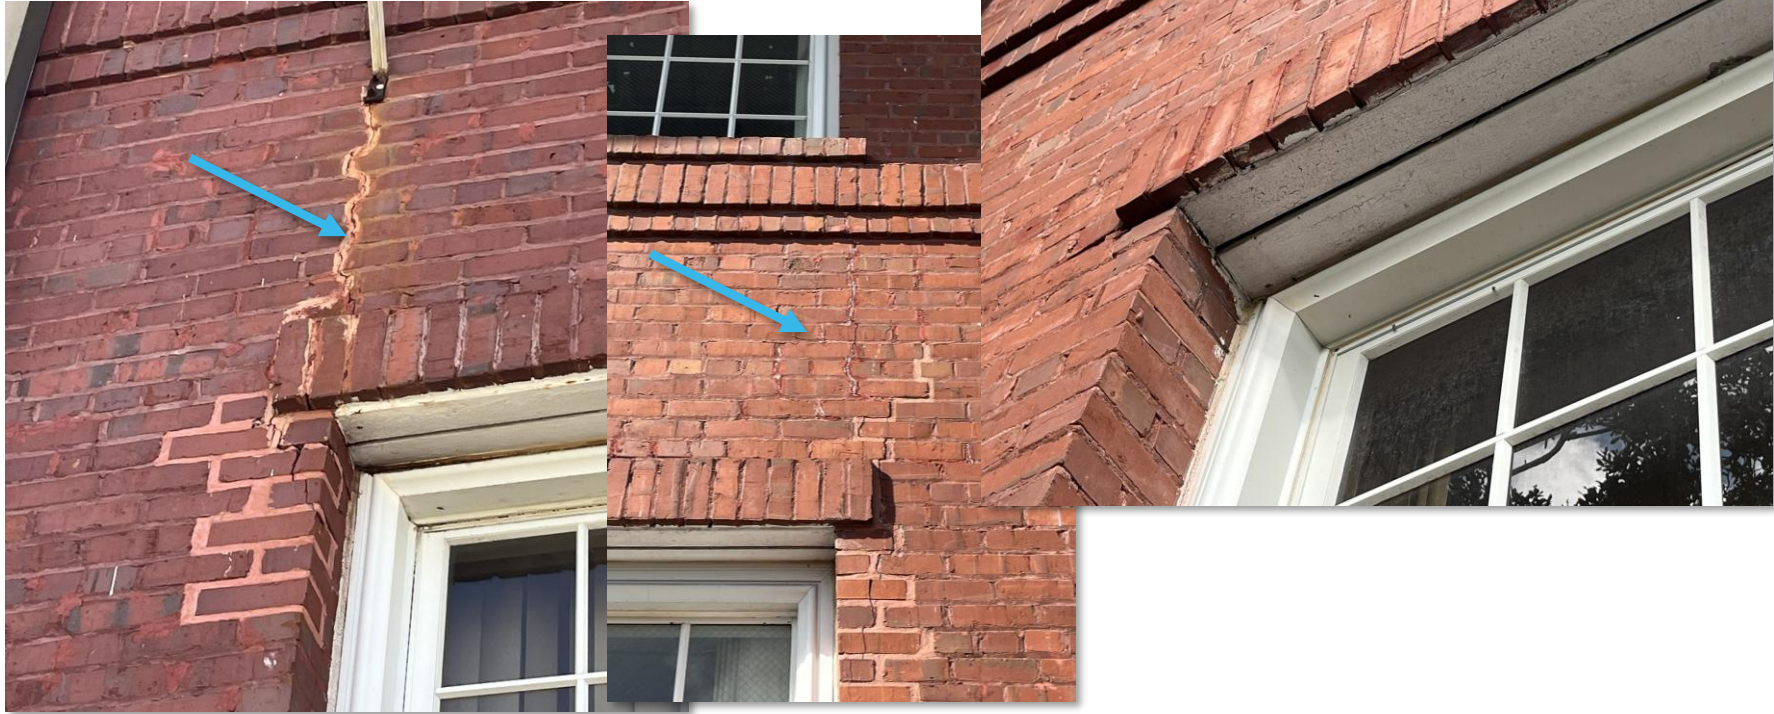
AREAS OF CONCERN - STRUCTURAL SETTLING

- *REPAIR STEP CRACKING*
- *TERMITE TREATMENT*
- *MECHANICAL MEANS TO PROMOTE AIR MOVEMENT*
