# North Ward Elementary School

City Council Work Session  
Sept. 15, 2025

Building Assessment  
August 13, 2024

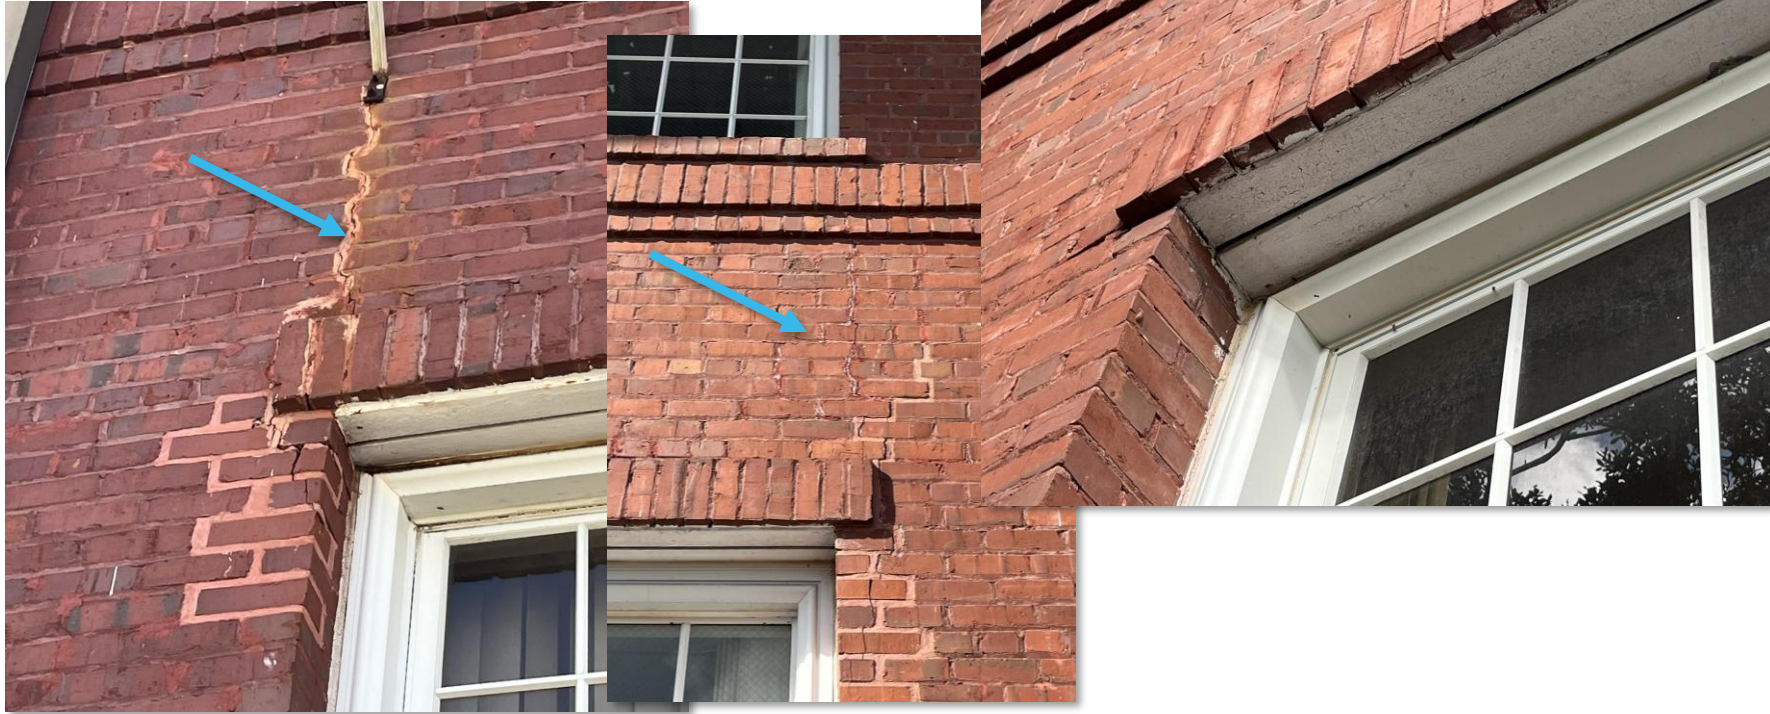
## AREAS OF CONCERN - STRUCTURAL SETTLING

- *REPAIR STEP CRACKING*
- *TERMITE TREATMENT*
- *MECHANICAL MEANS TO PROMOTE AIR MOVEMENT*
