# 1105 CARLTON STREET BUILDING ASSESSMENT

1105 CARLTON STREET  
CLEARWATER, FL 33755

CITY OF CLEARWATER

FINAL

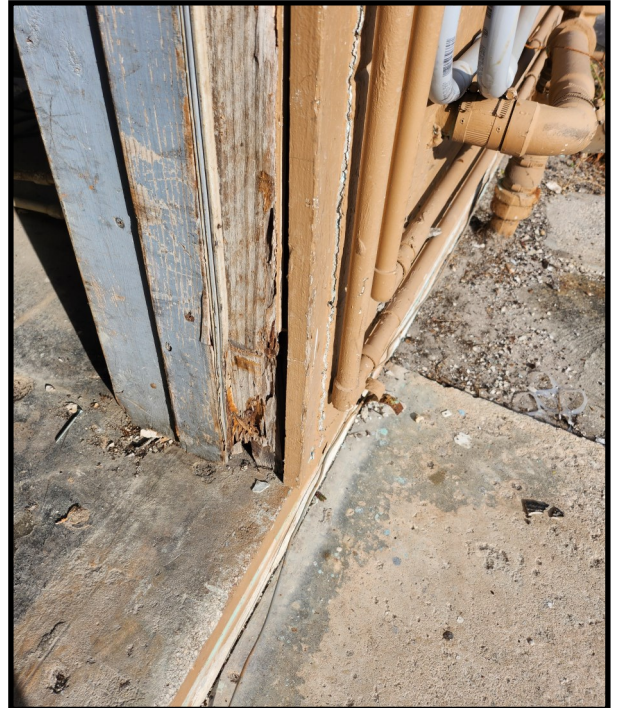
Photo 22 -

There are signs of water damage at various locations around the soffit (Photo 20). There is an existing wood canopy over the front entry which appears to be in satisfactory condition, there is also a metal awning over the front door directly under the canopy that is in disrepair (Photo 21). There are a variety of windows throughout the building ranging from jalousie to double hung, we were not provided any product or attachment information on any of the windows, therefore we cannot comment on their available wind load capacity or impact resistance. The exterior wood door frames show signs of water damage and rot (Photo 22). The exterior doors are in a similar state and the hinges are barely attached (Photo 23).

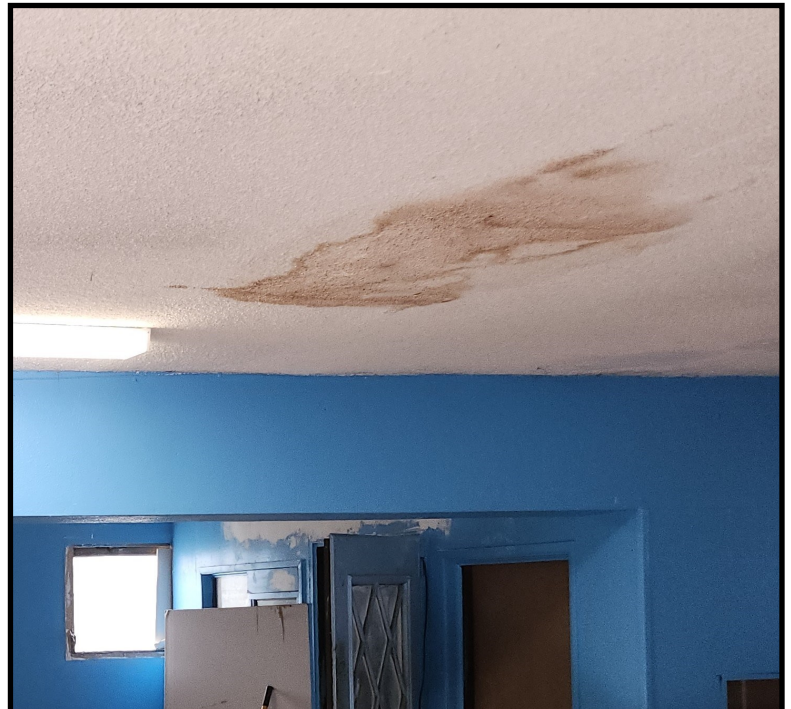
Photo 24 -

The ceiling on the first floor shows signs of water damage (Photo 24). This damage is consistent with what is seen on the visible portions of the second floor joists and decking, there also appears that some repair have been made by sistering and new wood member to the existing joist (Photos 25 & 26). It is crucial that the first floor ceiling be removed to see the extent of the damage and see which members shall be replaced or repaired. The visible portion of the wide flange beam supporting the second floor joists appears to be acceptable. The pipe column supporting the wide flange beam on the east side appears to be in satisfactory condition, the support on the west end is encased with in wall but assumed to a pipe column but the condition is known.

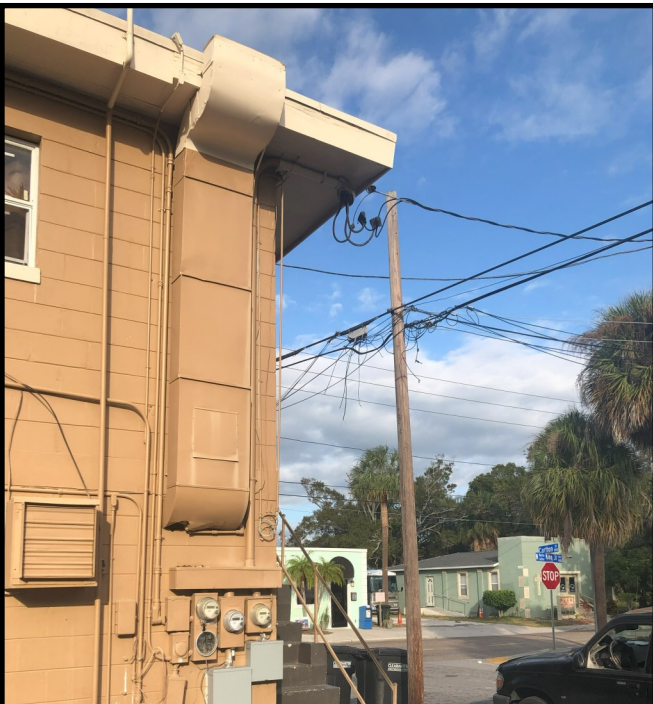
Photo 07 -

The first floor had been used as a restaurant and the kitchen hood has been removed. The remaining exhaust duct and makeup air fan are inadequate and would need to be replaced if a new commercial kitchen hood with fire suppression was to be installed (Photos 5,6 & 7).

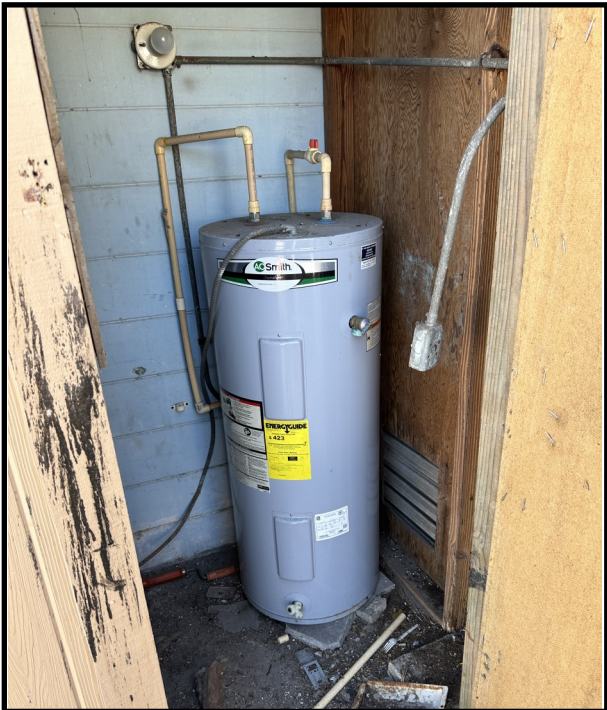
Photo 15 -

The existing 40-gallon electric water heater is in a closet located under the north stair case. It was manufactured on November 2, 2018 and has a warranty that is good thru November 1, 2024. We would recommend adding a small expansion tank to prevent the leaking at the pressure relief valve as indicated by deposits on the valve. This water heater serves both the 1st and 2nd floors (Photo 15).

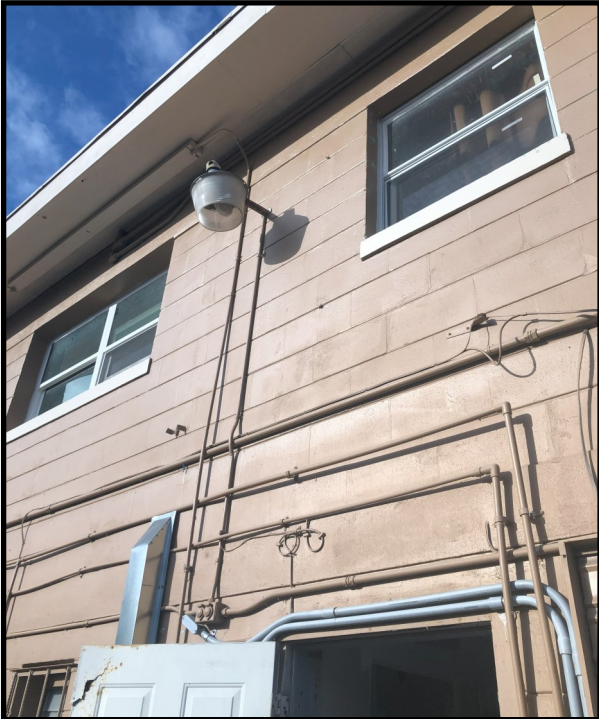
Photo 09 -

Building exterior lighting was limited and operation could not be verified (Photo 9). The exterior wall lights were incandescent type and it recommend to replace all fixtures with LED type fixtures. The emergency lights shall be provided above the building egress front and back doors in accordance with 2017 NFPA 101 Life Safety Code. Florida Energy Efficiency Code (FEEC) requires exterior lighting controls include astronomic features allowing the system to adjust for changes in seasonal daylight patterns.

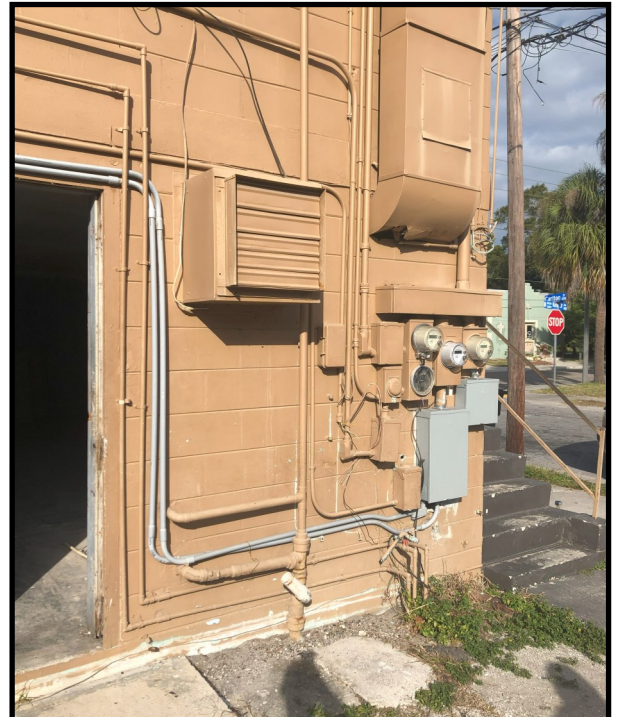
Photo 10 -

It appears that PVC conduits were used in both building exterior locations (Photo 10 & 11) and interior locations (Photo 12 & 13). It is not recommended to use PVC conduits in these locations due to the potential of toxic fumes being released from PVC conduit during a fire. Recommend to replace exterior PVC conduits with rigid aluminum conduits and replace PVC in interior locations with EMT conduits.

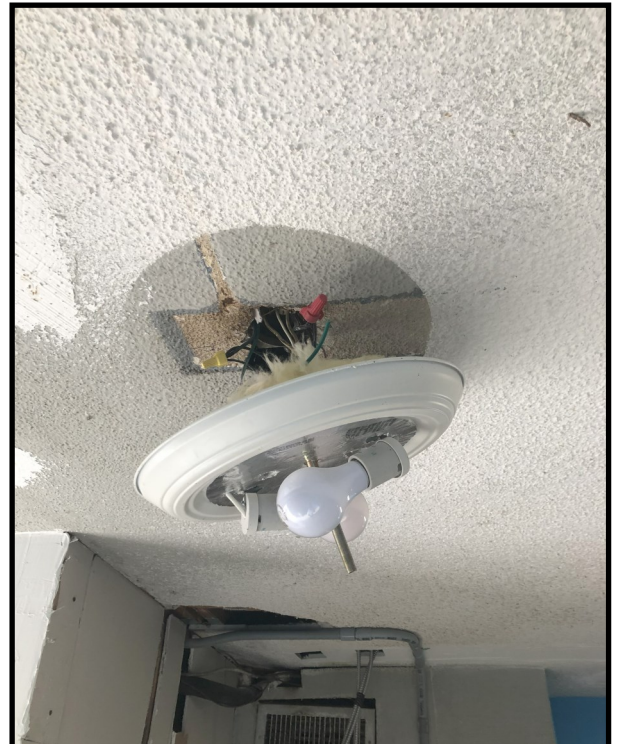
Photo 16 -

Light fixtures were not secure to the ceiling and missing outlet boxes (Photo 16). Some light fixtures were not working (Photo 17). Some light switches were missing cover plates and outlet boxes were not secured in walls in accordance with the 2017 NEC (Photo 18). Some light switches were disconnected and abandoned in the outlet box (Photo 19). The 2017 Florida Energy Efficiency Code requires automatic lighting controls for a restaurant space. New lighting control system with occupancy/vacancy sensors and dimmer switches shall be installed per FBC.

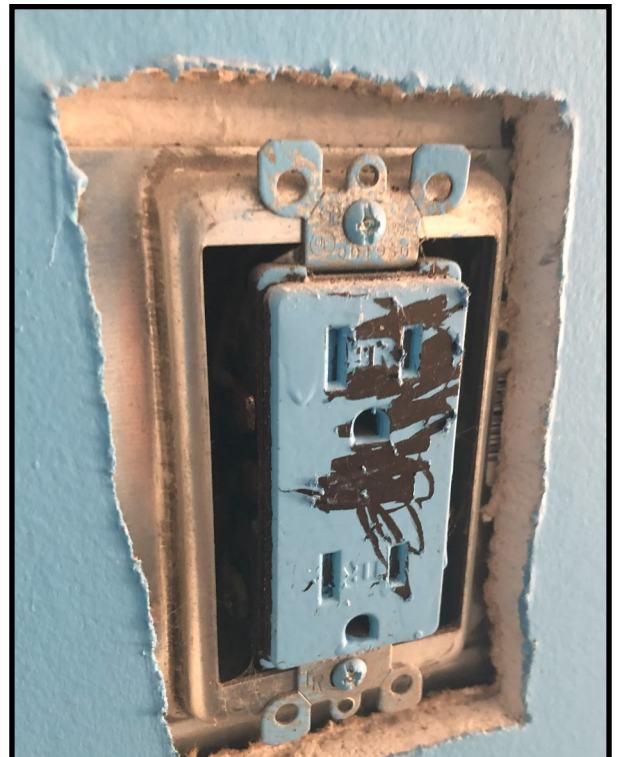
Photo 20 -

Some receptacles were missing cover plates (Photo 20) several receptacles were not secured in the outlet boxes (Photo 21).

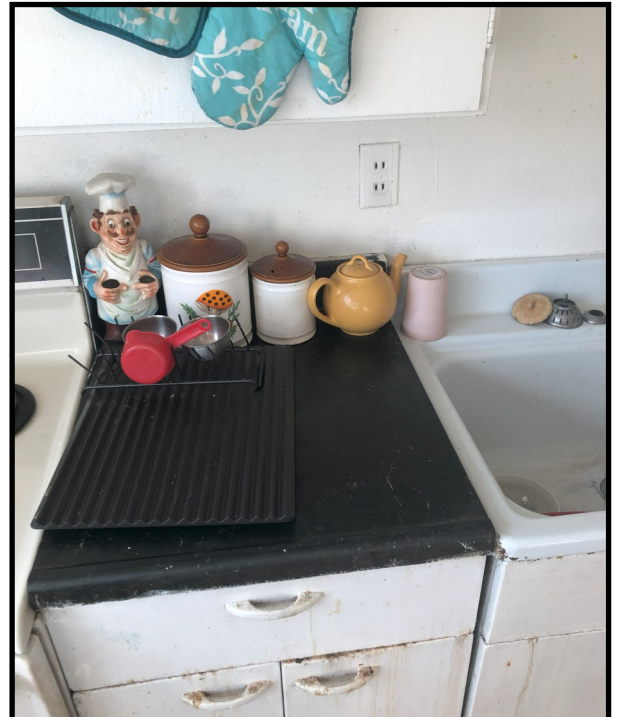
Photo 30 -

The 2nd floor kitchen above counter receptacle (Photo 30) shall be GF type receptacles per NEC. The receptacle shall be replaced with GF type receptacle. A minimum of 2 dedicated 15 or 20 amp branch circuits are required to serve dwelling unit kitchen countertop receptacles. Dedicated circuits are required to serve refrigerators and microwaves.

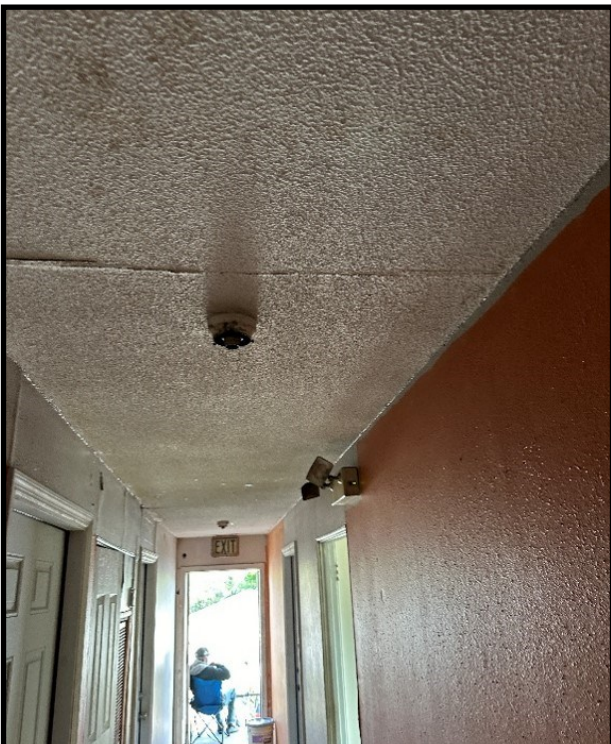
Photo 31 -

The 2nd floor corridor lights were missing lamps (Photo 31 & 32). The exit lights were not operational (Photo 33 & 34). It is recommended that all lighting and lighting controls in building to be upgraded to LED lighting for compliance with the FEEC and 2016 ASHRAE 90.1.

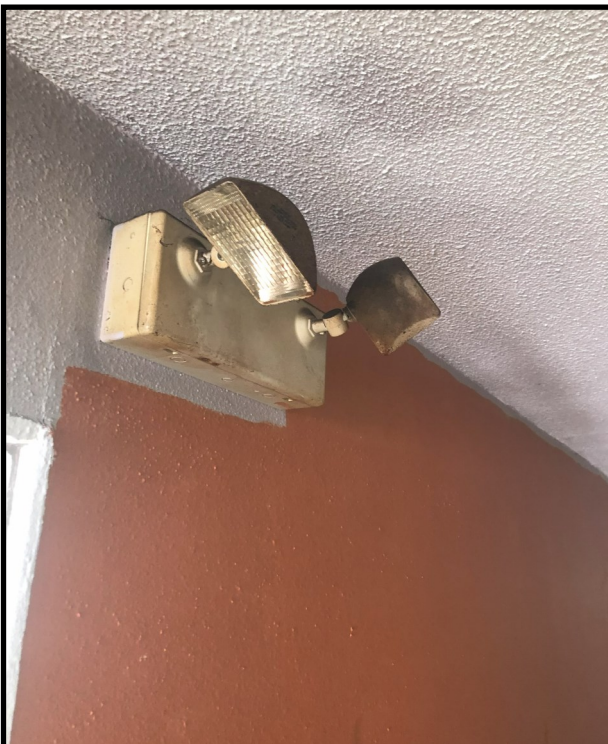
Photo 35 -

Operation of corridor emergency lights could not be verified (Photo 35). The NFPA 101 Life Safety Code requires that the emergency lights or lighted exit signs be inspected and tested at least once a month. New emergency lights shall be installed to replace the non-operable lights.
