**Phase I Environmental Site  
Assessment  
618-620 Drew Street  
Clearwater, Florida**

**City of Clearwater**

Stantec Consulting Services Inc.  
380 Park Place Boulevard, Suite 300  
Clearwater, Florida 33759

Stantec Project No.: 172607904

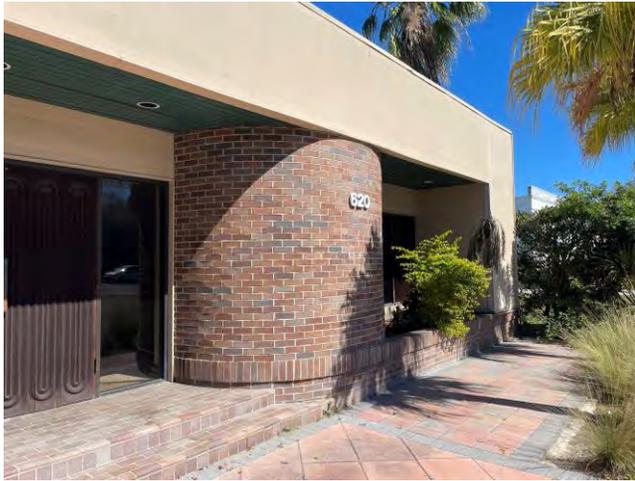
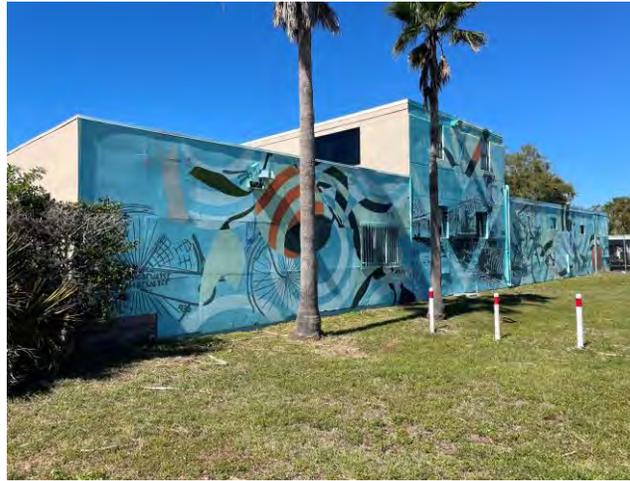
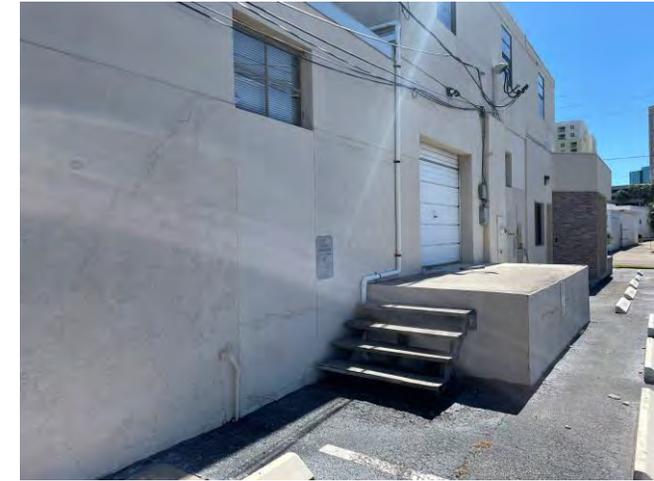
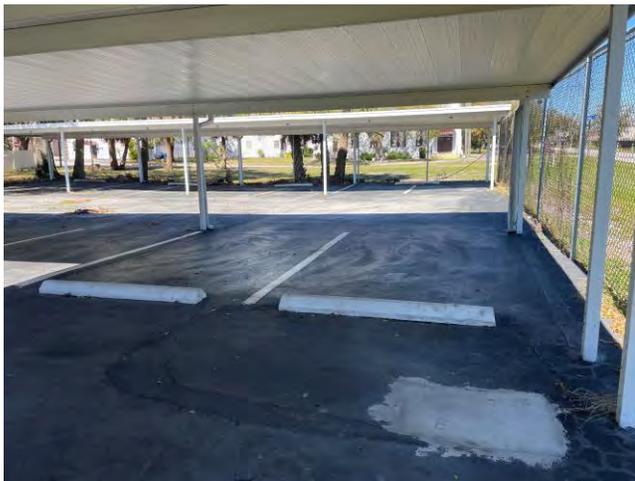
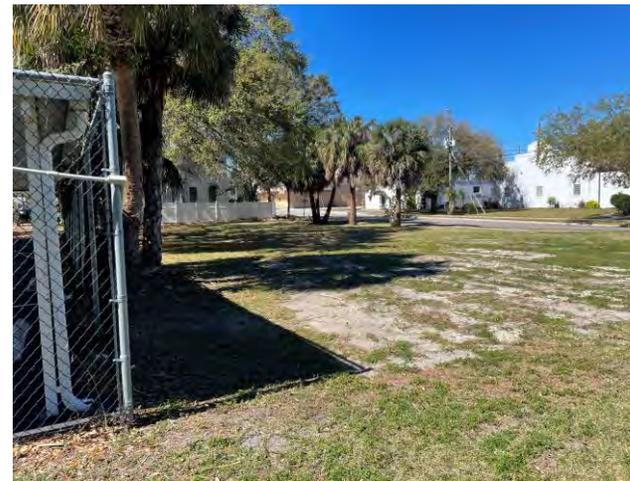
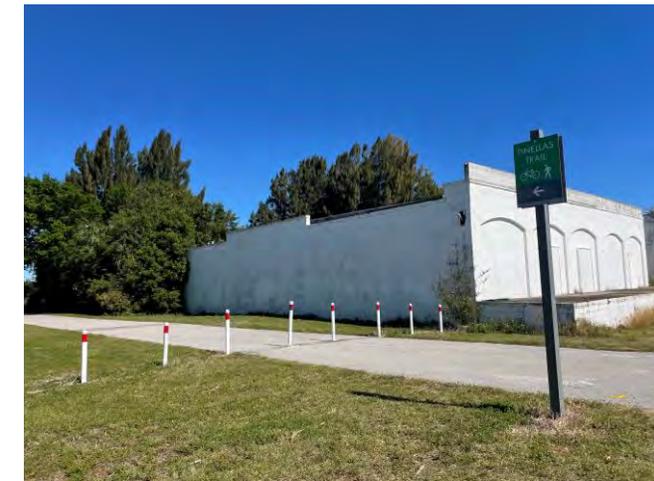
# **Site Photos - 2023**

*Top photos: Typical views of the subject property structure.  
Bottom photos: View of on-site parking area, undeveloped parcels and adjacent Pinellas Trail (former railroad).*
