**The City of Clearwater
North Ward School**

Building Assessment
August 13, 2024

Final Issuance

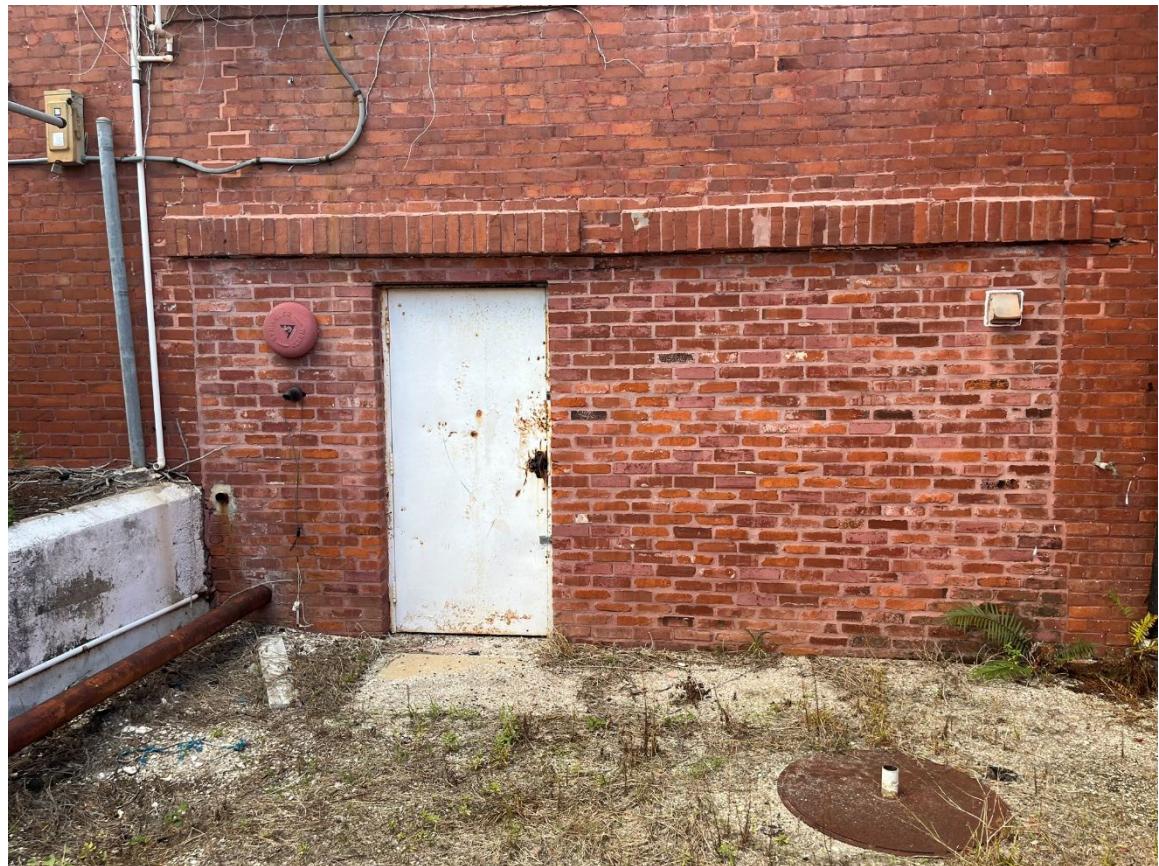
Figure 13 – Building 1 basement entry

On the west side of the building, in what appears to be an historic masonry opening into the basement, there is non-original masonry infill, as evidenced by the non-matching color of the brick and mortar (Figure 13). Similarly, there are miscellaneous masonry repairs that have been carried out previously (Figure 11).

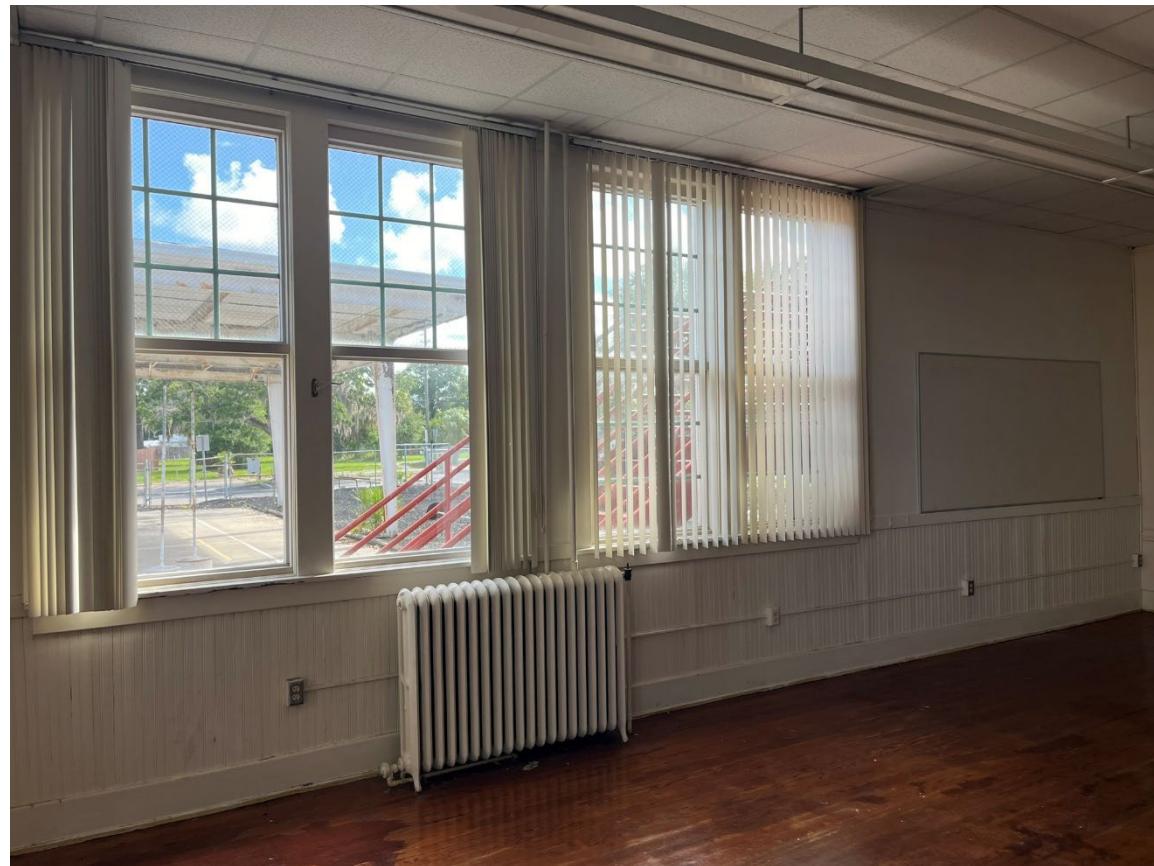
Figure 14 – Building 1 windows at egress stair

Several windows on the north façade, adjacent to the exterior egress stair, are hollow metal with wired glass, intended to provide fire protection when they were installed (*Figure 14*). Other windows are blanked off with solid panels to accommodate exterior mounted mechanical units (*Figure 15*) – refer to the mechanical analysis elsewhere in this report for more information. The exterior doors are non-historic hollow metal doors, with aluminum transom windows. The wood sidelights at the front entry doors remain intact, except the glazing has been replaced with tempered glass (*Figure 16*).

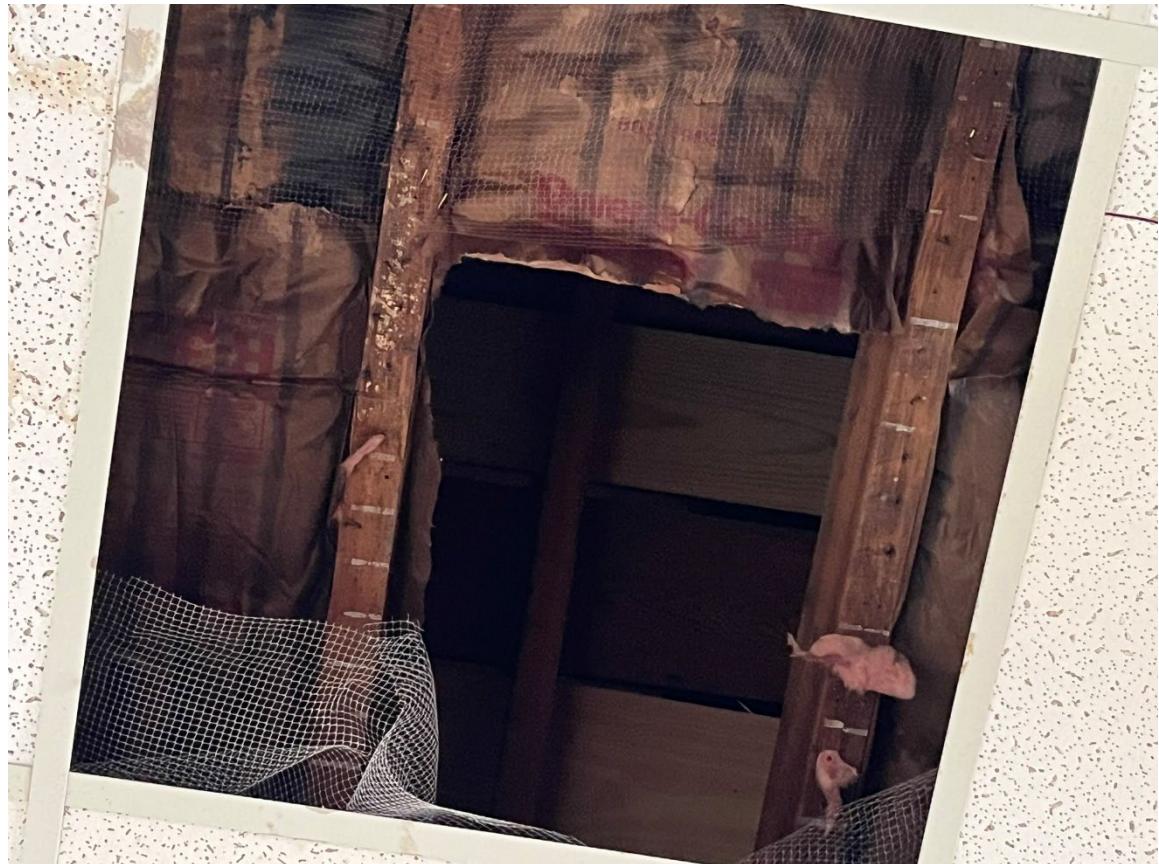
Figure 21 – Building 1 attic

Above the second-floor ceiling, fiberglass batt insulation has been laid in between the roof trusses and supported by metal mesh, or “chicken wire” (*Figure 21*).

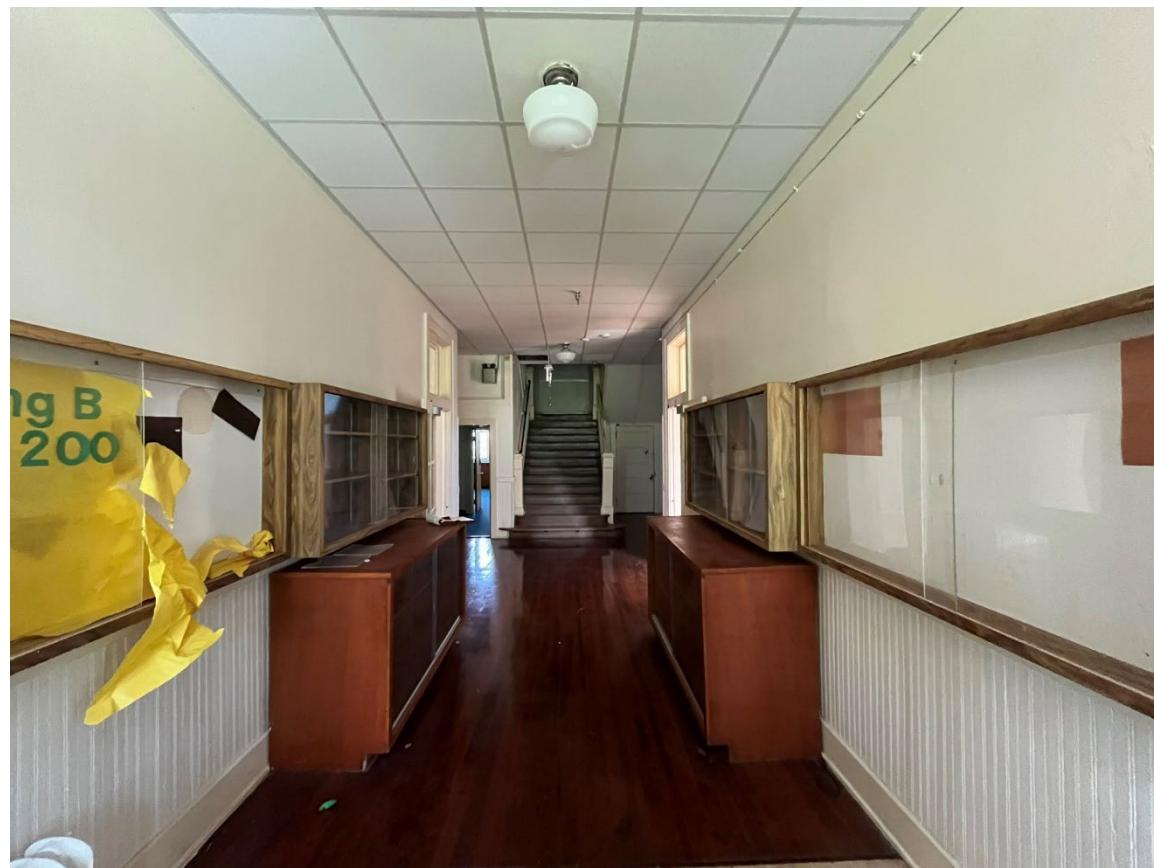
Figure 22 – Building 1 corridor

The original bead board wainscoting, baseboard and shoe molding are largely intact throughout the classrooms and corridors (*Figure 22*). The bead board has areas of minor warping where the bead board has loosened its attachment to the substrate behind. The original wainscot cap has been replaced in many instances with non-historic trim that appears to be a crown molding profile (*Figure 23*). Surface-mounted conduit for electrical and low voltage is pervasive.

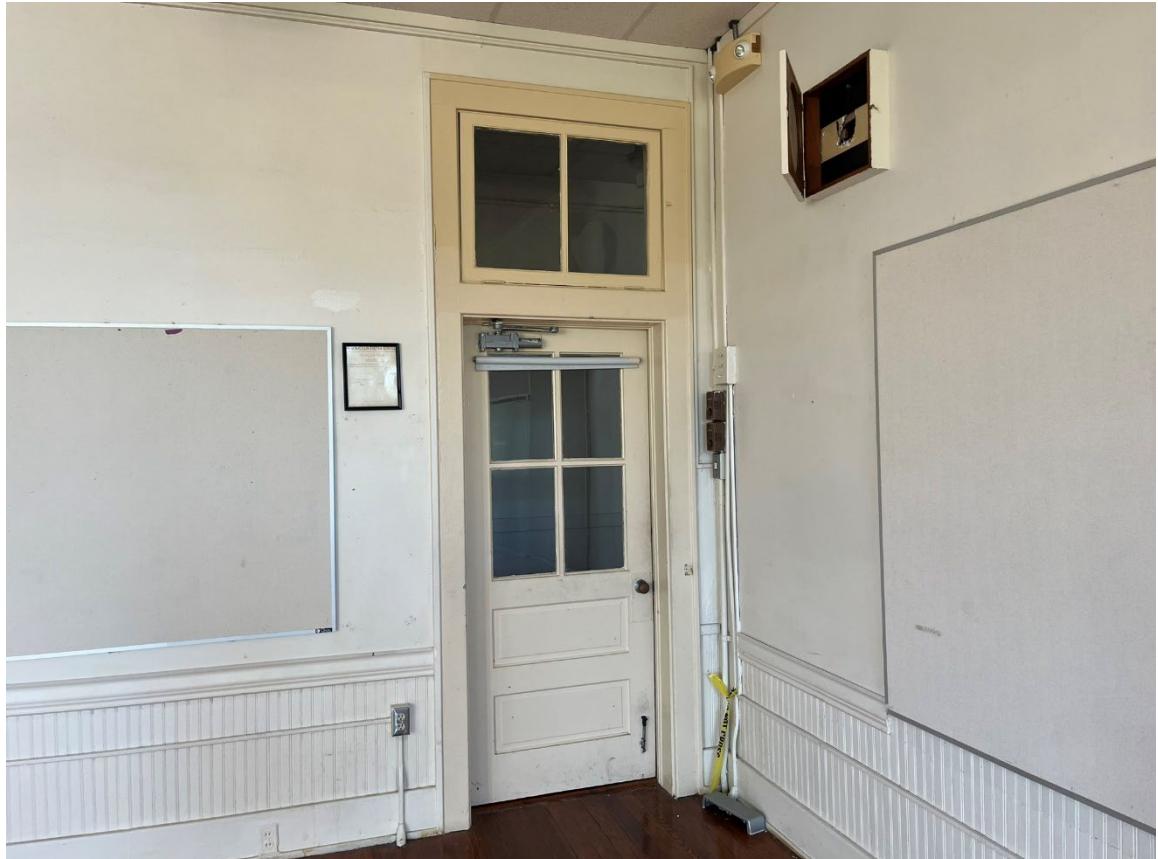
Figure 24 – Building 1 classroom door

Many of the original wood doors and operable transom windows are still intact. The classroom doors have two-over-two glass lights above two inset panels (*Figure 24*). Other doors are a five-panel design. The brass knobs and hinges remain but all other hardware is non-historic. The original glazing has been replaced with clear glass at the classrooms and textured privacy glass at some of the offices. The double doors at the theater have been replaced with narrow light hollow metal doors and exit hardware.

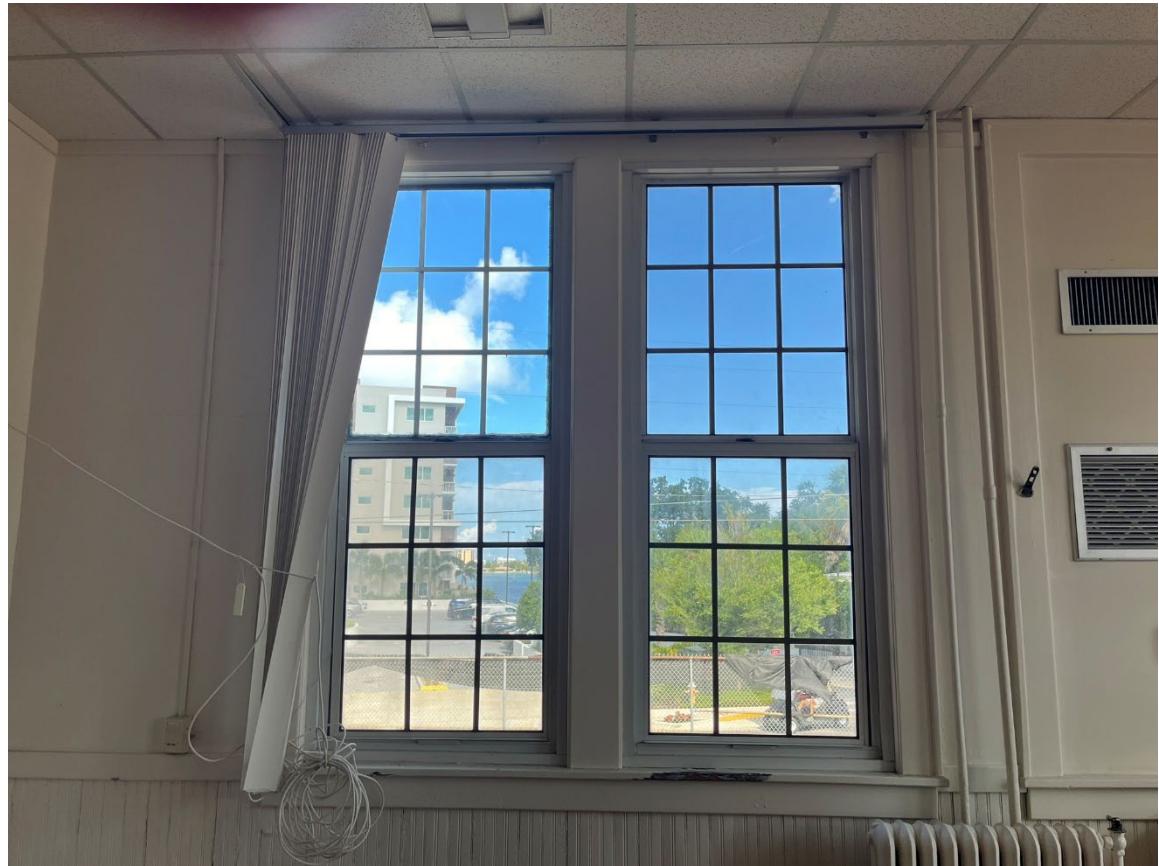
Figure 25 – Building 1 interior window trim

The historic window trim is in good condition (*Figure 25*). The windows at the stage have expanded wire mesh installed over the bottom half as fall protection.

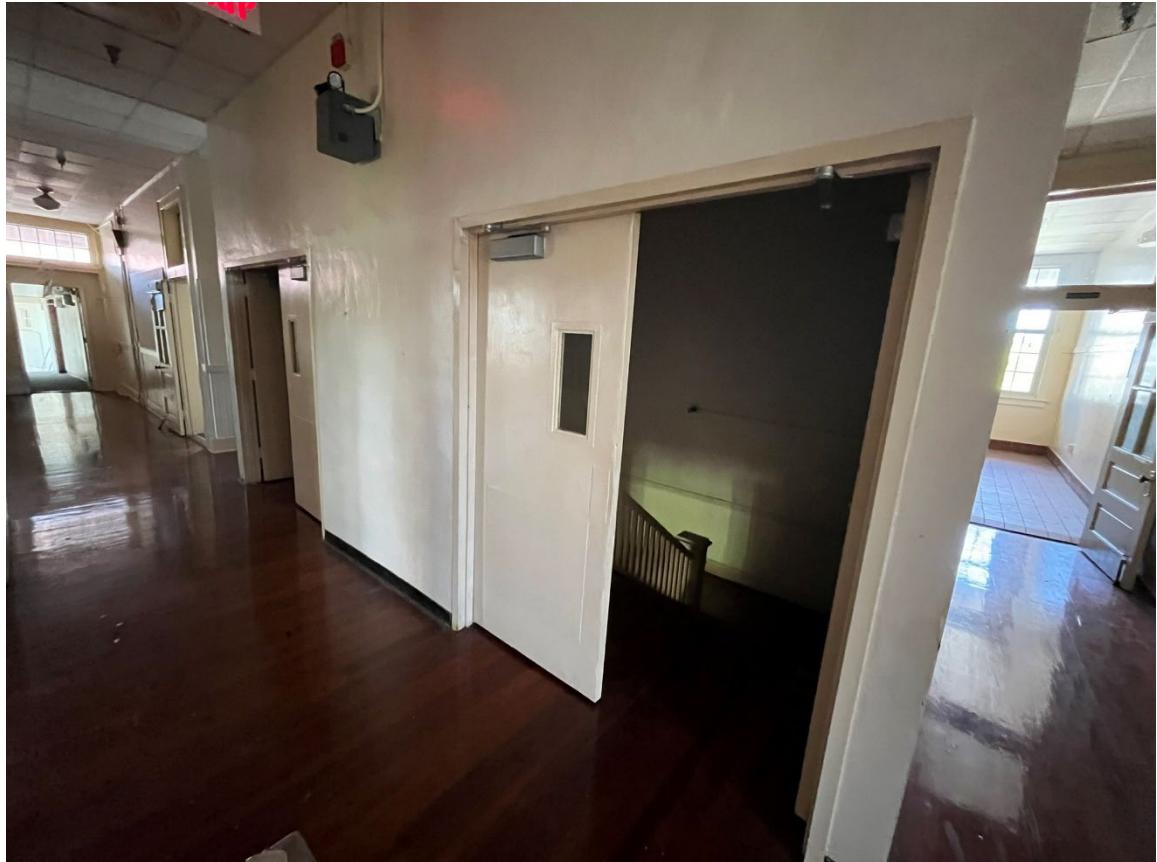
Figure 36 – Building 1 stair top landing

Most significantly, a partition and two sets of double doors have been added on the second floor (*Figure 35*, *Figure 36*), presumed as a means to provide fire separation between the two floors. The doors have hold-open devices on the floor.

The treads and risers generally appear to be code compliant. The balustrade is too low to act as a guard required by code. The added partition and doors at the top of the stairs are a gross modification to one of the building's character-defining features. Whether or not the current building code requires such a separation depends on the use of the building. A full analysis of the existing building, its proposed use, and the relevant codes will need to be conducted.

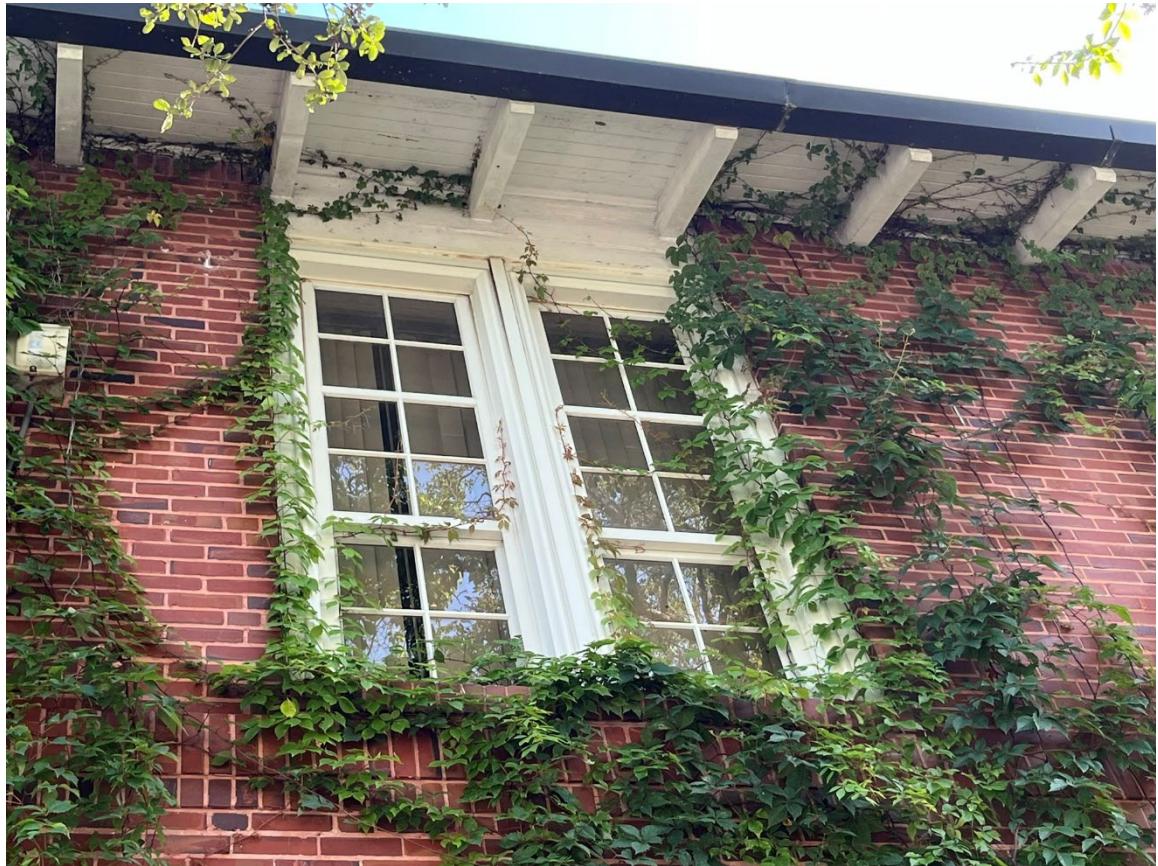
Figure 38 – Building 2 roof eave and window

The roof overhang includes exposed 4x6 rafter tails spaced at approximately 30 inches on center. The eave soffit material is some type of tongue & groove wood board (*Figure 38*). The rafter tails and soffit appear to be in better shape than at Building 1, perhaps because of the thicker member sizing.

The second-floor windows have a wood panel above them (*Figure 38*), extending to the roof framing, negating the need for a masonry lintel. Non-arched windows elsewhere on the first floor have steel lintels but, unlike Building 1, step cracking is not apparent.

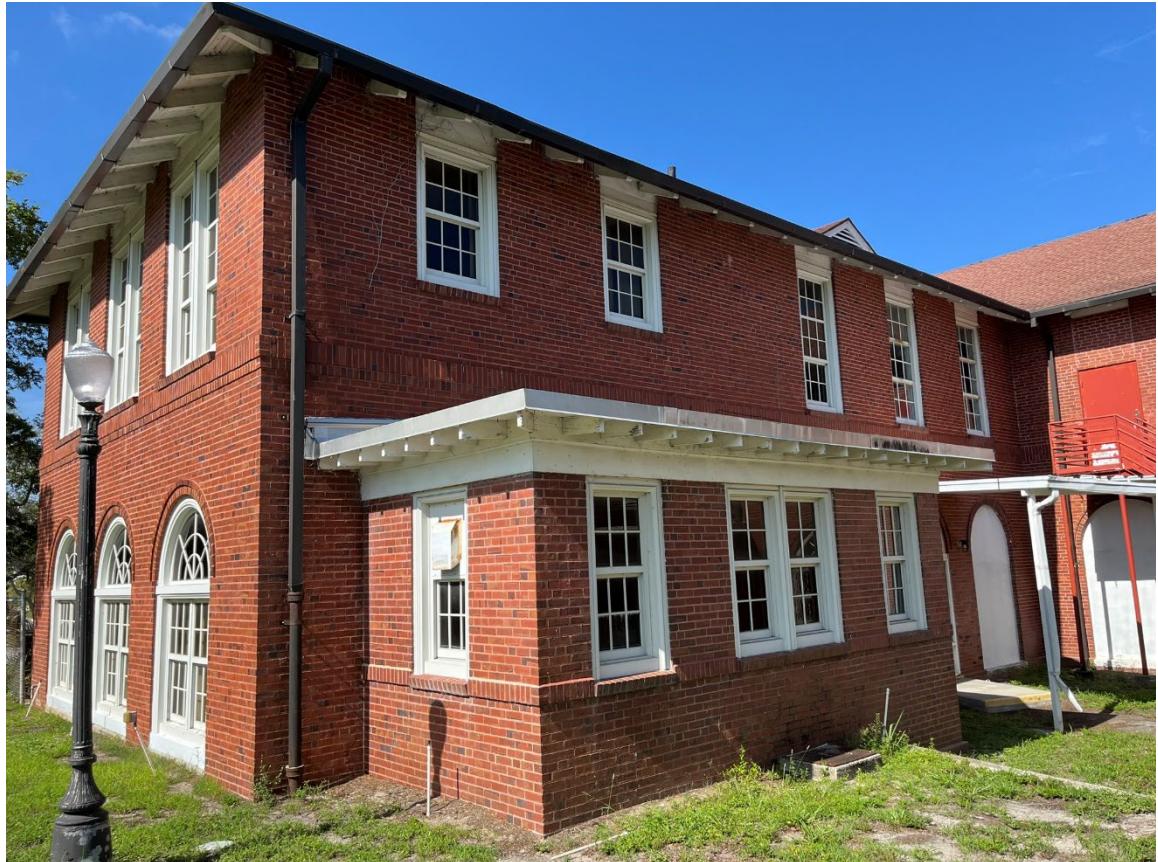
Figure 39 – Building 2 north façade

The western-most classroom on the first floor was originally the kindergarten classroom. As such, this classroom had dedicated restrooms attached to it in the form of a one-story space (*Figure 39*). This roof is low-slope with built-up roofing. The original construction drawings show a cornice with decorative rafter tails exposed. A much simpler construction detail exists today – it's unknown if the original detail was ever executed.

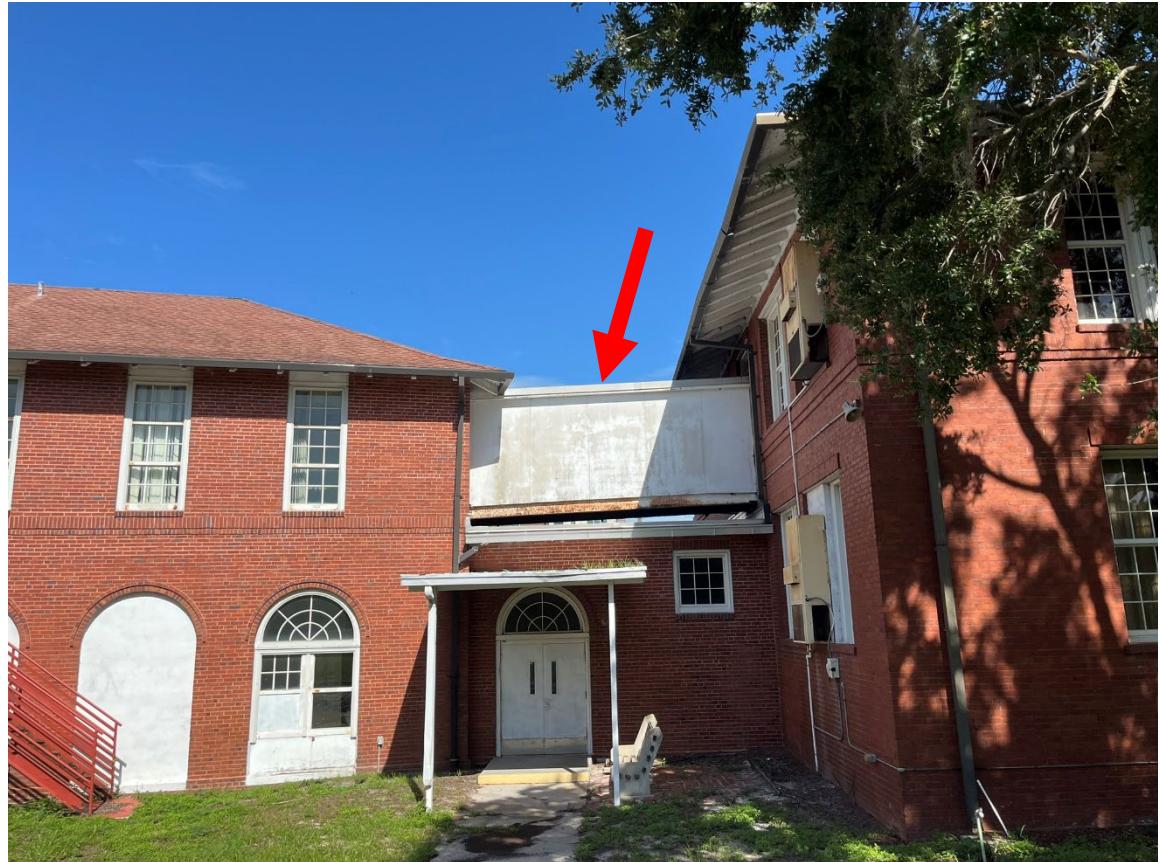
Figure 46 – Second floor connector between Buildings 1 and 2

At an unknown date, a connecting corridor was added on the second floor from Building 1 to Building 2 (*Figure 46*). Its steel structure hovers above the roof below, and the walls are finished with smooth plastic panels. Its roof flashes into the brick walls they abut.

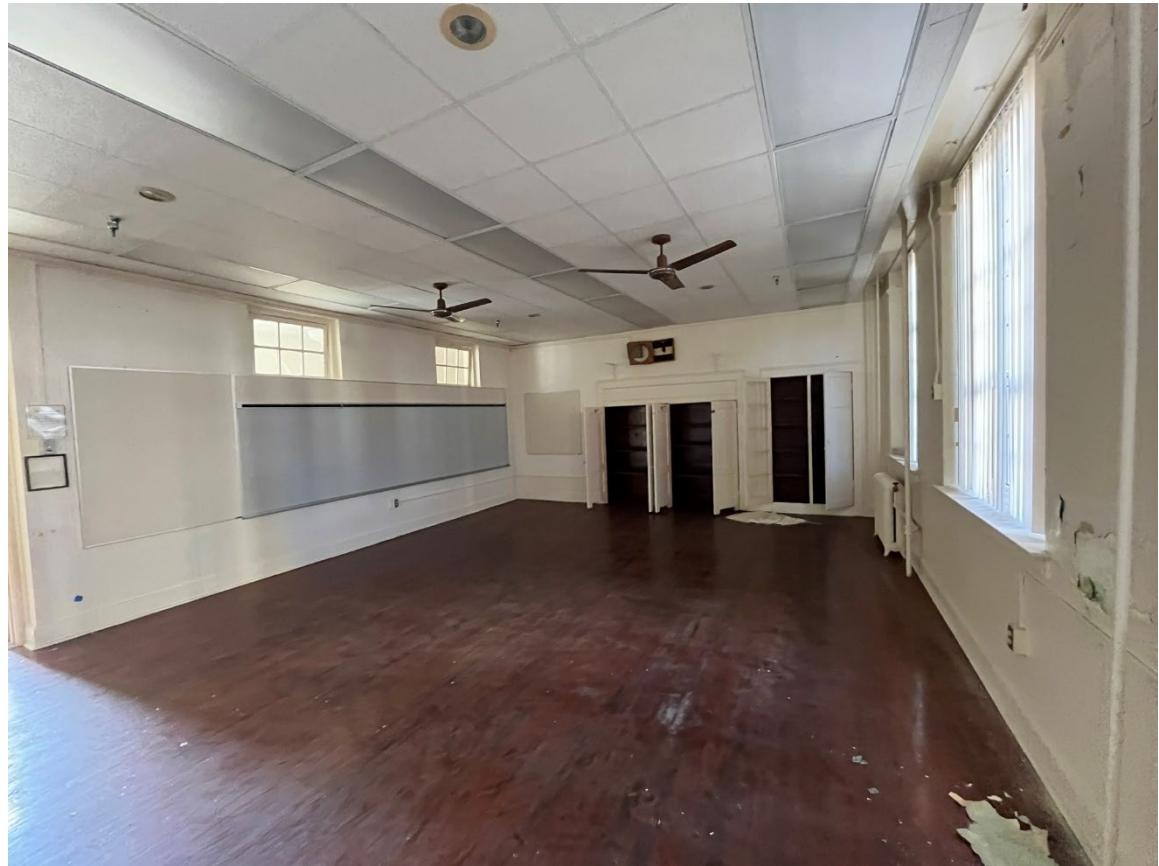
Figure 48 – Building 2 classroom

Unlike Building 1, the classroom walls do not have bead board wainscoting, although the original wood baseboard and shoe molding are largely intact (*Figure 48*). The classrooms retain much of their original built-in cabinetry (*Figure 49*), including brass hooks and pivoting hardware that allows the cabinet doors to recess (*Figure 50*). The closets have stained bead board and wood backing and shelving.

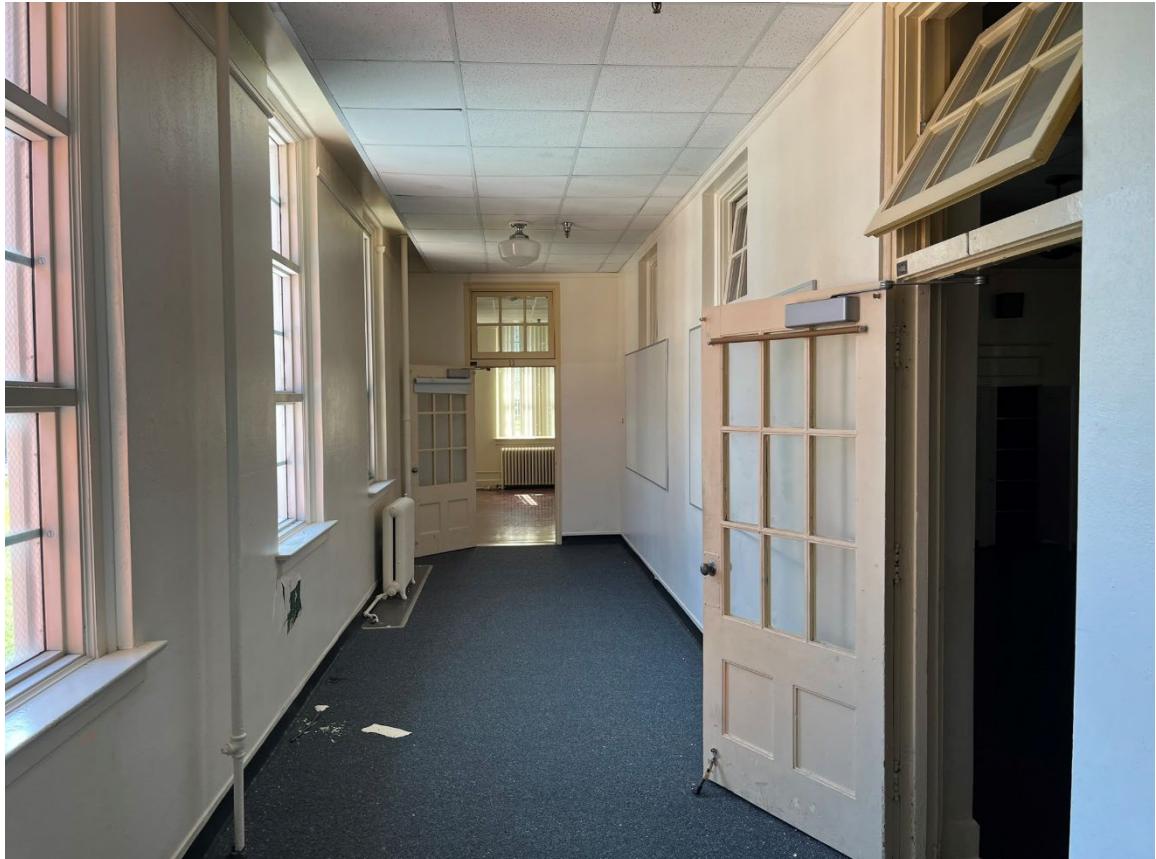
Figure 51 – Building 2 second floor corridor

Many of the original wood doors and operable transom windows are still intact. Similar to the exterior windows, their design differs from Building 1 (*Figure 51*). The doors to the back-of-house spaces do not have lights. The historic window trim is in good condition.

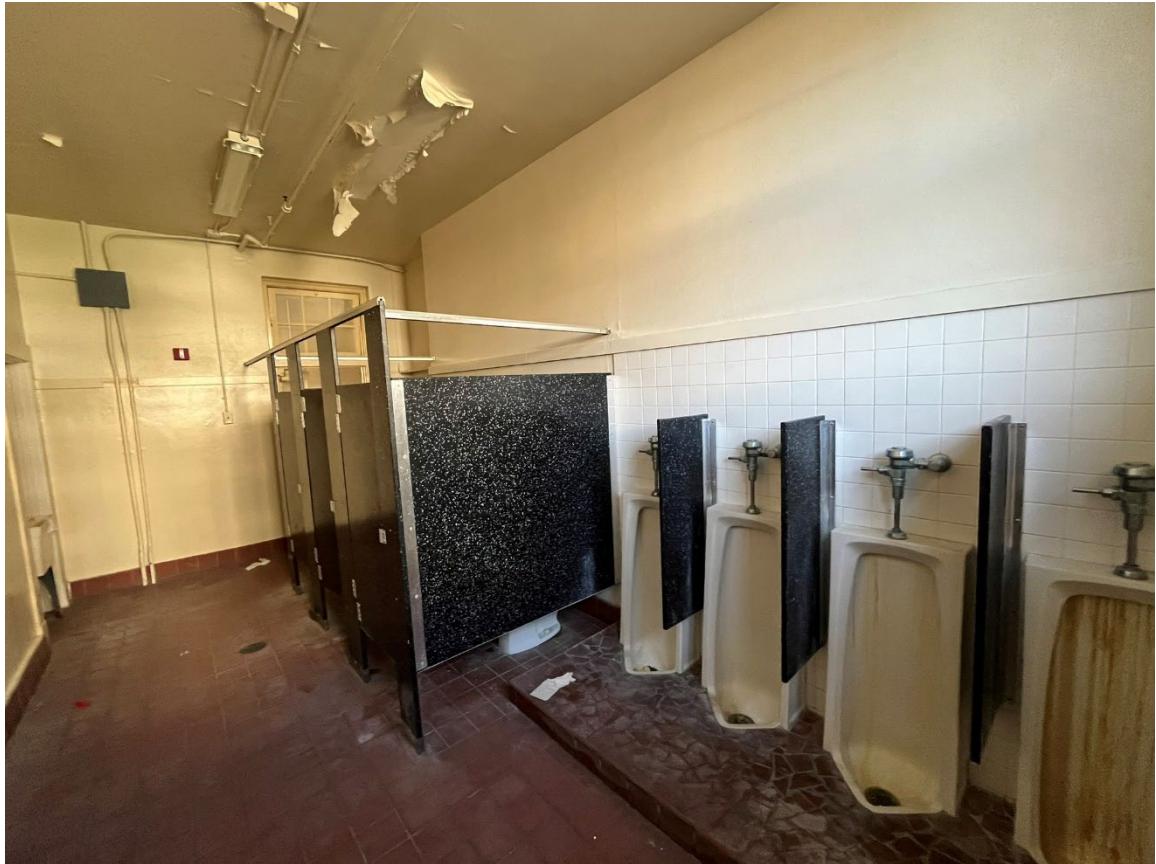
Figure 53 – Building 2 restroom

The original 3 1/4" plank pine flooring is still intact in the classrooms. In general, the wood flooring appears to be in fair condition. There is some sponginess and creaking when walked upon but no areas of significant disrepair. The corridors originally had a 'cement' finish according to the original construction drawings with a curved cove base (*Figure 52*). Carpet has since been installed in the corridors (*Figure 47*). The restrooms have quarry tile (*Figure 53*).

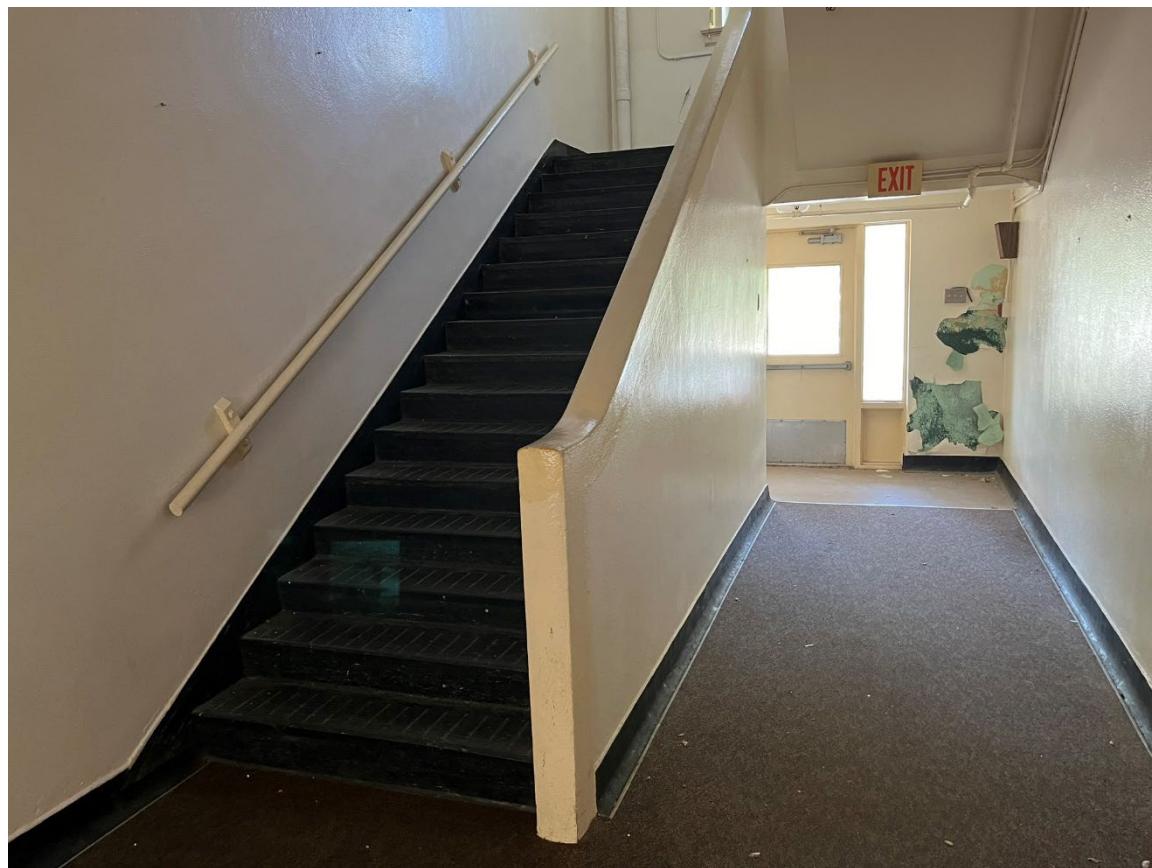
Figure 54 – Building 2 stair

The only internal stair in Building 2 (*Figure 54*) is simpler than the Building 1 stair, lacking any ornamental detailing and designed with a conventional switchback layout. The half-height side wall is smooth plaster without a handrail. The treads and risers have been covered with rubber.

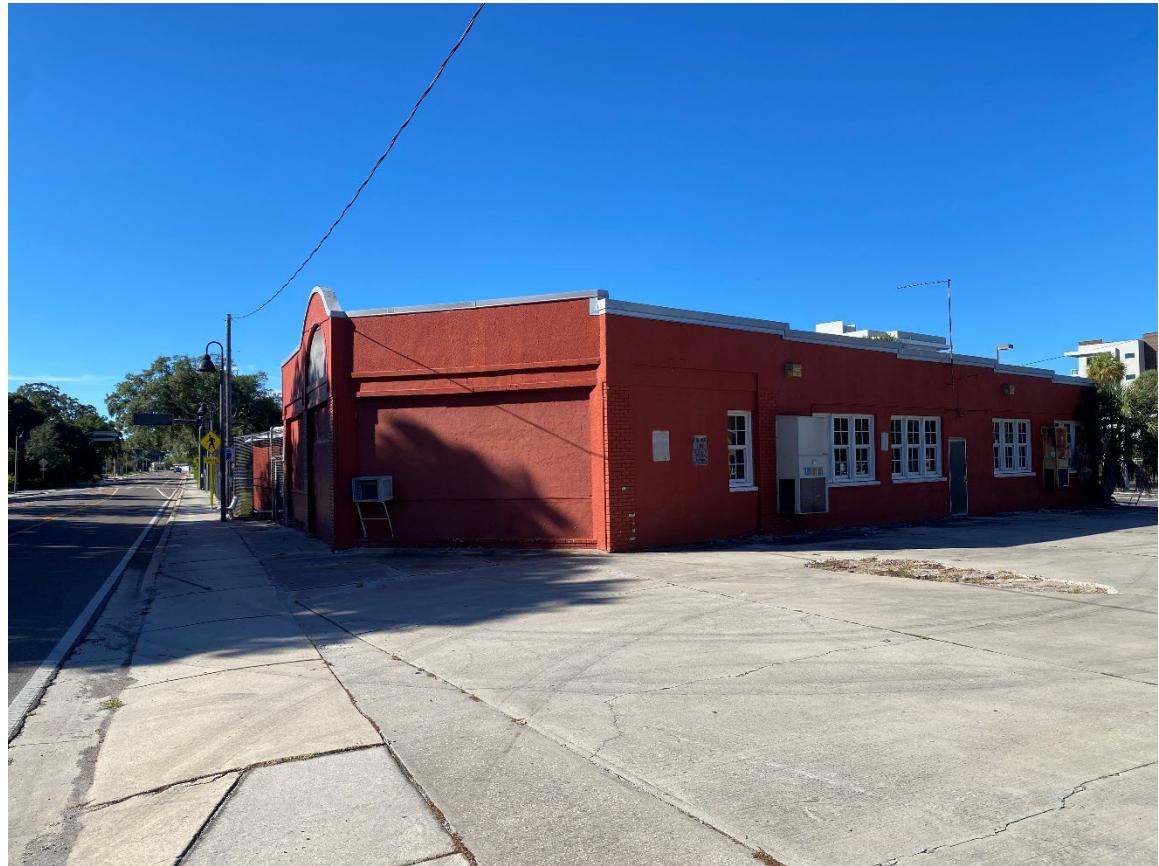
Figure 56 – Building 3

As previously noted, Building 3 (*Figure 56*) is the one-story building on the northeast corner of the lot that was originally an automotive dealership before the District bought the building and converted it into classrooms and a library.

There is significant cracking in the exterior walls, visible from the inside, indicating settlement issues. Additionally, the interior paint coating is delaminating throughout the building, likely because of moisture intrusion. One area of particular concern is at the northeast corner of building where serious degradation is evident (*Figure 58*).

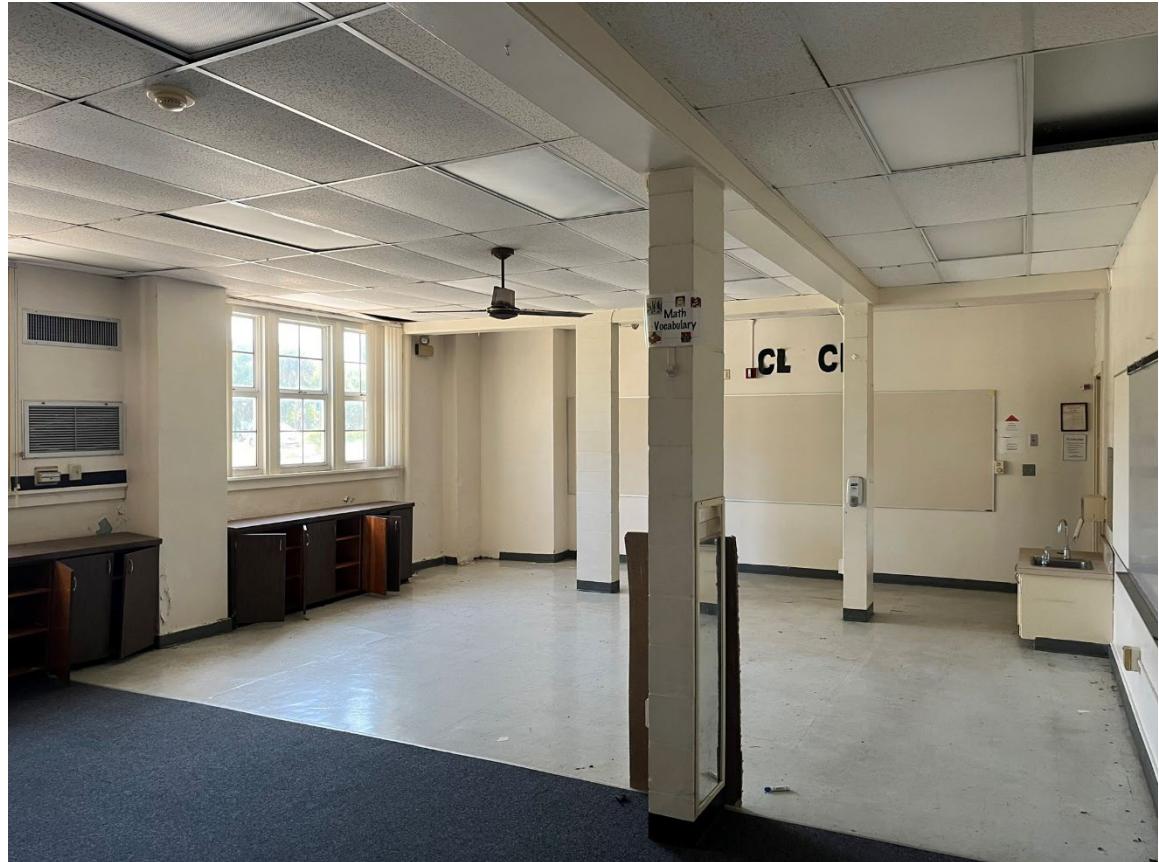
Figure 57 – Building 3 interior

However the interior was originally laid out, those partitions are now gone, and the space is subdivided into instructional rooms. The 1950's era finishes are consistent with the type and quality seen in the other buildings on property (*Figure 57*), including dropped ceiling tile, carpet, vinyl tile flooring and rubber base. Few, if any, historic features remain that are noteworthy.

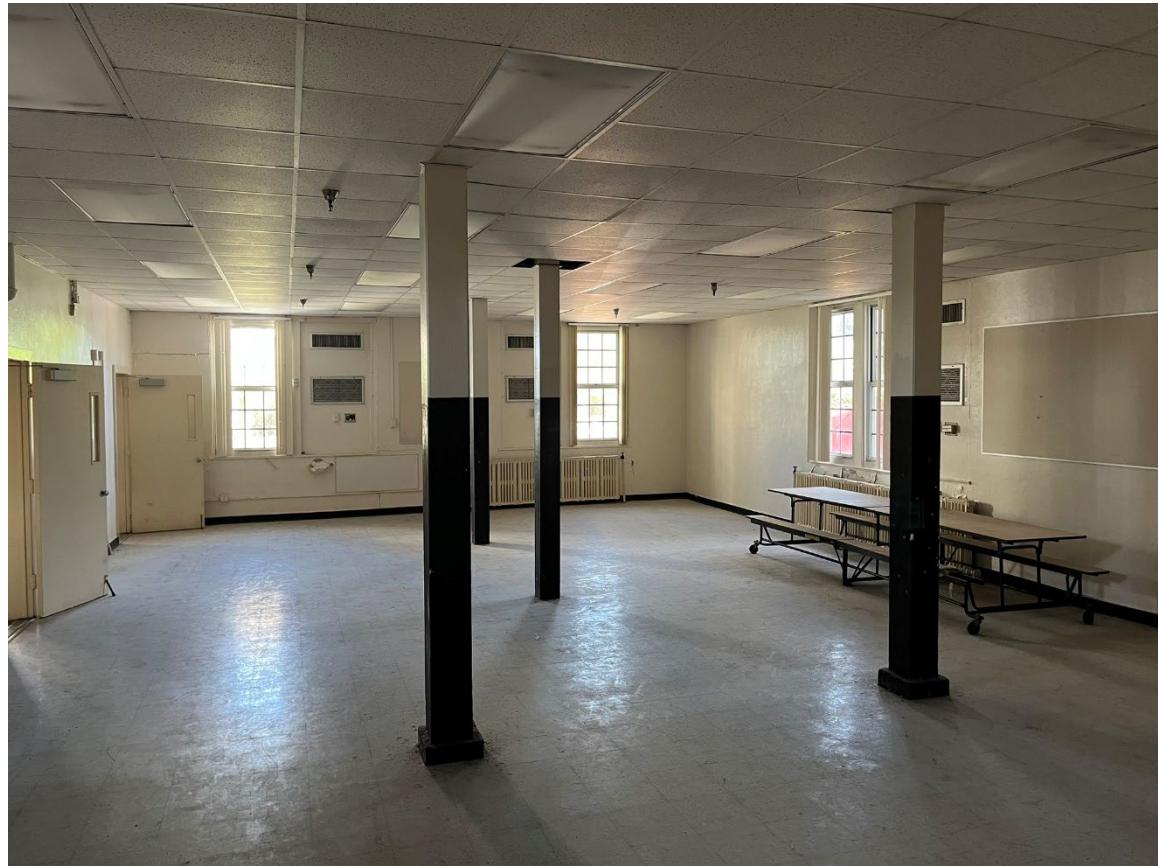
Figure 59 – Building 4 Cafeteria

Building 4 is the mid-century replacement of the kitchen and cafeteria. This building is very different from the earlier construction onsite – exterior plaster on concrete block, low-slope roofs, use of wood columns instead of load-bearing walls, and more modest interior finishes and detailing (*Figure 59*). The ceiling is a non-original dropped tile and grid system; the windows are replacement aluminum; the flooring is vinyl tile in the cafeteria and quarry tile in the kitchen. The doors are hollow metal – there is no documentation on the original design. Glass block niches are in the partition separating the cafeteria from the kitchen.

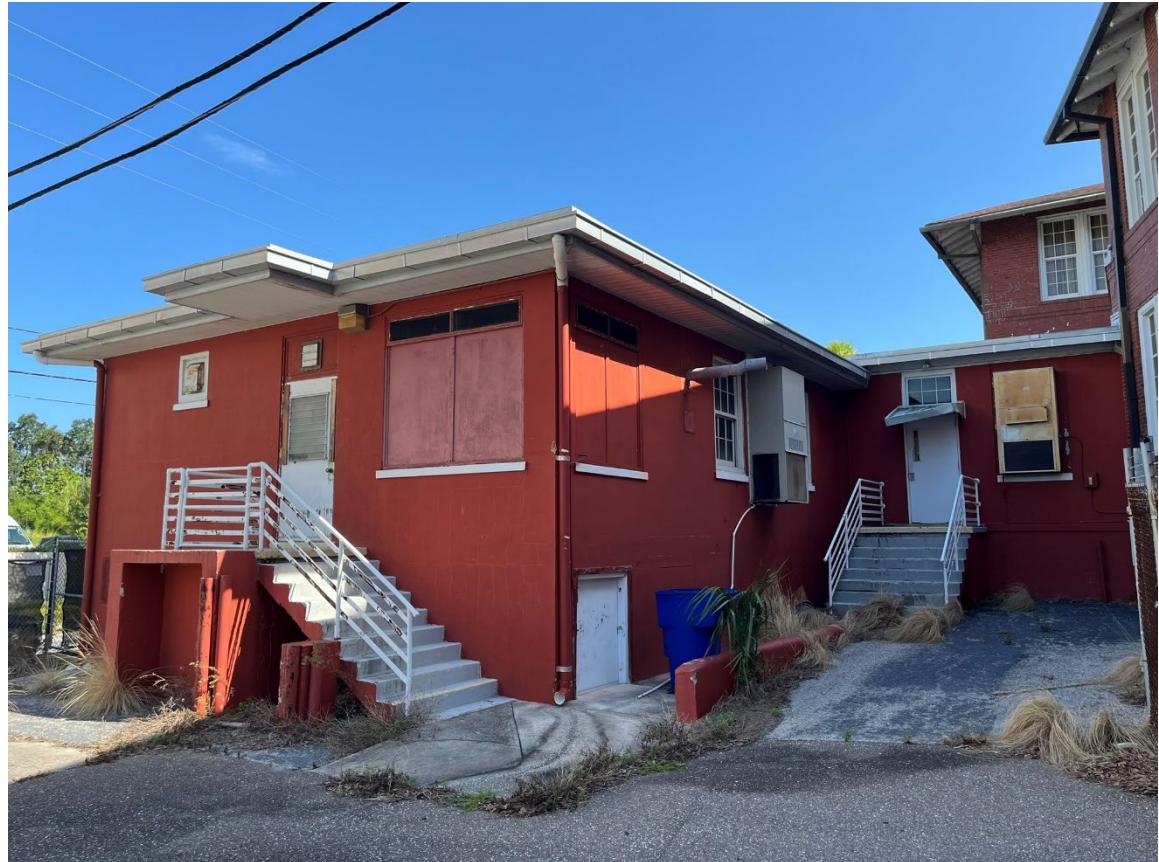
Figure 60 – Building 4 exterior

The roofing is a rolled, bituminous product – there is no evidence of active leaking. Given the significant grade change on that side of the site, the building is elevated above a crawlspace. On the backside of the kitchen, there is an exterior stair (*Figure 60*).

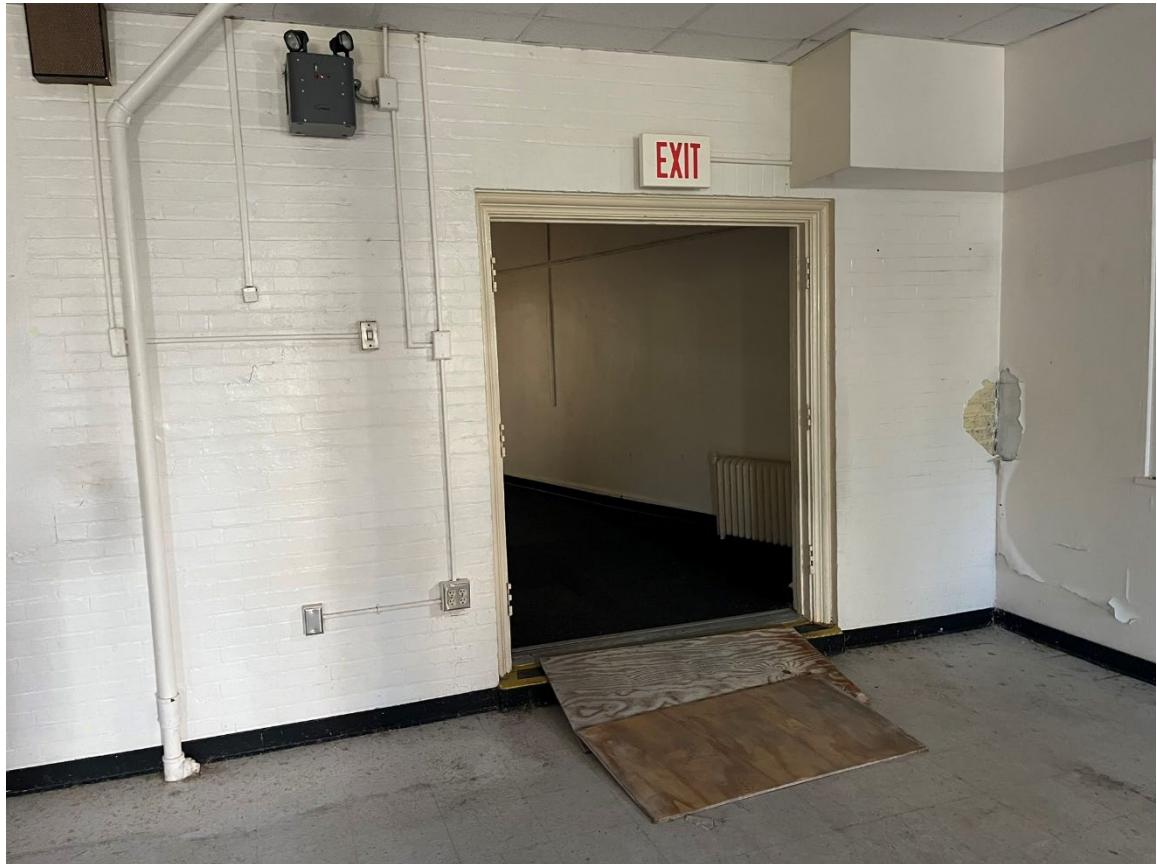
Figure 61 – Building 4 Cafeteria

After moving through a corridor and by adjacent office space, the cafeteria slab is set down approximately six inches (*Figure 61*). The kitchen slab is further recessed, approximately three feet (*Figure 62*).

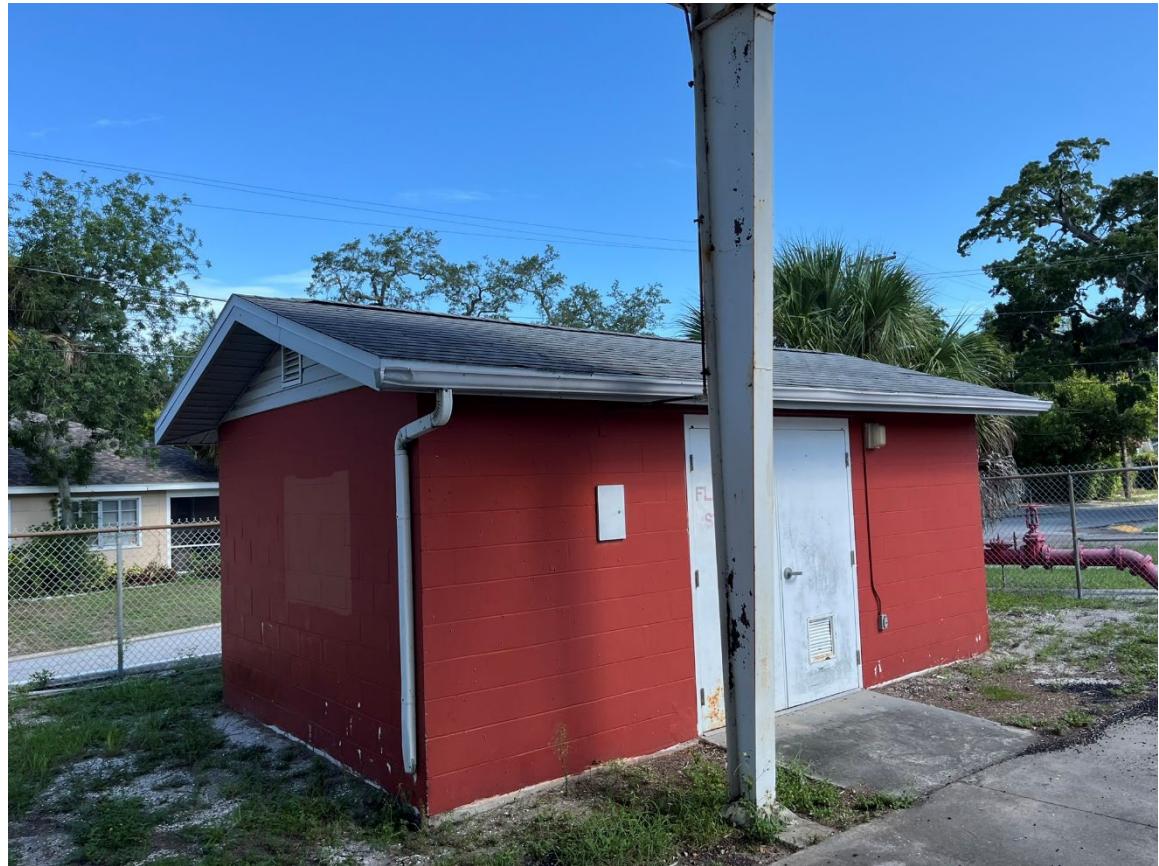
Figure 64 – Building 5

Building 5 is a small mechanical building at the northwest corner of the property (*Figure 64*). It is painted concrete block construction with a simple gable asphalt shingle roof. Given its age and utilitarian use, the building appears to be in fair shape.
