**The City of Clearwater
North Ward School**

Building Assessment
August 13, 2024

Final Issuance

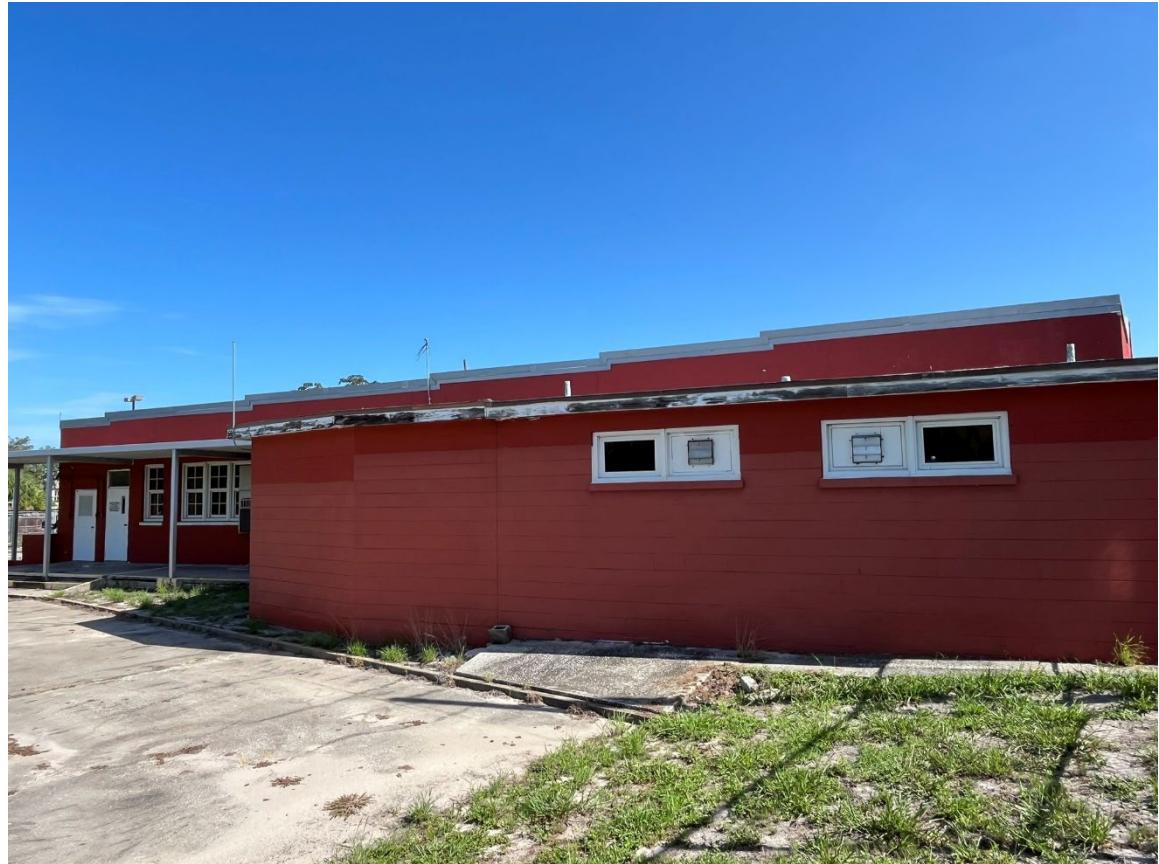
Figure 65 – Building 6

Building 6 is a low, concrete block building immediately to the south of Building 3 and connected via an open walkway and aluminum canopy (*Figure 65*). The building houses restrooms and a storage room. The building construction is rudimentary, and given its deteriorated condition, not a candidate for restoration.

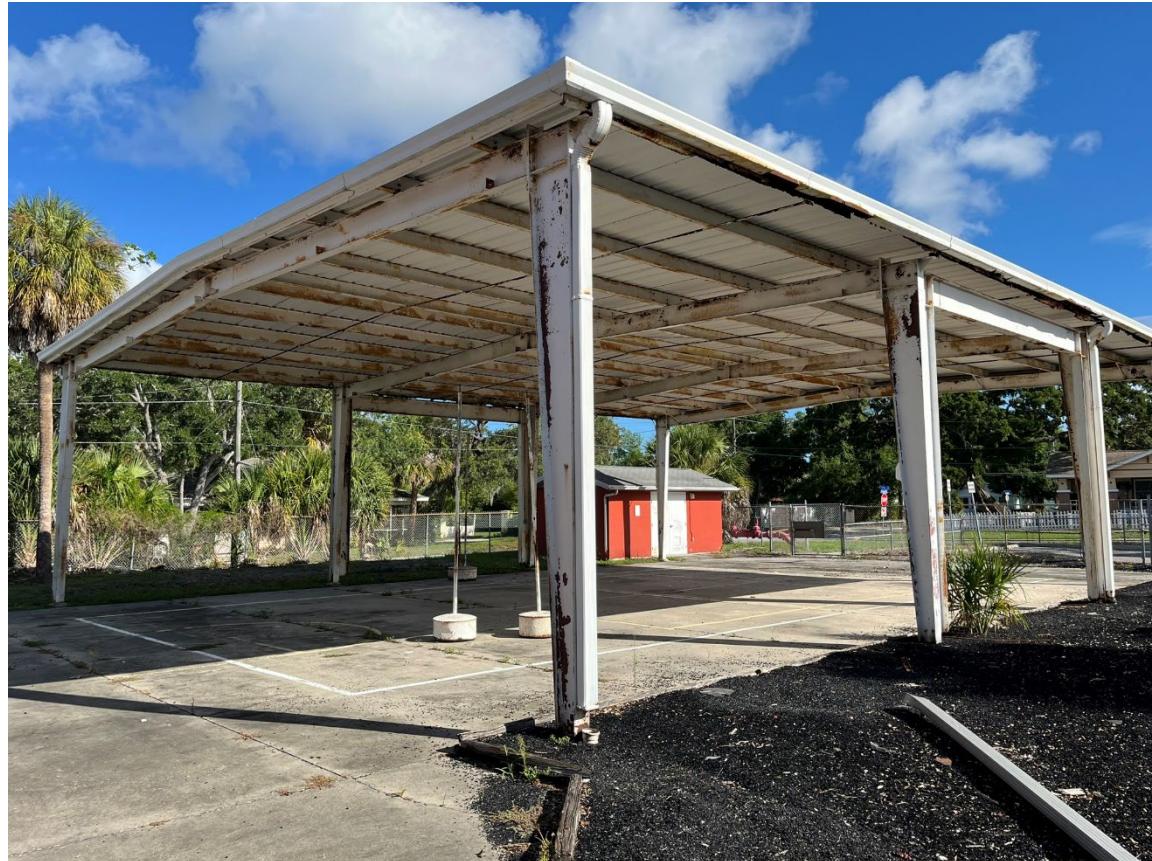
Figure 66 – Covered Play Court

A covered play court (*Figure 66*) sits on the north side of the property. Its design and construction are conventional for District standards: pre-engineered metal frames, metal roof deck, aluminum gutters and downspouts, and concrete slab underneath with painted striping.

The metal structure is significantly deteriorated with rust due to failure of the coating system and lack of maintenance. The concrete slab has major cracking.

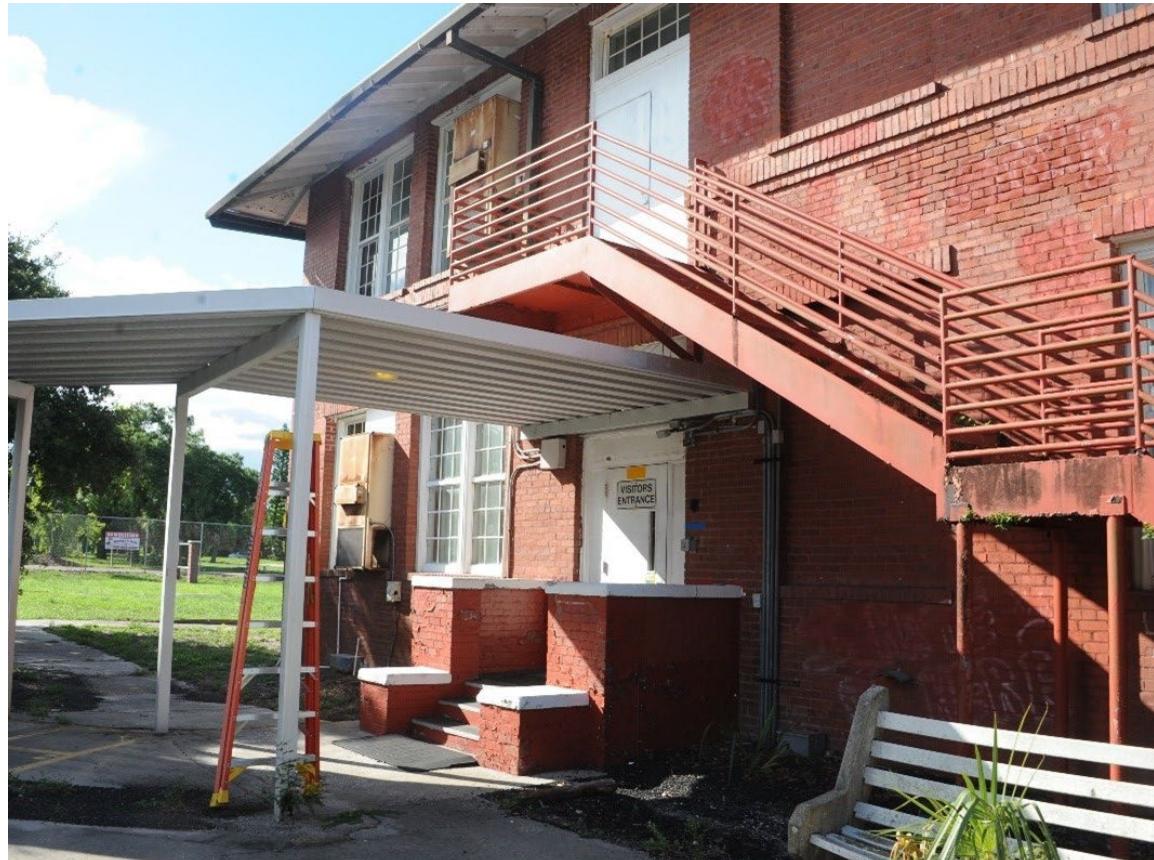
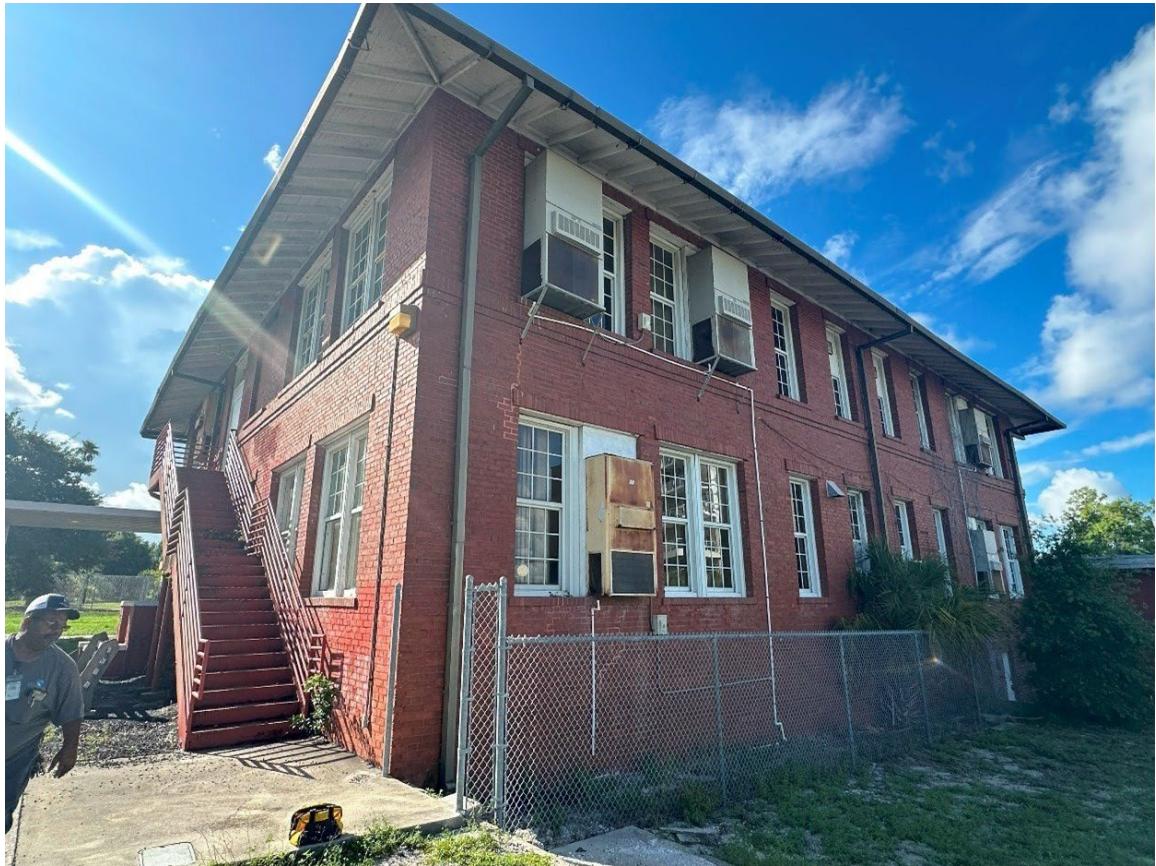
The existing 1915 and 1926 Buildings structure consists of load bearing wood studs on both sides of the corridor. Exterior walls consist of load bearing brick masonry (*Figure 68, Figure 69*). Settlement cracks were found in the brick bearing walls. It may be necessary to selectively underpin the foundations in these areas. Additional geotechnical studies will be necessary to determine the cause of the settlement. The corridor walls consist of wood studs that are 2x6 nominal @ 16" on center (*Figure 74*). The second-floor framing is 2x14 @ 16" on center. They span from the exterior load bearing walls to the corridor walls. First floor framing consists of 2x8 @ 16" on center. The framing is supported by wood girders in the crawl space spanning 12 feet supported by brick piers that were in good condition. The wood floor framing has the capacity to support a 40psf loading for classrooms. There is a concrete floor on the first floor of the 1926 building that can be seen in the boiler room (*Figure 73*). There is a metal pan stair providing egress from an assembly room on the second floor of the 1915 building (*Figure 70*). The stairs are corroded and should be replaced.

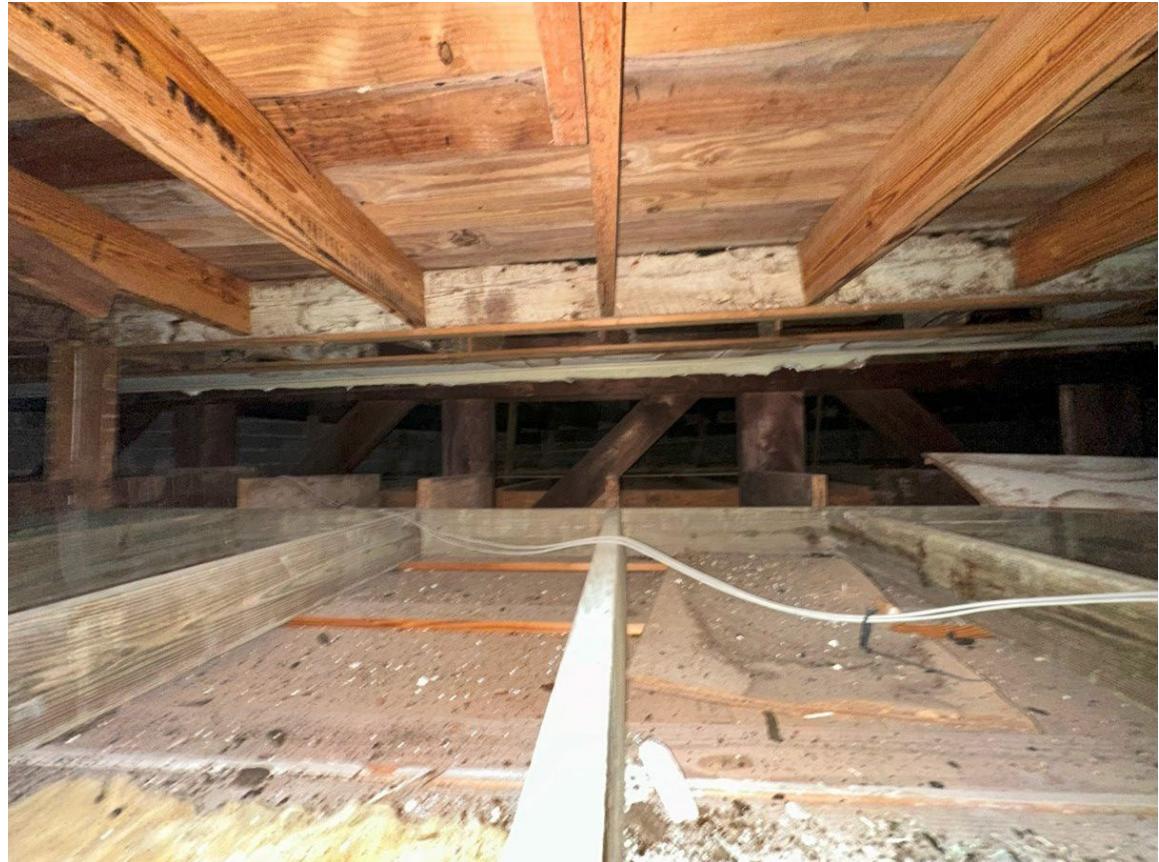
Figure 72 – View of attic space at Building 3, north side

The one-story building on the north side of the site consists of 8" thick masonry walls supporting 2x8 wood framing spaced 24" on center supporting 1" thick tongue and groove wood framing. There did not appear to be any hurricane strapping to tie the roof framing to the bearing walls (*Figure 72*).

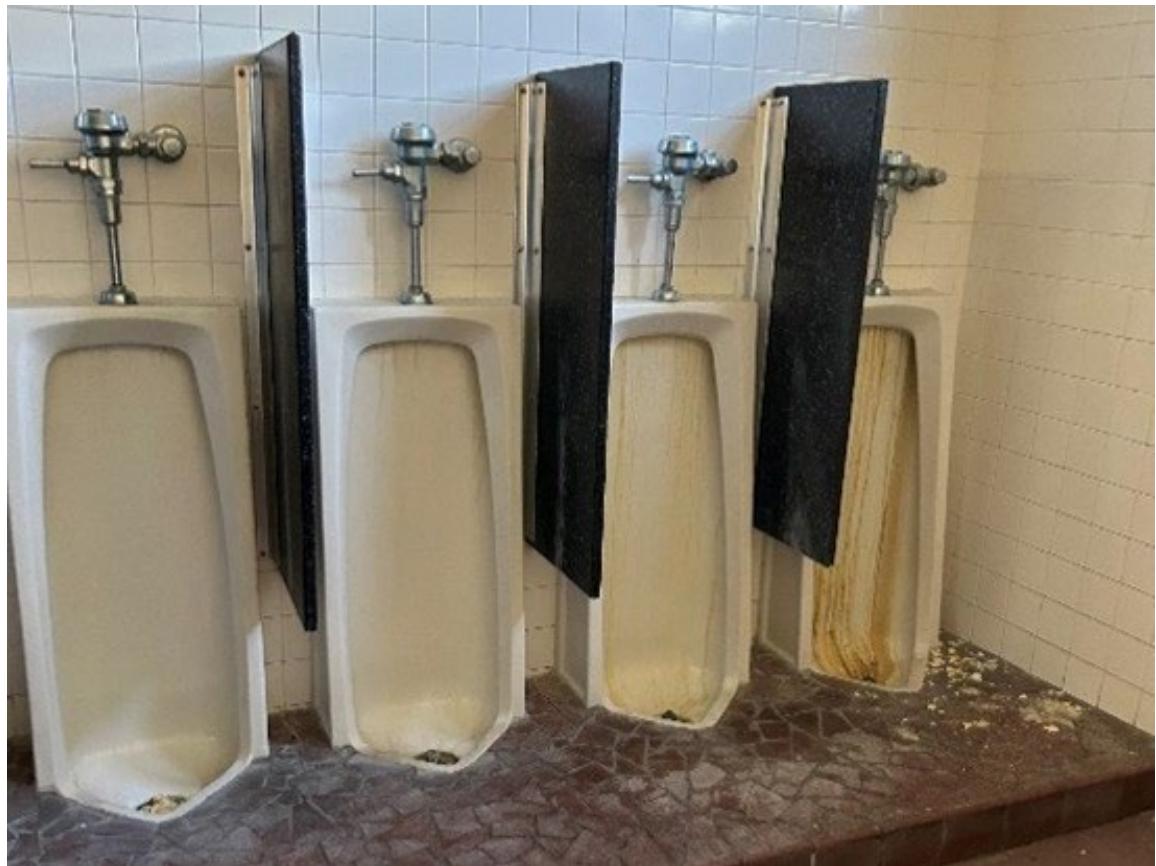
Figure 75 – Existing bank of urinals

All equipment and piping appear to be beyond its useful life.

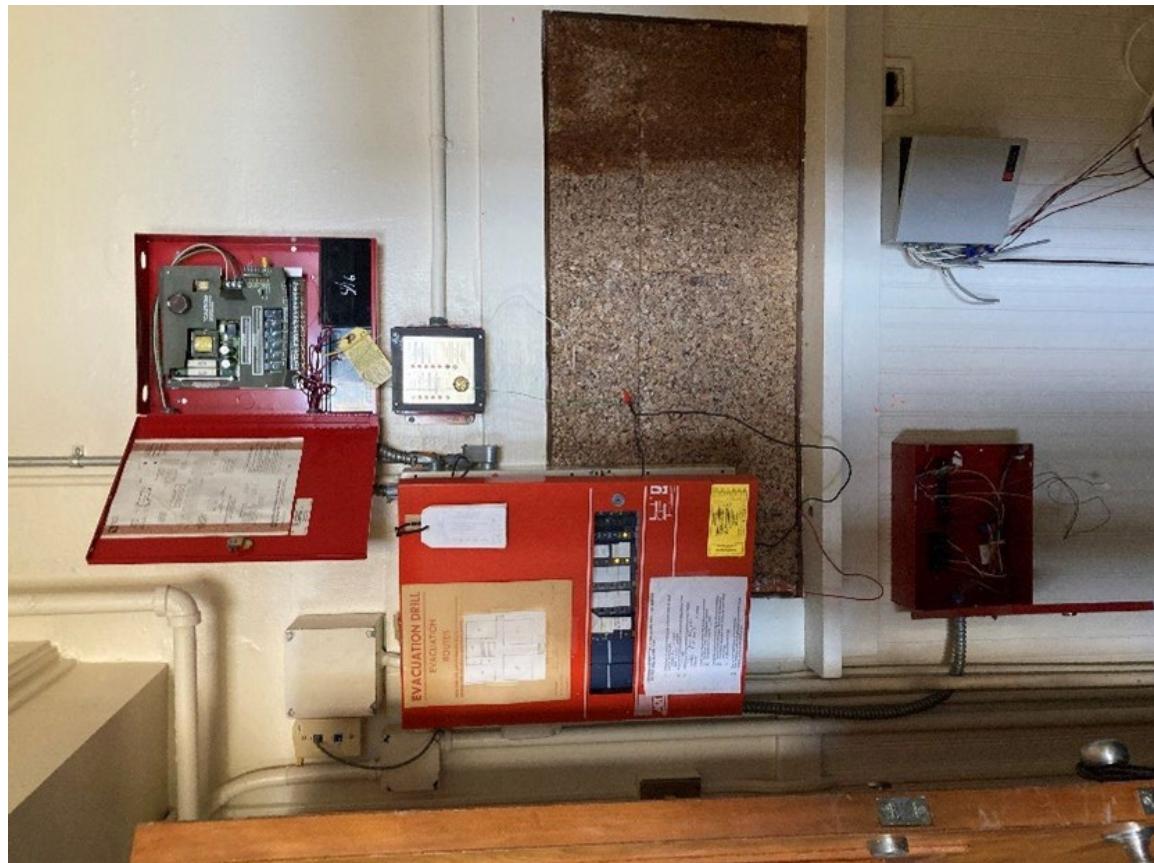
This system, generally very limited by today's standards, is in poor condition.

Figure 95 – Existing fire alarm control panel

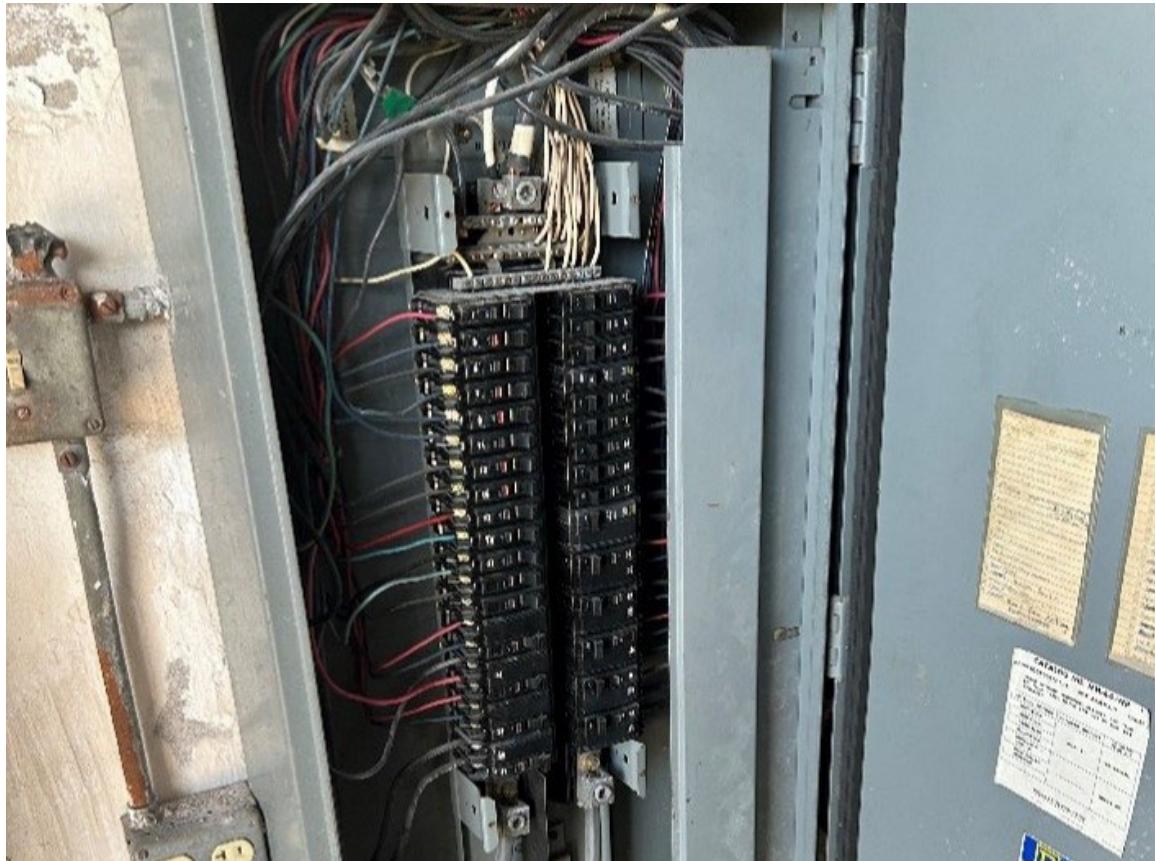
This building has a 120/240 volt, 1 phase, 3 wire, 225-amp feeder that is routed underground from Panel MDP to the electrical room in building 2. The feeder terminates in a 225-amp main lug only panel, with no main breaker. This is a code violation that will need to be corrected.

Figure 97 – Building 3 main lug only panelboard

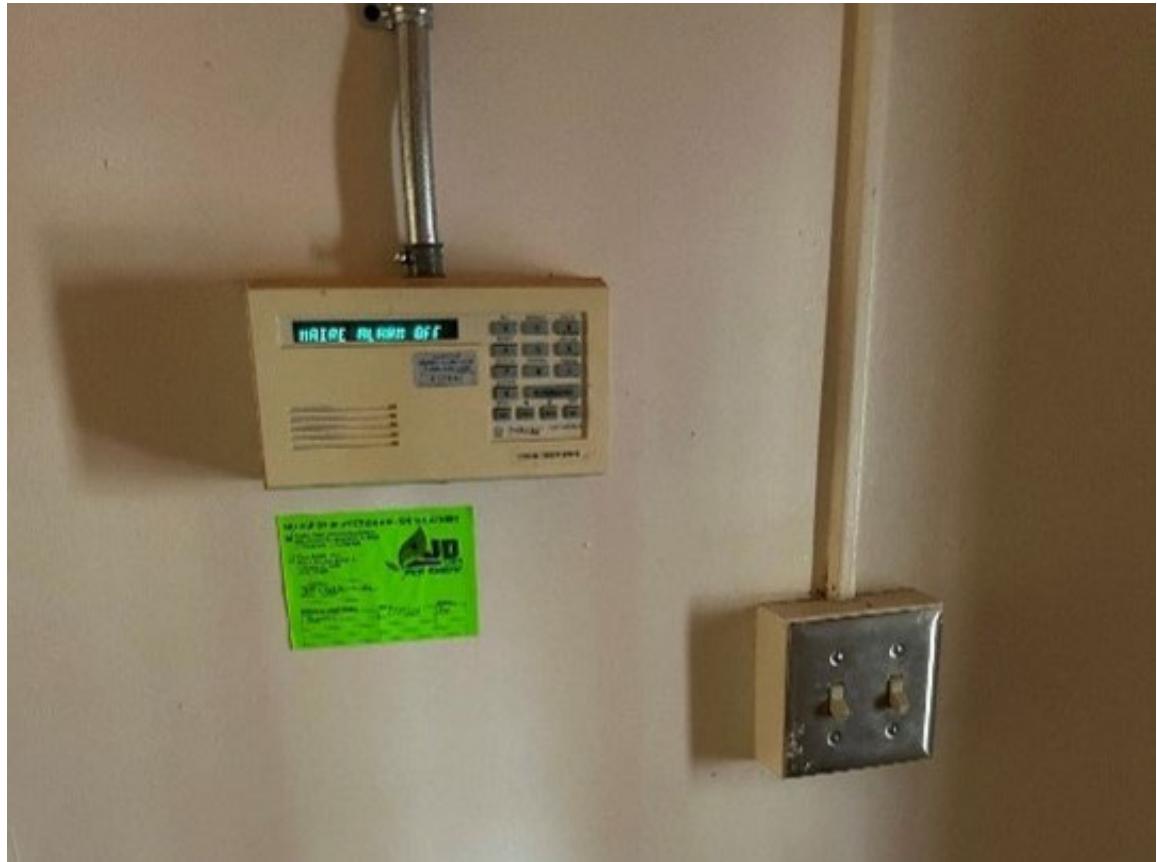
The voice/data network is in the same condition as Building 1. The building has an active intrusion detection security system.

Figure 98 – Security system keypad
