# 1105 CARLTON STREET BUILDING ASSESSMENT

1105 CARLTON STREET  
CLEARWATER, FL 33755

CITY OF CLEARWATER

FINAL

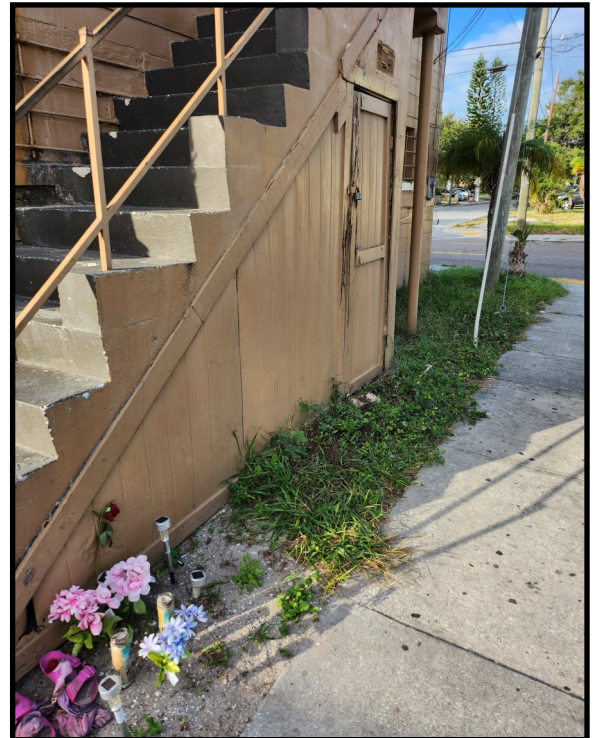
Photo 08 -

The second floor is accessed by cast in place concrete stairs on the north and south side of the building. The handrail posts are embedded in a concrete block that is post installed on the stairs. The north side posts, top and bottom rails are square tube without intermediate pickets between the posts (Photo 8). On the south side the posts and top rail (no bottom rail or pickets) appear to be conduit (Photo 9). Both sets of handrails are structurally deficient. The landings at the second floor are partially supported by steel pipe columns which show signs of significant corrosion at the bases and cap plates (Photos 10 & 11).

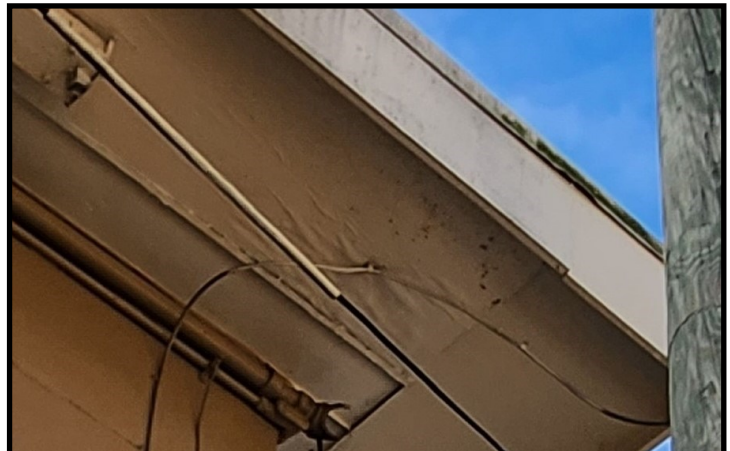
Photo 20 -

There are signs of water damage at various locations around the soffit (Photo 20). There is an existing wood canopy over the front entry which appears to be in satisfactory condition, there is also a metal awning over the front door directly under the canopy that is in disrepair (Photo 21). There are a variety of windows throughout the building ranging from jalousie to double hung, we were not provided any product or attachment information on any of the windows, therefore we cannot comment on their available wind load capacity or impact resistance. The exterior wood door frames show signs of water damage and rot (Photo 22). The exterior doors are in a similar state and the hinges are barely attached (Photo 23).

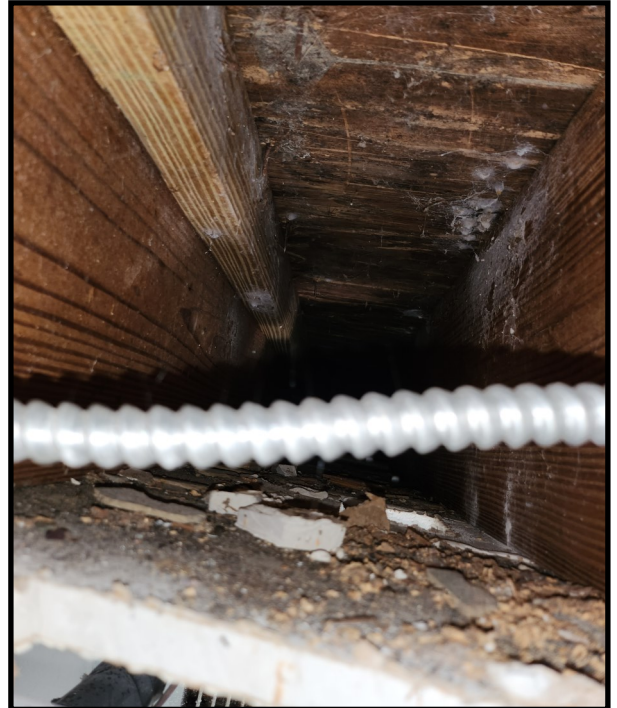
Photo 26 -

The ceiling on the first floor shows signs of water damage (Photo 24). This damage is consistent with what is seen on the visible portions of the second floor joists and decking, there also appears that some repair have been made by sistering and new wood member to the existing joist (Photos 25 & 26). It is crucial that the first floor ceiling be removed to see the extent of the damage and see which members shall be replaced or repaired. The visible portion of the wide flange beam supporting the second floor joists appears to be acceptable. The pipe column supporting the wide flange beam on the east side appears to be in satisfactory condition, the support on the west end is encased with in wall but assumed to a pipe column but the condition is known.

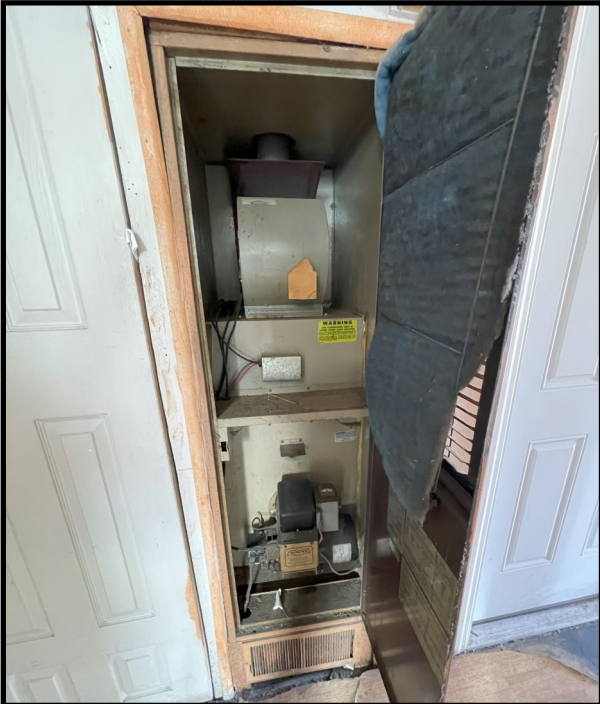
Photo 10 -

2ND floor heat is provided by a fuel fired furnace located in a closet. We were unable to determine if the unit was in working condition. During the site evaluation we were unable to locate the fuel tank (Photo 10).

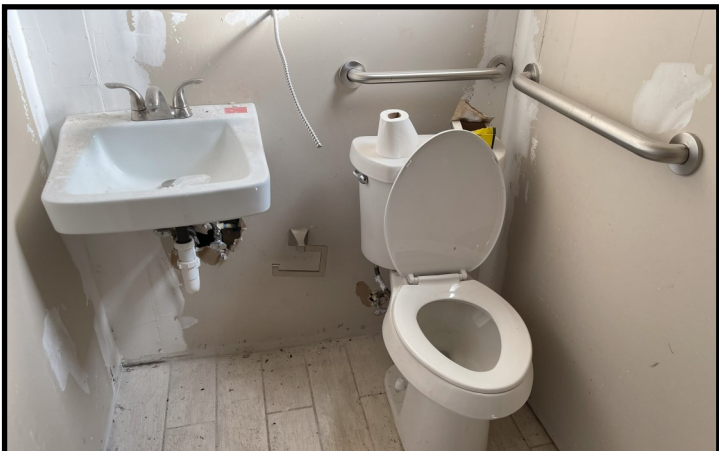
Photo 11 -

The toilet rooms appeared to have functioning toilets and lavatories (Photos 11 & 12).

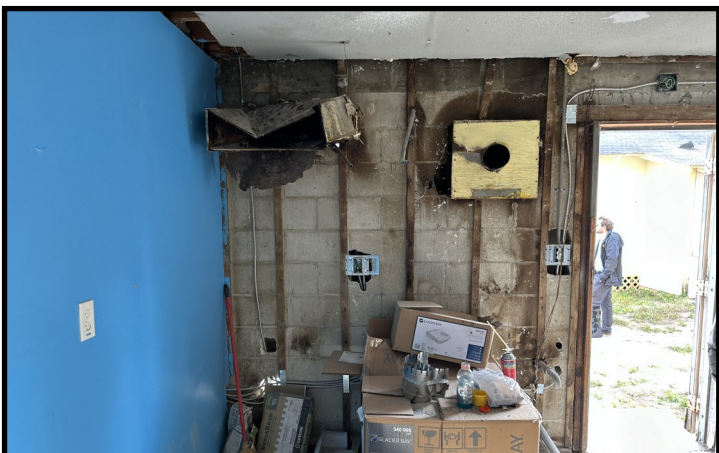
Photo 13 -

The restaurant kitchen has been removed with no fixtures remaining (Photo 13).

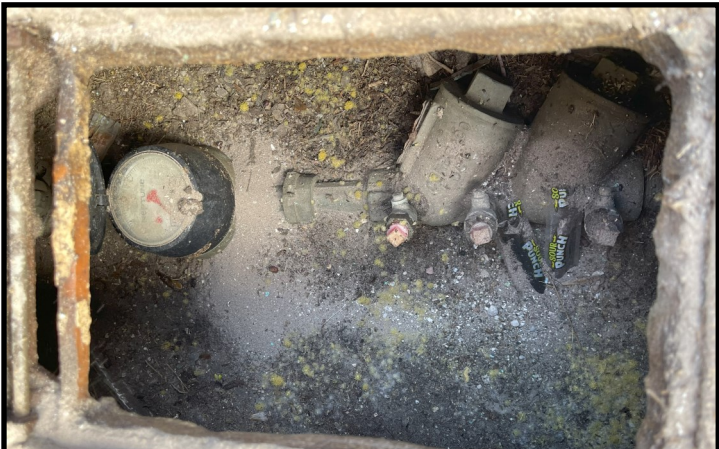
Photo 14 -

The existing domestic water plumbing system utilizes CPVC and copper pipes. There is an existing water meter and backflow preventor in a meter box outside of the building (Photo 14.)

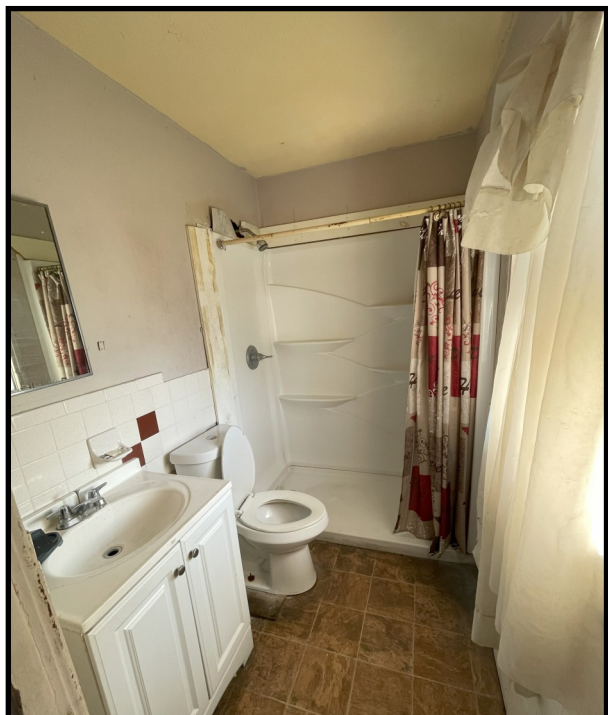
Photo 16 -

The toilet room appeared to have a functioning toilet, lavatory, and shower (Photo 16).

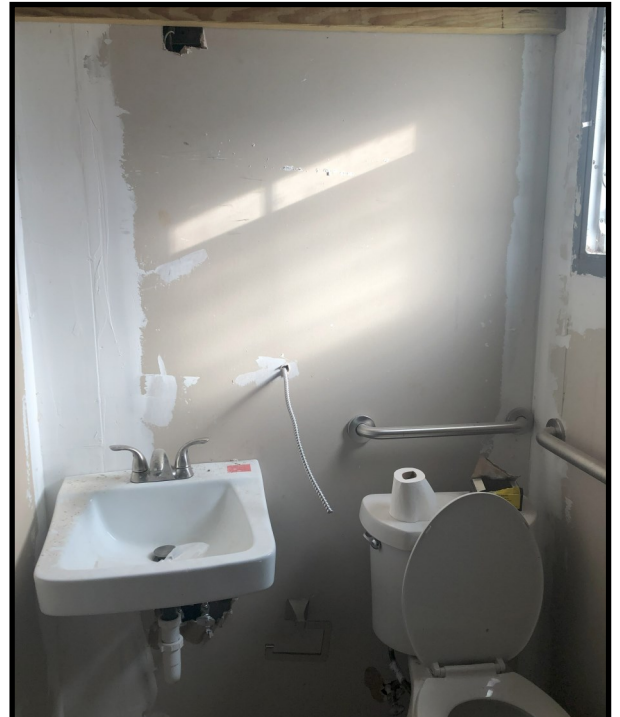
Photo 14 -

It appears that the 1st floor building electrical system was partially under renovation, however the construction work was not complete. MC cables were cut off and not connected to wiring device outlet boxes and equipment (Photo 14 & 15).

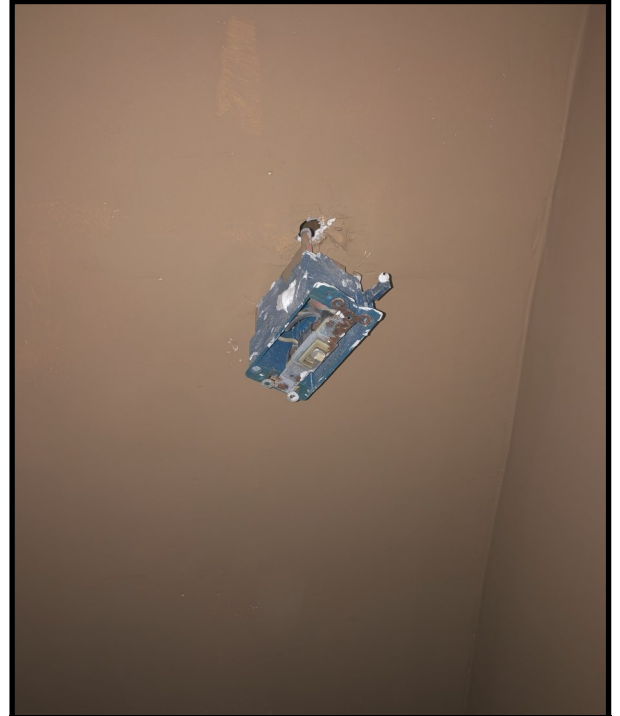
Photo 18 -

Light fixtures were not secure to the ceiling and missing outlet boxes (Photo 16). Some light fixtures were not working (Photo 17). Some light switches were missing cover plates and outlet boxes were not secured in walls in accordance with the 2017 NEC (Photo 18). Some light switches were disconnected and abandoned in the outlet box (Photo 19). The 2017 Florida Energy Efficiency Code requires automatic lighting controls for a restaurant space. New lighting control system with occupancy/vacancy sensors and dimmer switches shall be installed per FBC.

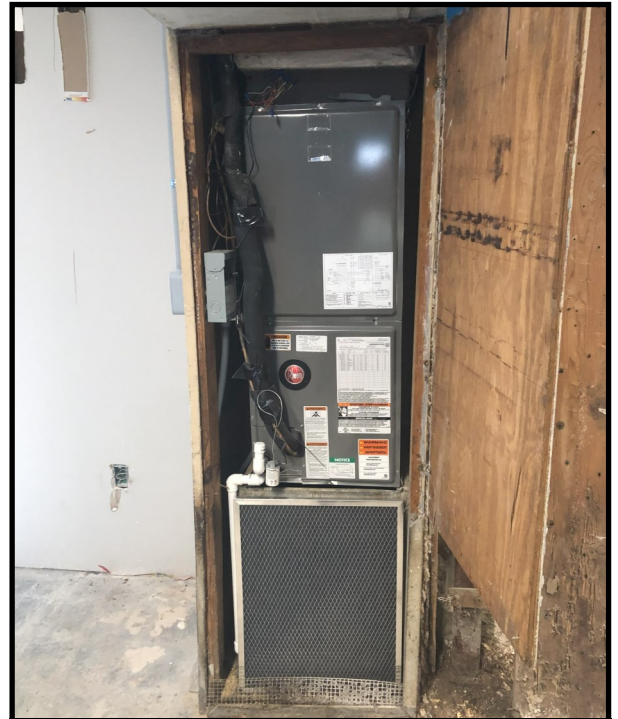
Photo 22 -

There was an Air Handler unit installed in the closet (Photo 22). The disconnect switch for the AHU does not have the required minimum clearance per NEC (Photo 23). This disconnect switch shall be relocated to maintain a minimum code clearance.

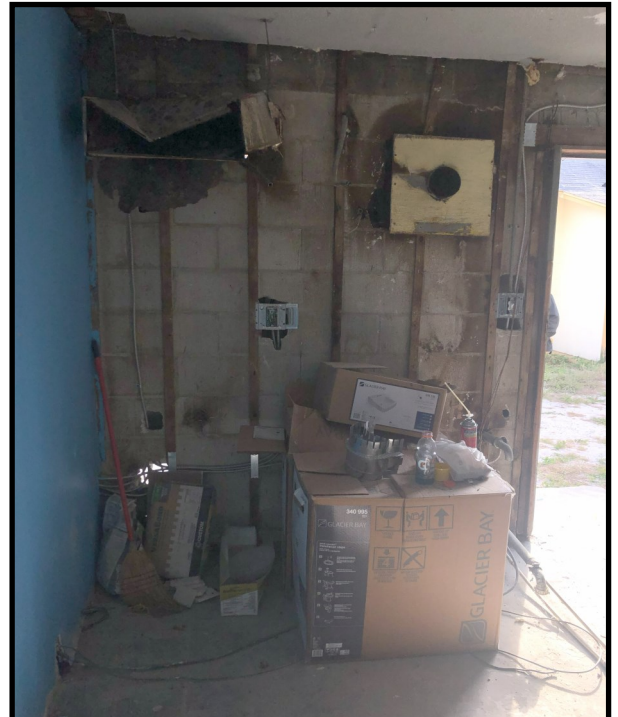
Photo 26 -

Kitchen equipment, kitchen hood, exhaust fan, etc. were not installed (Photo 26). If the first floor is to be renovated to a restaurant, additional electrical panels and circuits will be required to accommodating the new loads. The electrical distribution system will also need to be modified to meet the intended building occupancy classification.

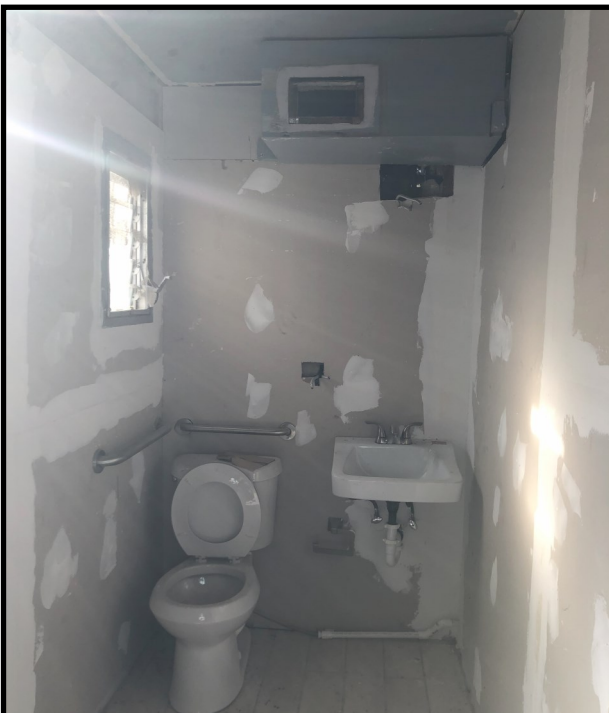
Photo 27 -

No light fixtures, switches and receptacles were installed in 1st floor restrooms (Photo 27 & 28). Receptacles within 6ft of a sink shall be GFCI protection receptable per NEC.

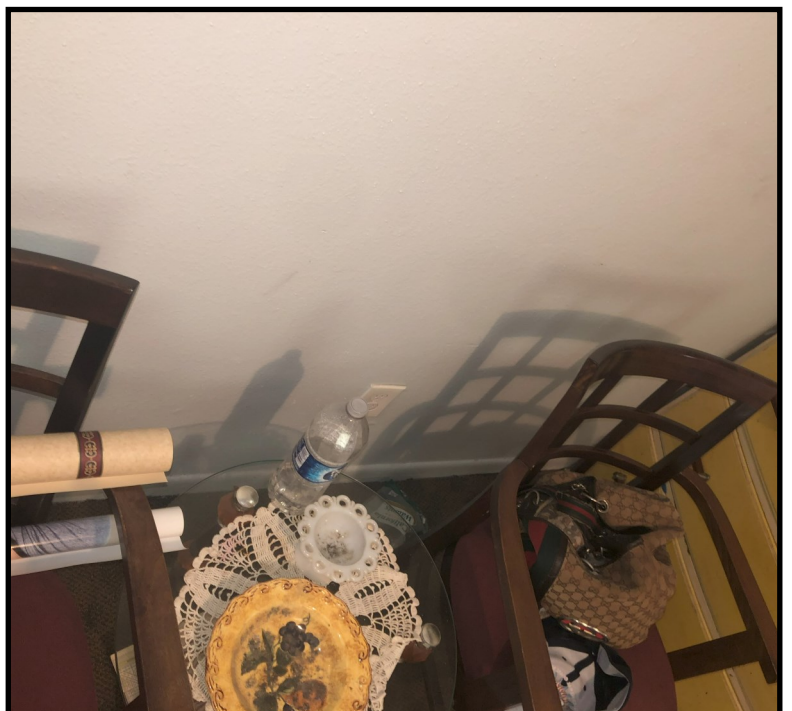
Photo 36 -

Dwelling unit dining rooms, living rooms, bedrooms, hallways, kitchen and laundry area receptacles shall be provided with Arc Fault Current Interrupter (AFCI) protection per NEC. The receptacles on the 2nd floor in these areas are not AFCI protected (Photo 36 & 37). AFCI type circuit breakers shall be used in new panel or provided with new AFCI receptacles.

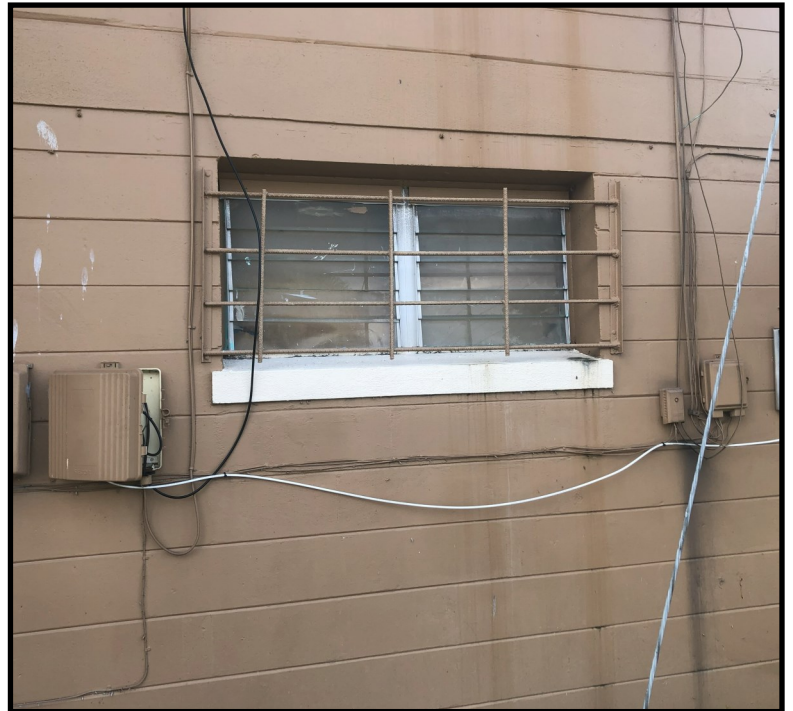
Photo 38 -

There are three master antenna television (MATV) enclosures located at building north wall serving three tenants on the second floor (Photo 38) and there is one MAVT enclosure located at building east wall serving restaurant on the first floor (Photo 39).
